MODEL  
2014MY Optima  
(QF)

NUMBER  
071

## TECHNICAL SERVICE BULLETIN

**SUBJECT:** FRONT WHEEL BEARING NOISE

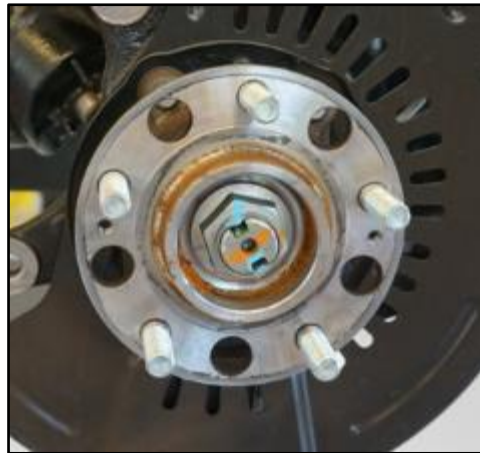
This bulletin provides the procedure to replace BOTH front wheel bearings on 2014MY Optima (QF) vehicles that experience an unusual noise (humming or popping) that is isolated to the front wheel bearing. The bearings normally do not have any looseness; the concern is solely noise-related and may be very difficult to pinpoint.

To enhance customer satisfaction, this bulletin outlines the replacement of BOTH front wheel bearings, even when only one side is affected.

1. Replace both both front wheel bearing with new ones by referring to the “Driveshaft and axle → Front Axle Assembly → Front Hub/Knuckle → Repair Procedures” chapter in the applicable Workshop Manual on KGIS.
2. Test drive the vehicle to ensure the problem is resolved.
