Technical Service Bulletin

GROUP	NUMBER
CAMPAIGN	16-01-046
DATE	MODEL(S)
NOVEMBED 2016	SONATA (VE)

SONATA (YF) UNDERBODY CORROSION PREVENTATIVE SERVICE (SERVICE CAMPAIGN 946)

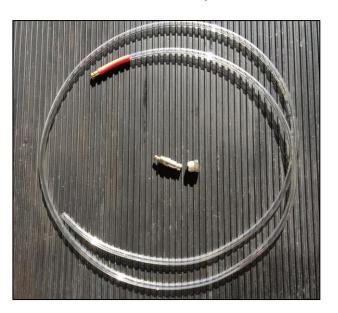
2b. Attach the compression fitting to the tubing on the new nozzle assembly.

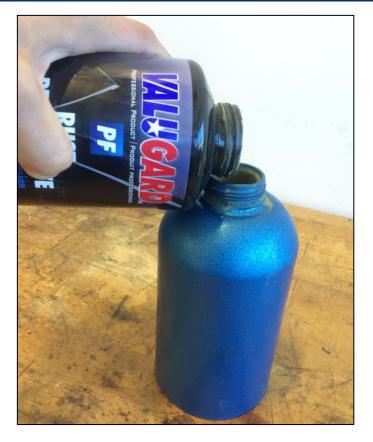
Fill wax gun reservoir with cavity wax.

Prime the wax gun by spraying into a trash bag (or similar) until a light mist is visibly coming out of the nozzle.

Air supply pressure must be set to 70 psi.

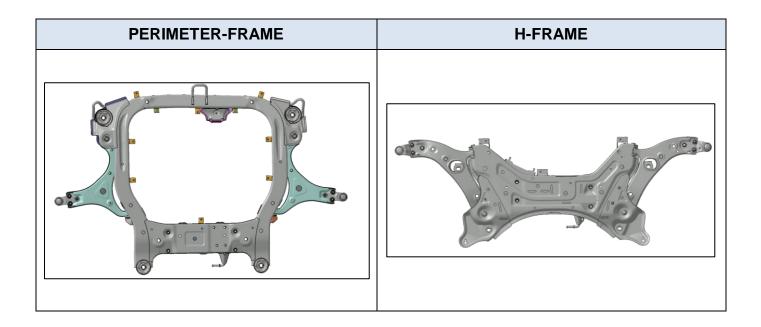
There are 2 types of subframes, perimeter-frame and H-frame. The application of cavity wax and undercoating spray is slightly different for each type.

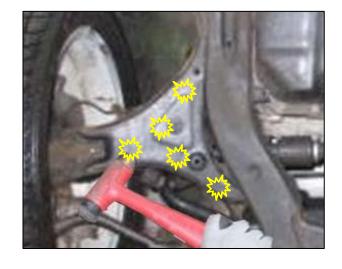
ALUMINUM

- 2. Lightly tap the vehicle underbody with a 16 oz. hammer to loosen debris and the PVC coating in the following locations:
 - Front lower control arms

If the vehicle has front lower control arms made of aluminum, no preventative maintenance procedures are required on the front lower control arms.

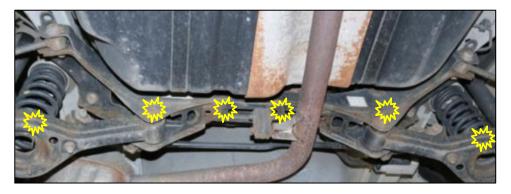
Rear lower control arms and cross member

If the vehicle has rear lower control arms made of aluminum, no preventative maintenance procedures are required on the rear lower control arms.

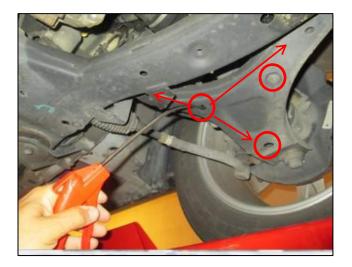
3. Remove the remaining debris by inserting an air nozzle into the locations shown, then blowing air in multiple directions.

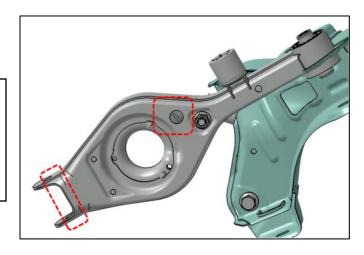
- Rear lower control arms

If the vehicle has rear lower control arms made of aluminum, no preventative maintenance procedures are required on the rear lower control arms.

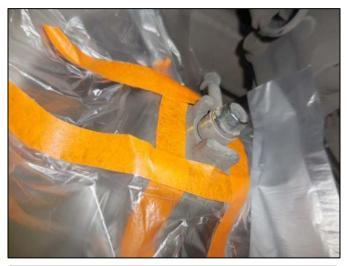
1. Clean the brake banjo bolt surfaces at all 4 calipers using a wire brush. Then wrap the brake assemblies with plastic bags to protect them from overspray. Use tape to secure the plastic in place. Leave the banjo fitting area exposed, as shown.

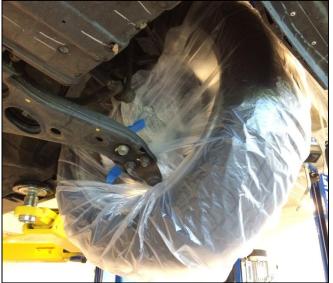
2. Wrap large plastic bags around the wheel/tire/brake assemblies to protect them from overspray. Use tape to secure the plastic in place.

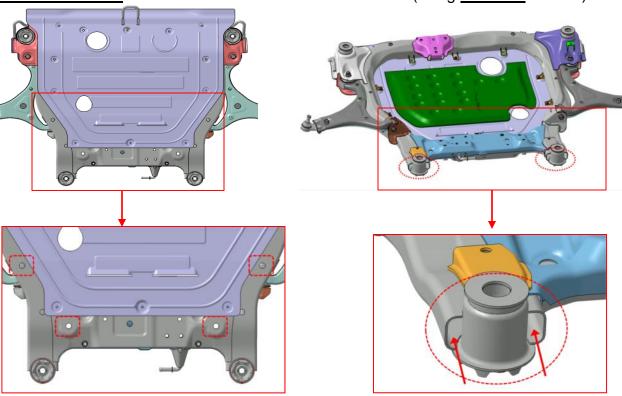
1a. **Perimeter-frame**: Front cross member – Interior surfaces (using <u>"outside"</u> nozzle)

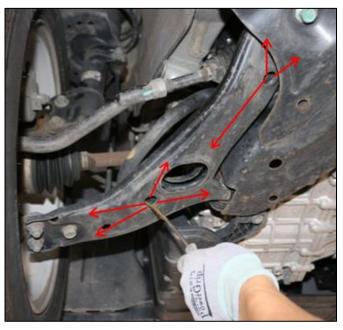
<u>H-frame:</u> Front lower control arms – interior surfaces (using *"inside"* nozzle)

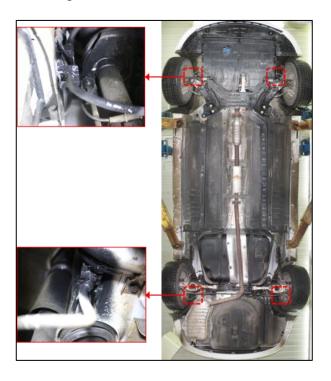
6. Front and rear brake banjo fittings and mounting brackets.

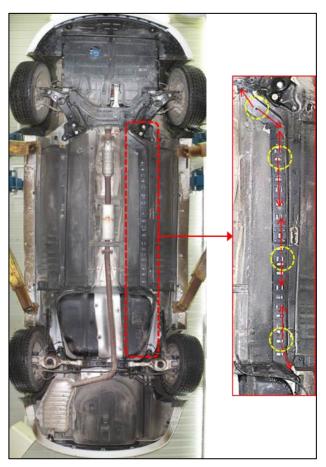
7. Fuel and brake lines.
