GM Bulletin No.: 21710
Date: March 2016

SUBJECT: Service Update for Inventory and Customer Vehicles
Manual Shift Lever Loose
Expires with Base Warranty

MODELS: 2015-2016 Chevrolet Colorado
2015-2016 GMC Canyon
Equipped with Manual Transmission (RPO N8D)

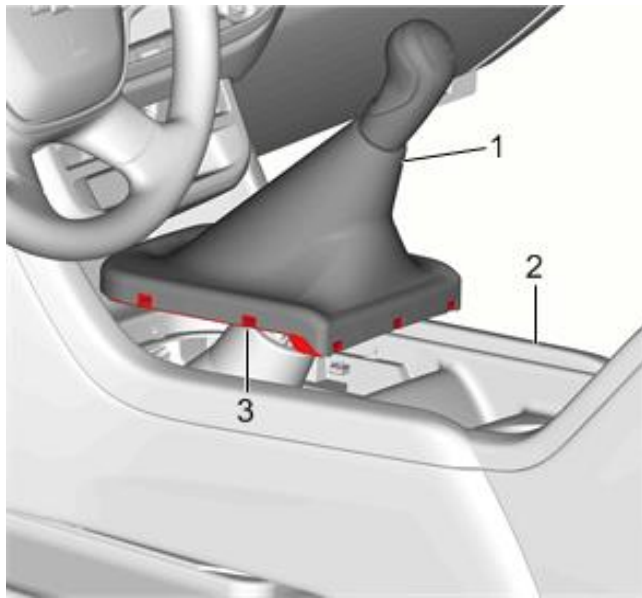
3785069

1. Using a flat-bladed trim tool, carefully release the retaining tabs on each side of the boot (1) in order to disengage the boot retainers (3) from the floor console (2).
2. Pull the boot upward to access the control lever set screw.

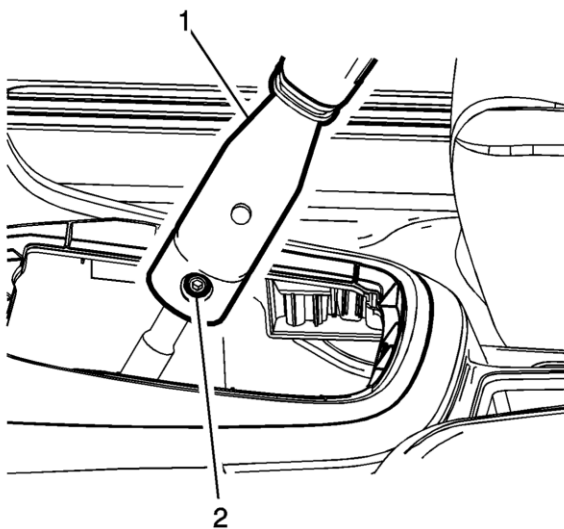
2613631

3. Remove the set screw (2) from the shift lever (1).
4. Remove the shift lever assembly from the transmission control lever.

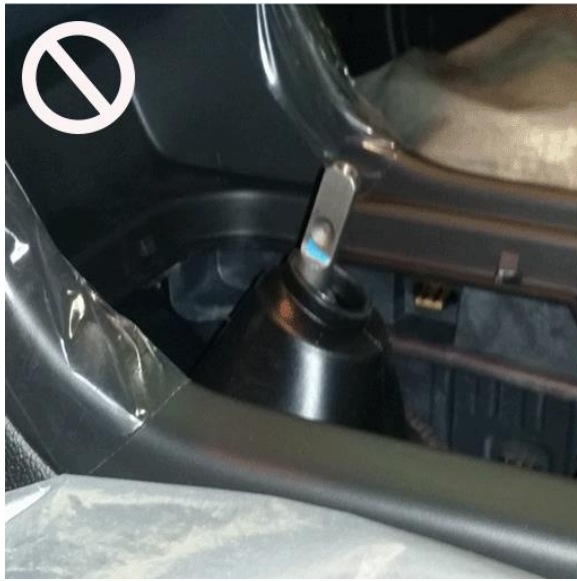
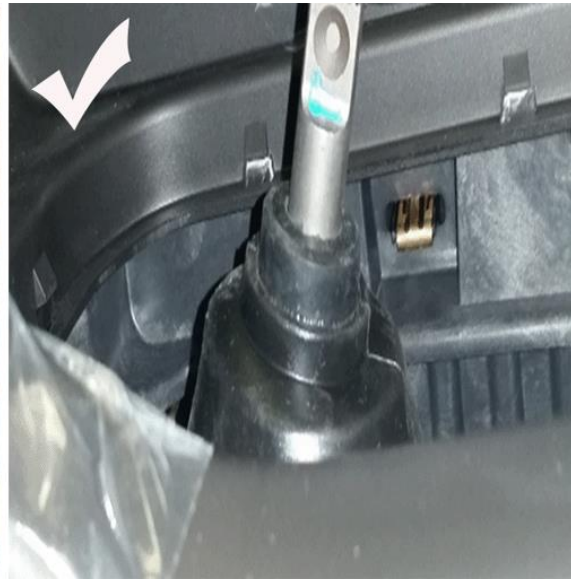
4453957

5. Ensure the transmission control lever boot is secured as shown above.

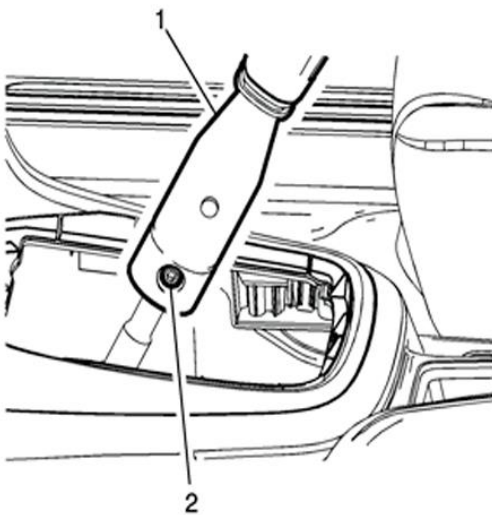
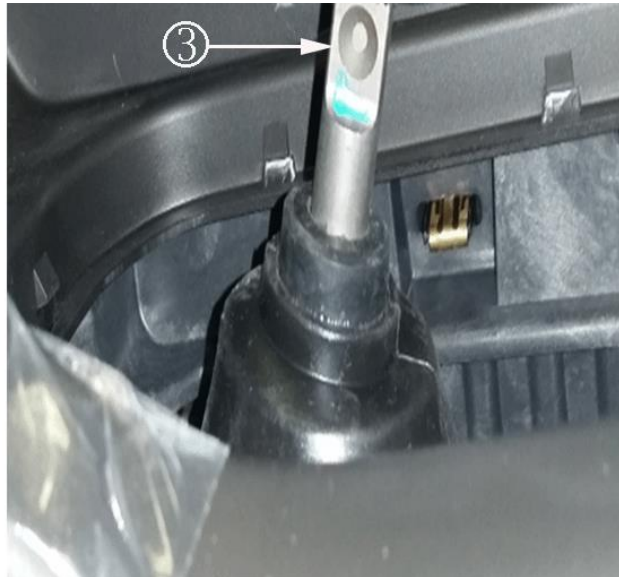
4453962

6. Install the control lever and boot assembly to the transmission control lever, aligning the set screw (2) threaded hole with the indent (3) on the transmission control lever.
7. Apply medium strength blue threadlocker to the shift lever set screw threads.
8. Install the shift lever set screw and tighten to 9 Nm (80 lb in).

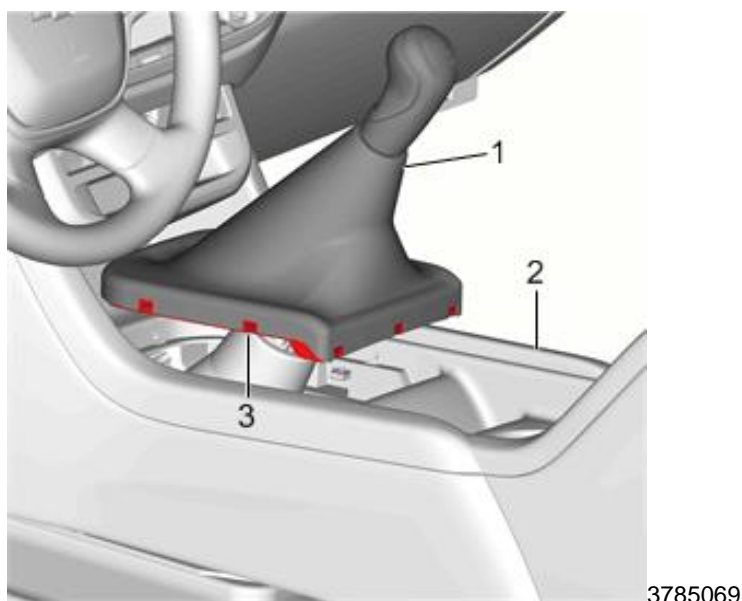
9. Position the boot tabs flat on the console opening and push downward on all four sides of the boot (1) in order to engage the boot retainers (3) with the floor console (2).
