**Title: ProStar Sleeper Cab Strut Noise or Air Leaks**

**Applies To: All ProStar Sleeper Cabs**

Diagnosis of a ProStar sleeper cab noise or air leak at rear strut assembly

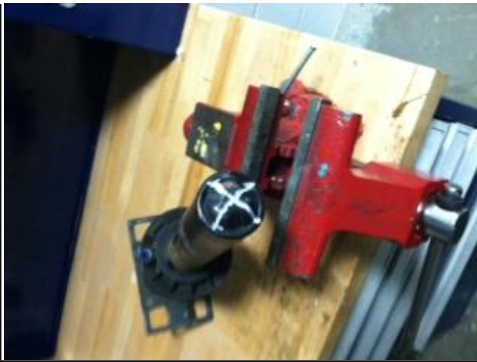
Figure 1 Marking the bottom of the strut

To correctly diagnose a ProStar sleeper cab strut noise or air leak complaint the follow the steps shown in the links below. It is critical to document the failure and mark the strut accordingly, use arrows, circles, and good descriptions. **Do NOT replace BOTH cab struts if only one is found defective**

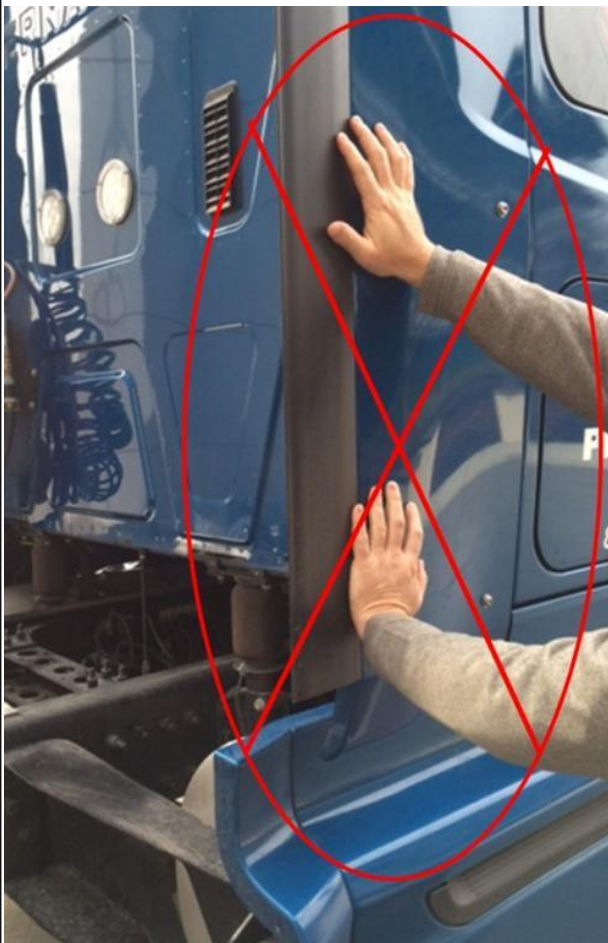
Figure 2 Do not rock cab from this location

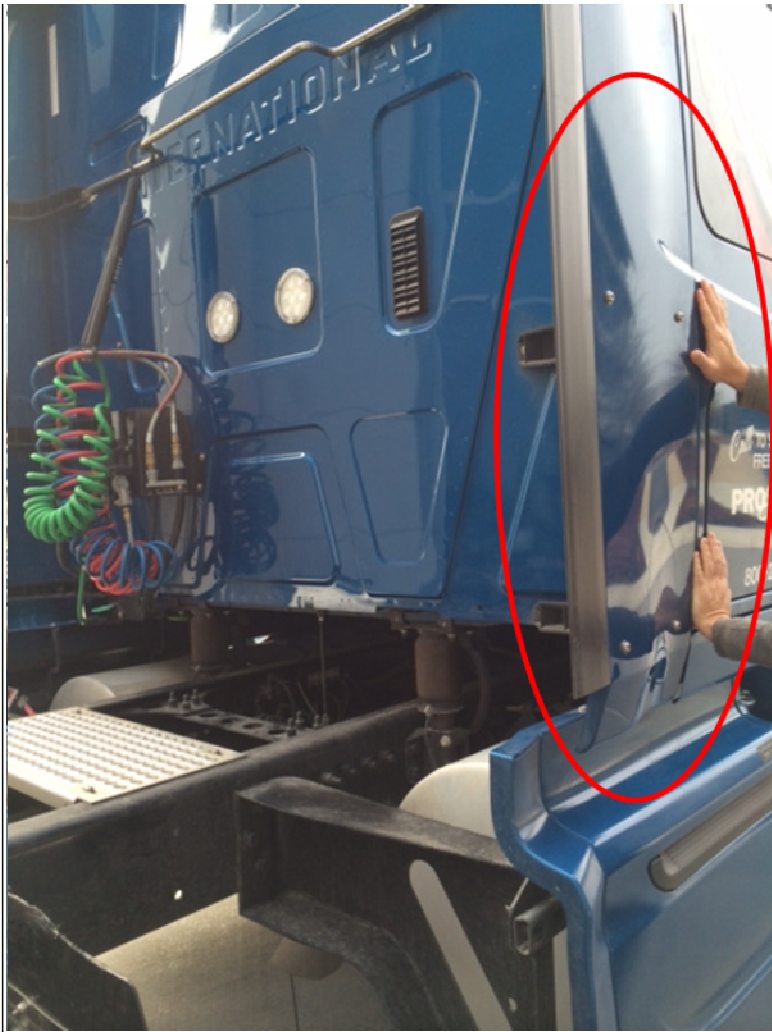
Figure 3 Rock cab, pushing from this location

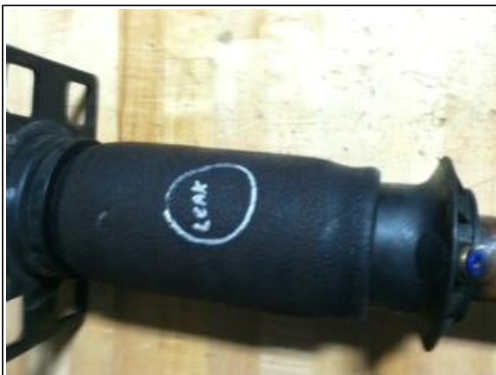
Figure 4 example of marking where air leak was found
