KIN		GROUP Service Campaign	MODEL 2011~2015MY Optima (TF) 2011~2015MY Optima Hybrid (TF HEV) 2009~2010MY Rondo (UN) 2009~2014MY Sedona (VQ)				
		NUMBER	DATE				
		SC135	September 2016				
VOLUNTARY EMISSIONS SERVICE CAMPAIGN							
SUBJECT:	EVAPORATIVE CANISTER INSPECTION						
AND/OR REPLACEMENT (SC135)

EVAPORATIVE CANISTER INSPECTION AND/OR REPLACEMENT

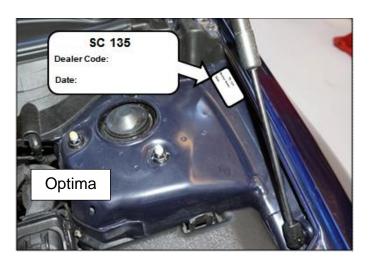
Apply SC 135 Campaign Completion Label onto the body in the area next to the shock tower, as shown. **NOTE: Be sure to clean the mounting surface to ensure proper label adhesion**.
