01 MIL on; intake air hose leaking

01 16 67 2029233/3 July 13, 2016. Supersedes Technical Service Bulletin Group 01 number 13-91 dated May 7, 2013 for reasons listed below.

Model(s)	Year	VIN Range	Vehicle-Specific Equipment
R8	2008 - 2014	All	4.2L and 5.2L engines

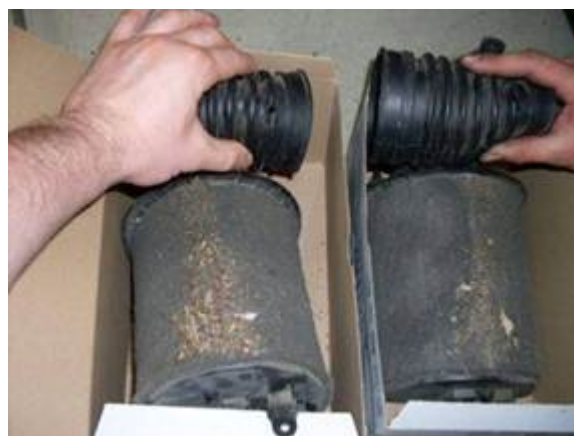
Because the air intake is close to the ground (behind the front wheel), excessive dirt can get into the intake air when the vehicle is driven in unusual conditions. Excessive dirt (Figure 1) can clog the air filter, which may cause illumination of the MIL, misfiring, and fuel trim-related DTCs because:

Figure 1. Example of excessive dirt on air filters.

1. Check for cracks or damage on both of the intake air hoses.
2. If either hose is damaged, replace both hoses and both air cleaner elements.

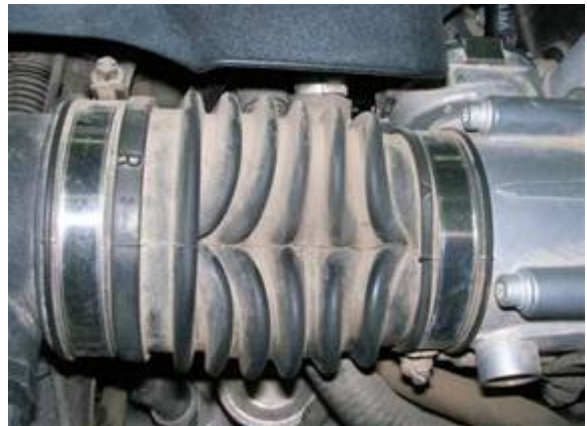
- When the air filter is clogged, not enough intake air is available to the engine, resulting in excessive vacuum in the air duct hose between air filter and throttle valve (Figure 2). The excessive vacuum can damage the air duct hose and cause it to collapse and become deformed. Repeated deformation of the hose causes it to crack.

Figure 2. Vacuum in the air duct hose between air filter and throttle valve.

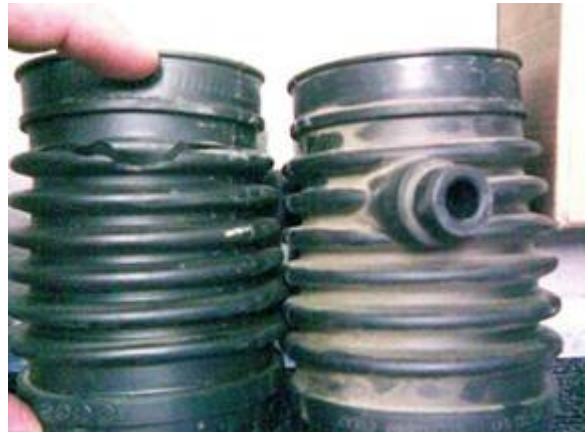
- Bypass air gets in through the crack in the intake hose (Figure 3) which can cause the MIL to become illuminated and can cause fuel trim-related DTCs to be set.

Figure 3. Crack in the intake hose.
