Technical Service Bulletin

SUBJECT:			No:	TSB-16-51-002
LIFTGATE GARNISH REMOVAL & INSTALLATION			DATE:	October, 2016
PROCEDURE – SERVICE MANUAL REVISION			MODEL:	2016 Outlander
CIRCULATE TO:	[] GENERAL MANAGER	[X] PARTS MANAGER		[X] TECHNICIAN
[X] SERVICE ADVISOR	[X] SERVICE MANAGER	[] WARRANTY PROCESSOR		[] SALES MANAGER

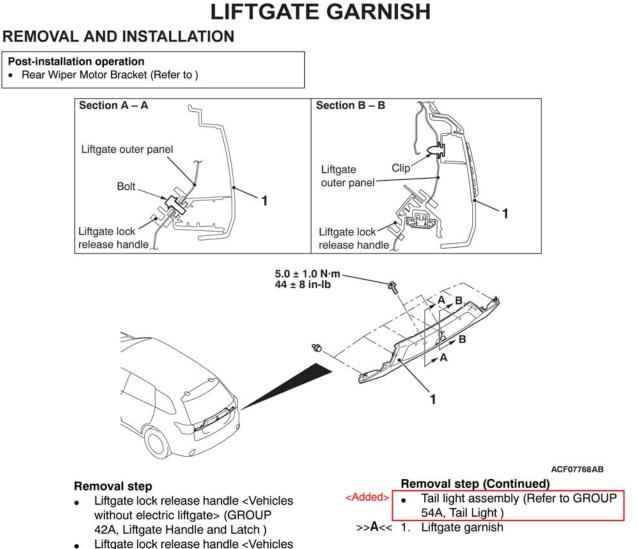
Liftgate lock release handle <Vehicles with electric liftgate> (GROUP 42A, Liftgate Handle and Latch)

>>A<< LIFTGATE GARNISH INSTALLATION

When installing the liftgate garnish, roll up the weatherstrip and secure it by a tape as shown to avoid trapping it.

Please make the indicated changes to the 2016 Outlander Service Manual, Group 51 - Exterior -> Liftgate Garnish -> Removal and Installation.
