# SERVICE BULLETIN

BT16-009

## 2015 – 2016 SENTRA; WIND NOISE FROM A-PILLAR OR FRONT DOOR AREA

**APPLIED VEHICLES:** 2015-2016 Sentra (B17)

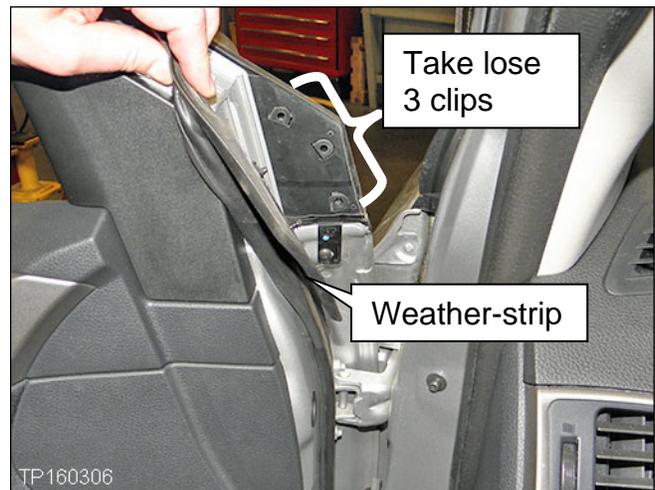
Figure 1

1. Unclip the weather-strip from the front edge of the door as shown in Figure 1.
  - There are 3 snap-in clips in this area.
  - Use a suitable plastic trim tool as needed.
  - Weather-strip is shown already unclipped in Figure 1.

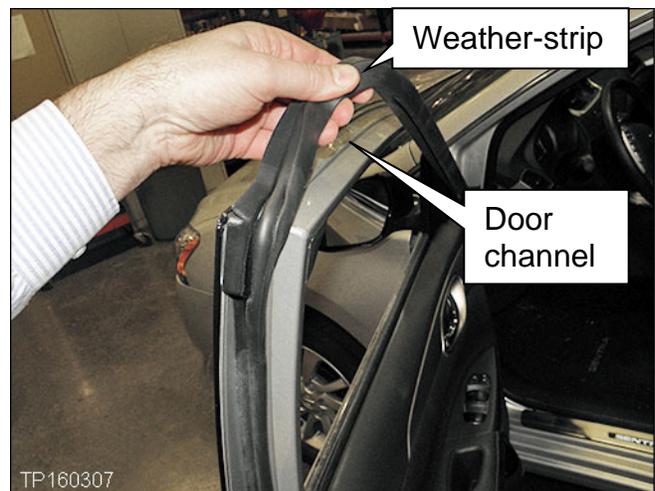
Figure 2

2. Pull the weather-strip loose from its channel across the top of the door and part way down the back of the door.

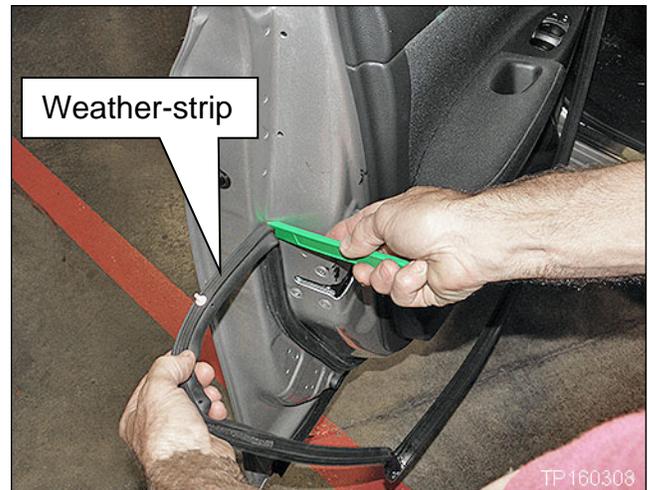
Figure 3

3. Unclip the weather-strip from the back, bottom, and front of the door.
  - Use a suitable plastic trim tool.

4. Install the new weather-strip in reverse order of removal.
  - Make sure the weather-strip is properly secured in its channel across the top of the door.
  - Make sure all of the weather-strip clips are properly snapped in place.
