## 2016 CX-9 Rear Sun Shade Will Not Retract

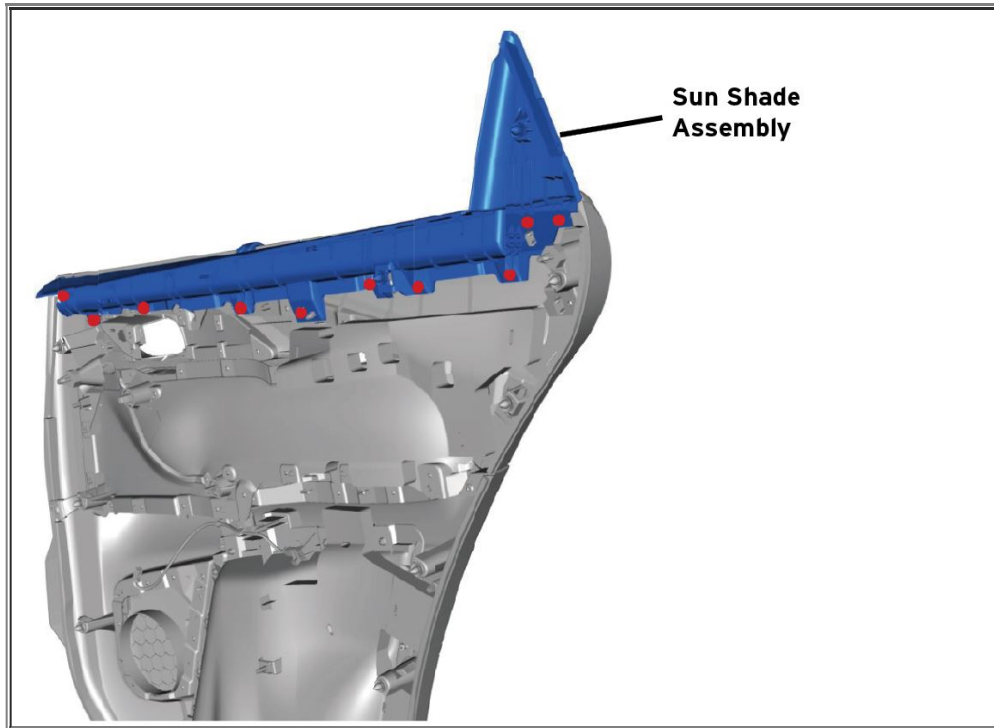
Some customers may complain about a rear sun shade that does not retract. This may be caused by a sun shade that is in the lock position (lock pin is pushed in).

Remove the rear door trim to gain access to the sun shade assembly. Pull the lock pin out to unlock the sun shade.

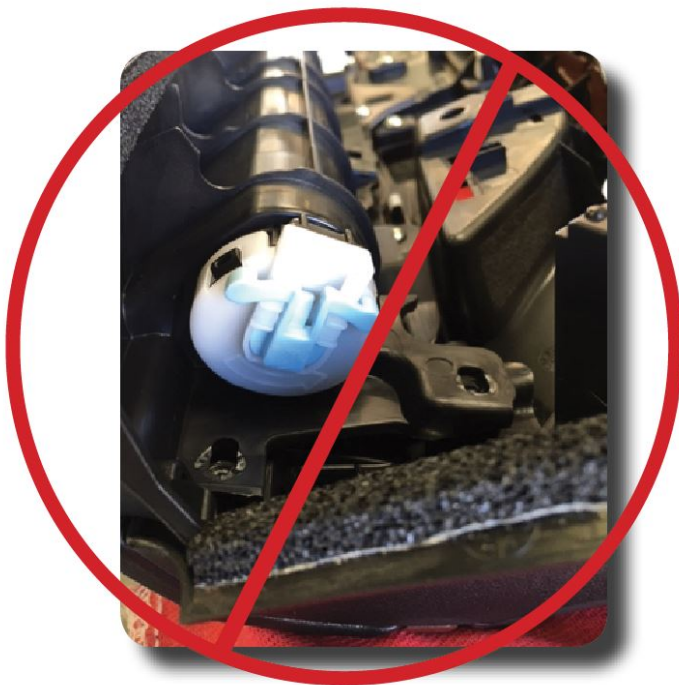
**NG**

**Sun shade is in the locked position**

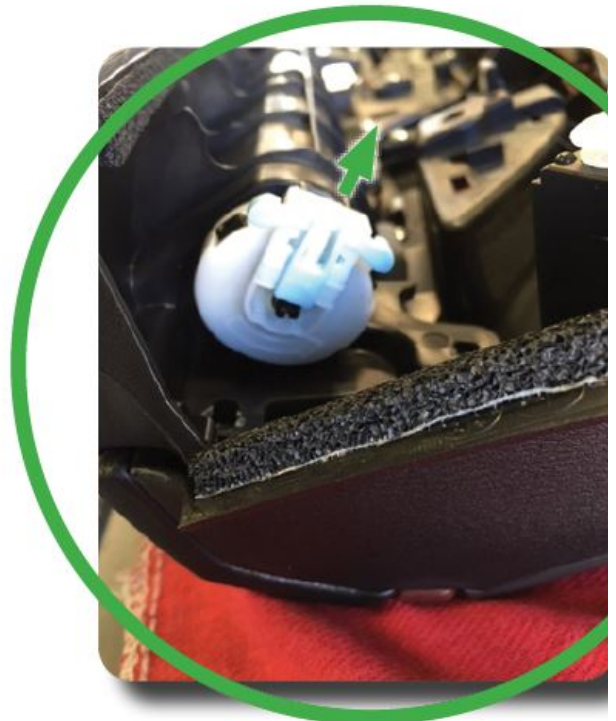
**OK**

**Sun shade is in the unlocked position**
