2016 CX-3 - Exterior Buzz / Rattle Type Noise at 2400 RPM

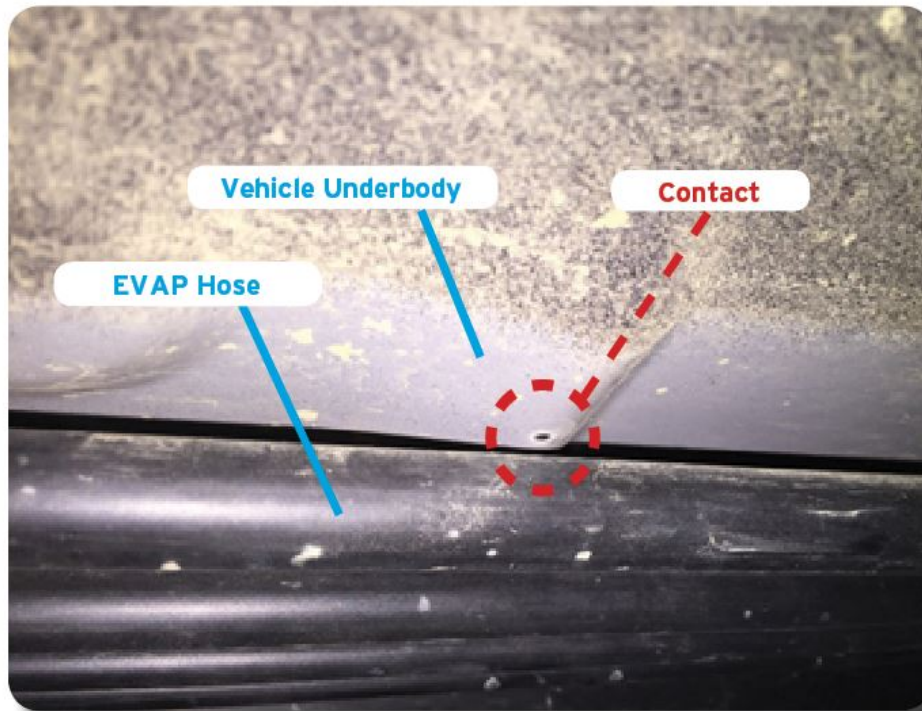
Some customers may complain about a buzz/rattle type noise at 2400 RPM. The noise can be heard at a stop or while driving. This may be caused by an EVAP Hose making contact with the vehicle underbody.
