# Technical Service Bulletin

SUBJECT: <b>TC-SST TRANSMISSION CLUTCH ASSEMBLY REPLACEMENT PROCEDURES – REVISED</b>			No: <b>TSB-16-22-001</b>
			DATE: <b>July, 2016</b>
			MODEL: <b>See below</b>
CIRCULATE TO:	<input type="checkbox"/> GENERAL MANAGER	<input checked="" type="checkbox"/> PARTS MANAGER	<input checked="" type="checkbox"/> TECHNICIAN
<input checked="" type="checkbox"/> SERVICE ADVISOR	<input checked="" type="checkbox"/> SERVICE MANAGER	<input checked="" type="checkbox"/> WARRANTY PROCESSOR	<input type="checkbox"/> SALES MANAGER

Procedures are now available for W6DGA TC-SST clutch assembly replacement. This TSB provides the necessary steps to complete diagnosis, clutch assembly replacement, and complete “Teach-in” procedures for the TCM.

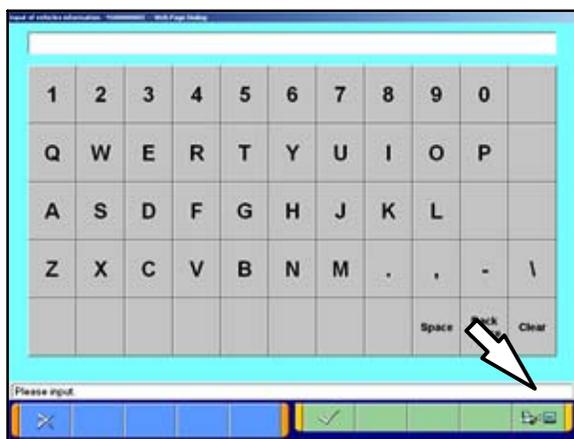
7. Click on the icon in the lower RH corner of the screen to have MUT-III automatically read the VIN. If a message appears advising the VIN cannot be input automatically, enter the 17 digit VIN.

Confirm VIN is correct and click the **check mark** to continue.

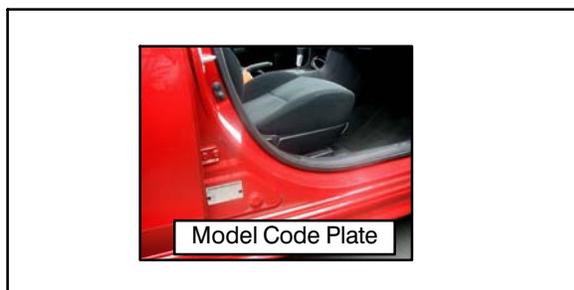
9. Vehicle class can be found on the model plate attached to the right side B-pillar.

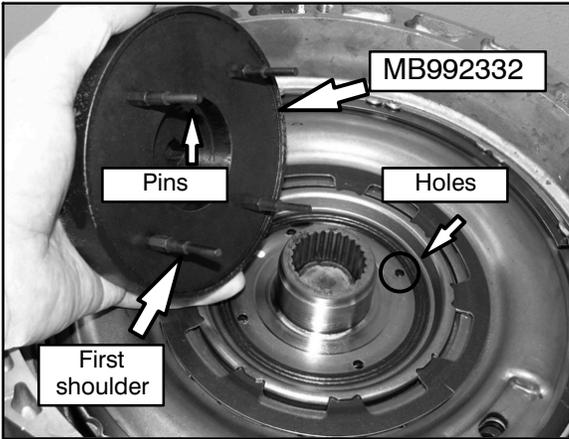
5. Insert four pins of special tool MB992332-01 – Clutch remover & installer, into four holes of the clutch assembly.

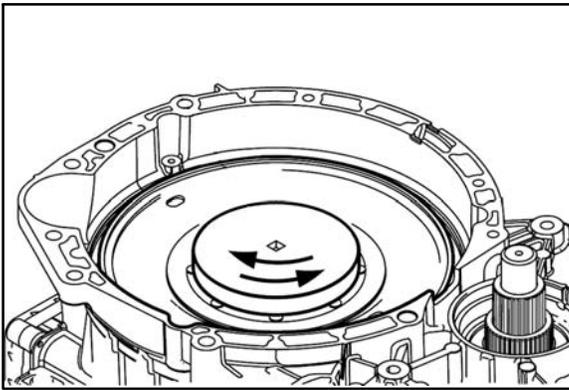
6. While pressing lightly on the tool, rotate the tool back and forth to engage all four clutch disks.

The tool pins will bottom at the first shoulder when fully inserted.

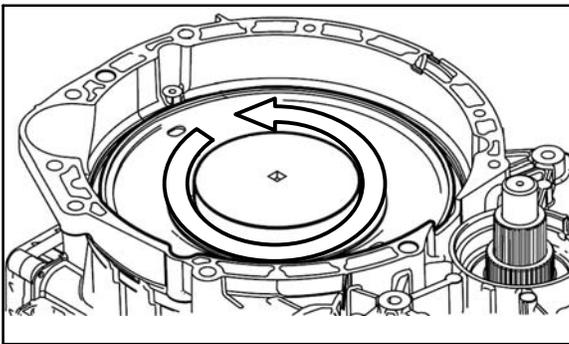
7. Rotate the clutch assembly counterclockwise, six or seven times to loosen the clutch assembly.

**NOTE:** There will be slight break away resistance when rotating the clutch assembly (tightening torque is only 66 in lbs.). Do not use excessive torque to loosen the assembly. The transmission may not have shifted to neutral when you selected “P” range prior to turning the engine off. Applying excessive torque can break the tool pins.

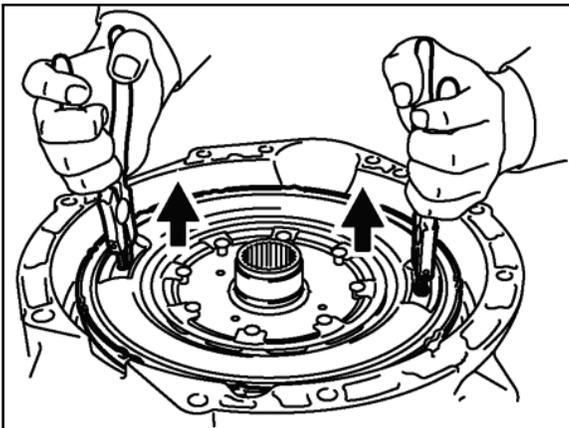
8. Insert expanding snap ring pliers to the openings shown. **DO NOT HOOK THE CLUTCH DISCS.** Lift the clutch assembly to remove it.

**NOTE:** The upper needle bearing of the main shaft support may remain in the clutch assembly. Remove it and reinstall it to the the main shaft support.

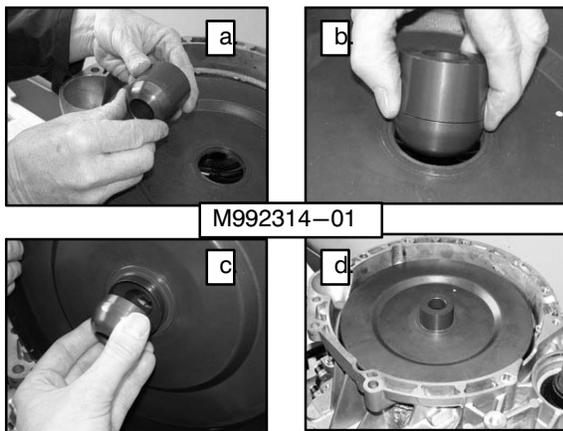
- a. Assemble two pieces of the seal protector.
- b. Insert the protector through the cover seal from the top surface as shown.
- c. From the underside of the cover, separate the protector.
- d. Place the assembled cover/seal protector over the clutch assembly with the protector aligned to the main shaft support.
- e. Press the cover down until the tool no longer engages the seal.
- f. Remove the tool.

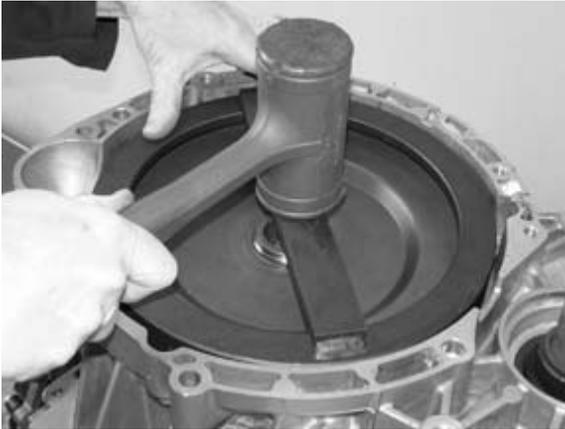
g. Use special tool cover installer (MB998323-01) with a dead blow mallet to seat the cover into place.

- (1) Place the special tool as shown.
- (2) Alternately strike the center and ends of the tool's crossbar, rotate the tool 90°, and repeat. Continue this process until the cover is fully seated

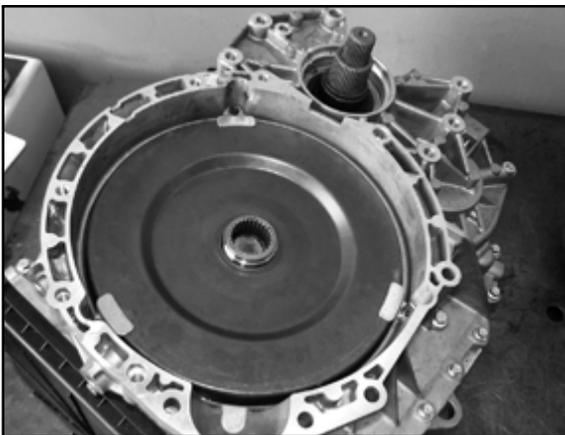
h. Secure the cover with three new tabs and bolts (provided with the clutch assembly).

**Torque the bolts to 89 ± 8 in.-lbs.**

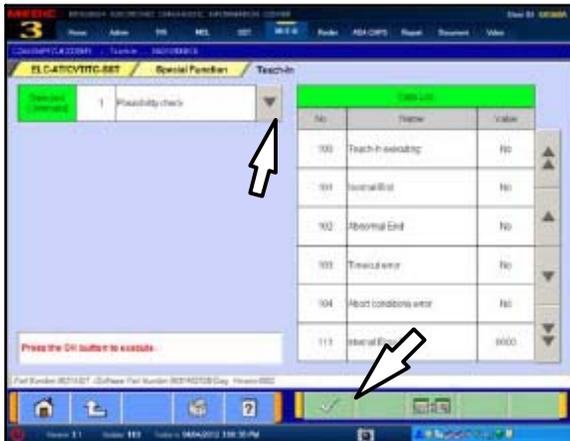
10. Select **Plausibility Check** and click the **check mark** to continue.

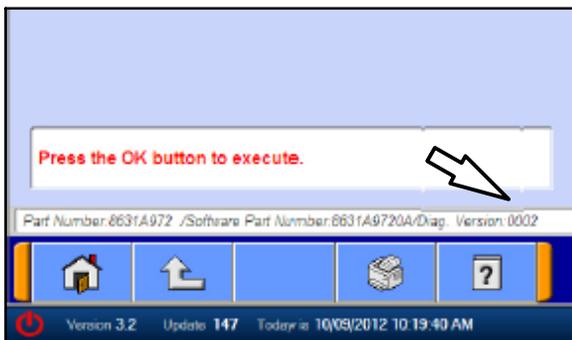
**NOTE:** If TCM software version is 0001 (unlike example at left), Reset Clutch Gain will not appear in the Selected Command column and does not need completion.

- Execute the command and confirm its proper completion by verifying Data Item No. 101 Normal End indicates YES.
- If Normal End (NO) is displayed, repeat this step.
- If you continue to have Normal End (NO) returned, contact Techline.

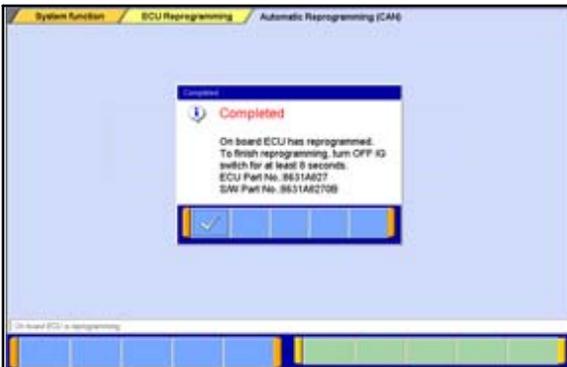
21. Once the programming is completed, the **Completed** dialog box is displayed.
