GROUP Fuel	MODEL 2016MY Optima (JFa)
	NUMBER SC 128	DATE March 2016
VOLUNTARY EMISSIONS RECALL		
SUBJECT: SC128 – 2016MY OPTIMA IMPROPER EMISSIONS PARTS INSTALLED VOLUNTARY EMISSIONS RECALL

This bulletin provides the procedure to replace the air cleaner box and/or the evaporative canister of some 2016MY Kia Optima (JFa) 2.0L Turbo (ULEV – 50 State Emissions) and 2.4L GDI (SULEV vehicles – California Emissions), produced from Job #1 through January 15, 2016. Some of these vehicles were built with the wrong air cleaner and/or evaporative canister. Kia is recalling these vehicles to correct the misbuild by installing the proper components, as originally intended. Prior to performing the procedure, refer to the table below to identify which components require replacement by engine type. Kia is requesting the completion of this Voluntary Emissions Service Campaign on all affected vehicles. Before conducting the procedure, verify the vehicle is included in the list of affected VINs.

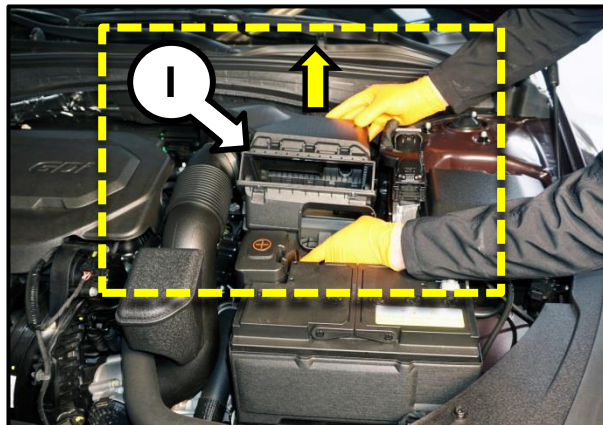
8. Remove the air cleaner box (I) from the vehicle.

9. Install the new air cleaner box by reversing the removal steps.
10. Reinstall the original air filter element into the new air cleaner box.
11. Start the vehicle to confirm proper operation.

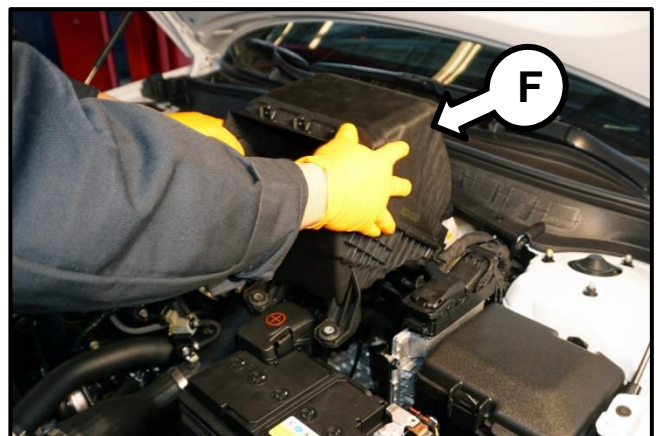
7. Lift and remove the air cleaner box (F) from the vehicle.

8. Install the new air cleaner box by reversing the removal steps.
9. Reinstall the original air filter element into the new air cleaner box.

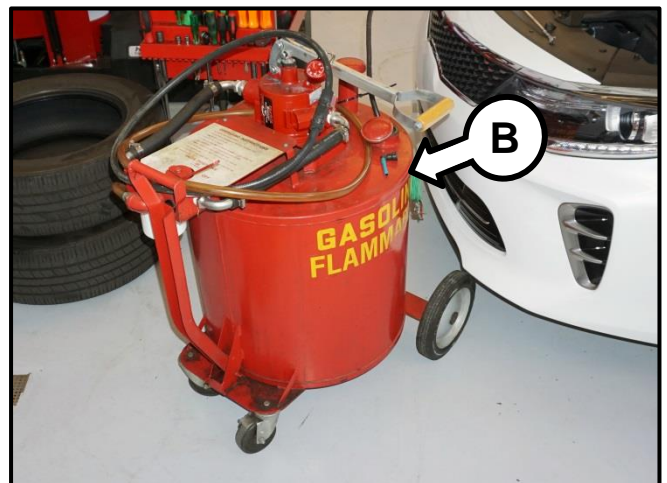
3. Transfer the fuel into a suitable gasoline transfer device (B).

If fuel tank is more than 1/4 full, it must be drained to avoid possible spillage from fuel filler pipe, to reduce excessive weight and to prevent possible personal injury while fuel tank is being removed and reinstalled.

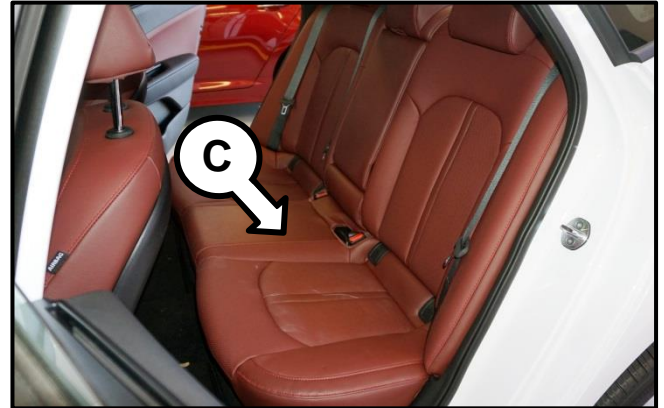
4. Carefully remove the lower seat cushion (C) from the vehicle.

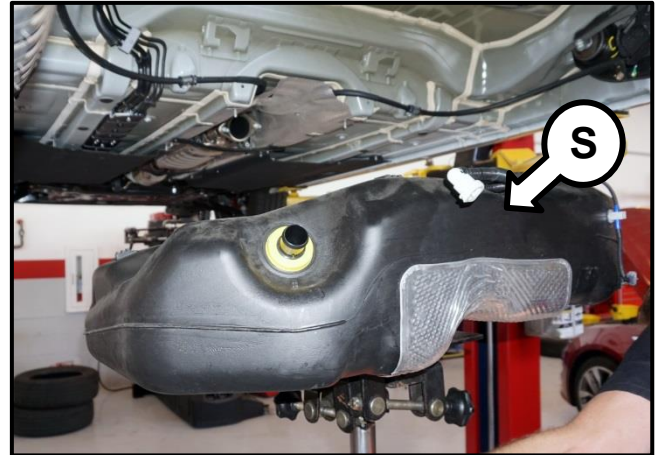
14. Carefully lower the fuel tank (S) using the transmission jack, as shown.

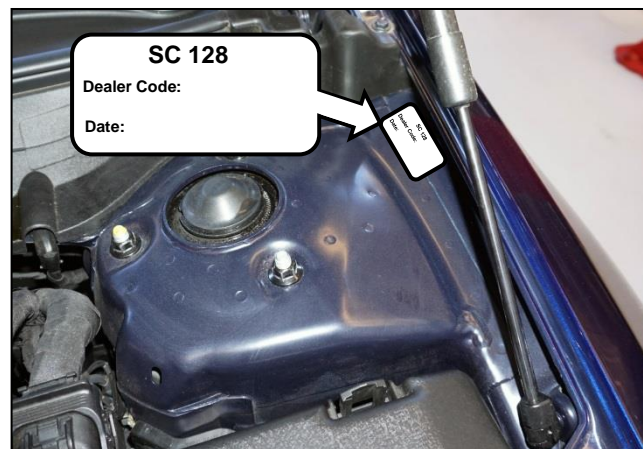
Apply SC 128 Campaign Completion Label onto the body in the area next to the shock tower, as shown. **NOTE: Be sure to clean the mounting surface to ensure proper label adhesion.**
