Cruise Control Stalk Illumination Intermittent Operation

YEAR(S)	MODEL(S)	ADDITIONAL INFORMATION
2014 - 2016	Sienna

Some 2014 – 2016 Sienna vehicles may exhibit an intermittent cruise control stalk illumination flicker condition. Please follow the Repair Procedure in this bulletin to address this condition.

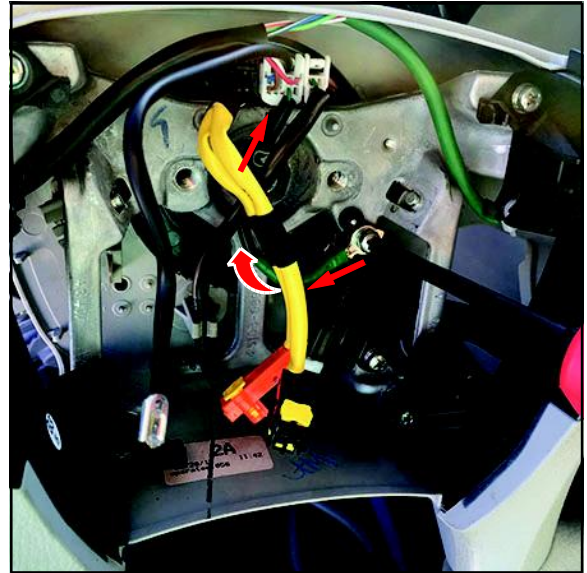
Figure 12.

Route the repair wire UNDER the existing brown (or black) wire sheath, following the path of the dotted line as shown. Do NOT attach ring terminal at this time.

Do NOT connect the Ring terminal end at this step. Be sure to route the harness under and away from SRS wiring.

If the brown (or black) sheathed harness is routed to the right side of the steering wheel, route the repair harness on that side instead.

Place harness away from airbag connections.

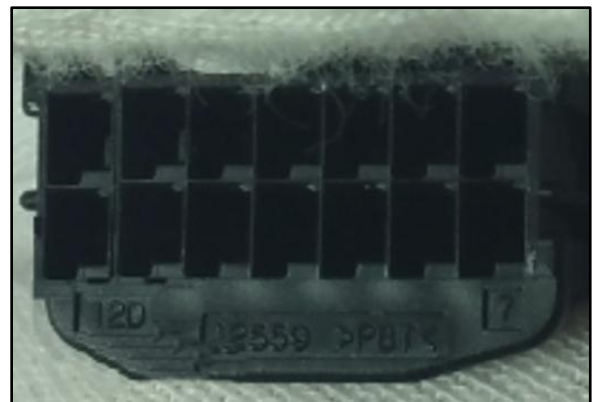
Figure 15. D149, 14-Pin Connector

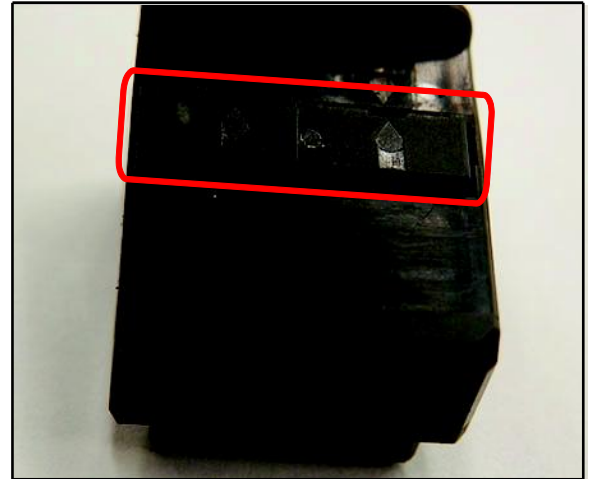
Figure 16.

12. Lift connector lock tab using same guidelines in step 7.

NOTE
Do NOT try to remove it. Only slightly lift.

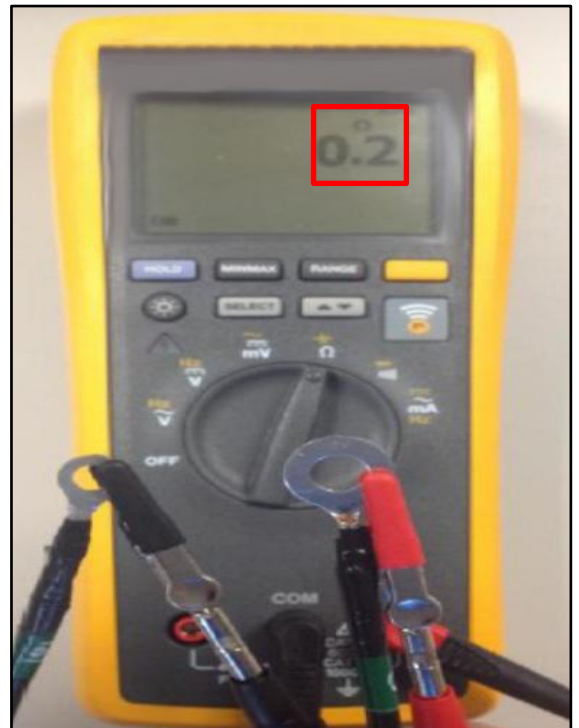
Figure 21.

16. Check resistance between the ring terminals of both harnesses. The standard resistance is less than one ohm. If resistance is not as specified, check installation of both harnesses.

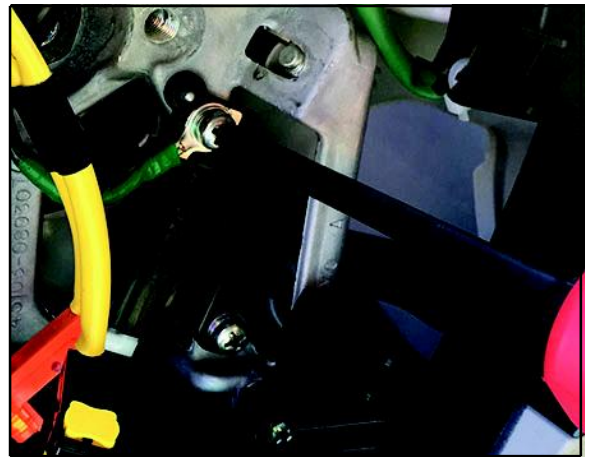
Figure 22.

17. Secure repair wire PN 82998-08010 or 82998-0E010 ring terminal to cruise control switch ground terminal.
 - A. Remove screw from cruise control switch ground terminal.
 - B. Place repair wire ring terminal over screw.
 - C. Reinstall screw in cruise control switch.
Torque: 2.4 N*m (24 kgf*cm, 21 ft*lbf)

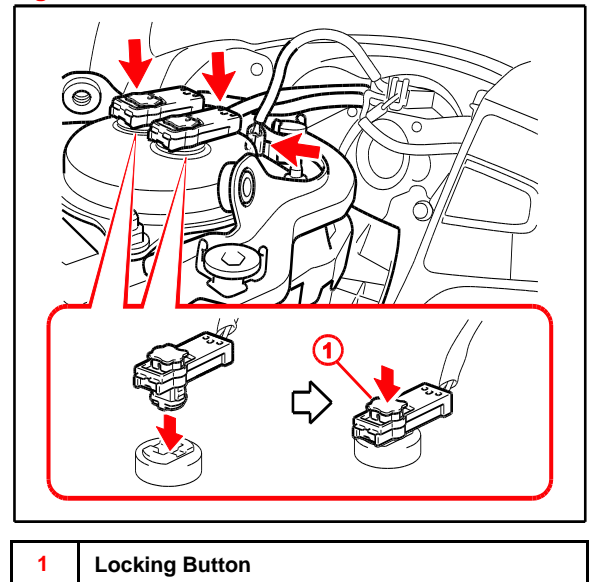
Figure 25.

- C. Connect the horn terminal.
