Rear Bumper Gap

Service Category Vehicle Exterior

Section Exterior Panels/Trim

YEAR(S)	MODEL(S)	ADDITIONAL INFORMATION
2014 – 2015	Yaris	Body Type(s): 3Dr. Hatch Back, 5Dr. Hatch Back VDS(s): JTUD3, KTUD3 WMI(s): VNK

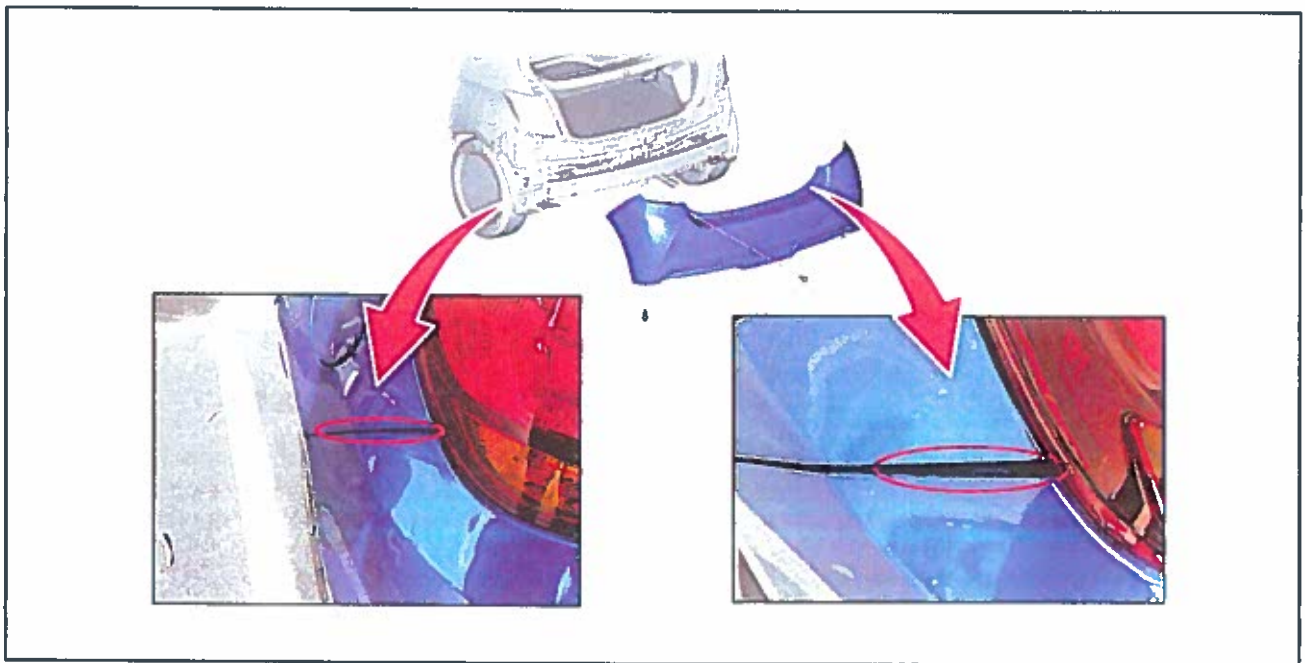
Some 2014 – 2015 model year Yaris vehicles may exhibit a condition where there is an excessive gap between the rear bumper and the body due to a partial separation between the retainer and the bumper cover. Resecuring the rear bumper cover may not sufficiently prevent this gap from returning. The Rear Bumper Retainer has been revised to provide additional retention force to the rear bumper cover. Follow the Repair Procedure in this bulletin to address this concern.

1. Remove the rear bumper as per the Repair Manual.

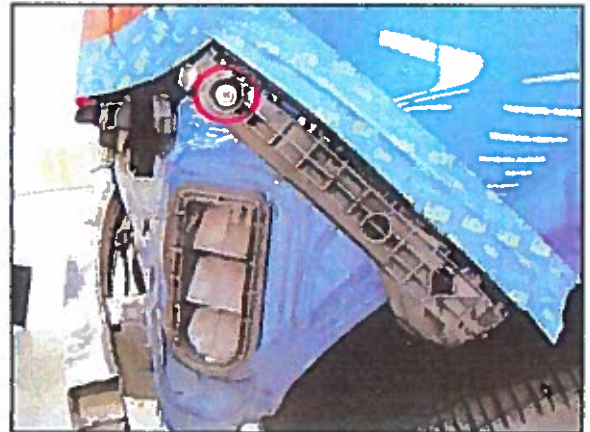
Figure 1.

2. Remove the rear bumper cover retainer by uninstalling the (1) 10mm screw and disengaging the retainer from the body by prying against the body as shown.

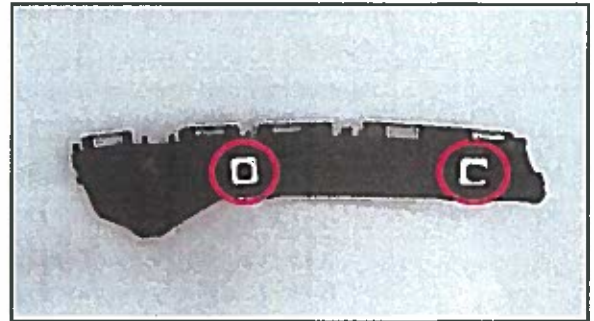
Figure 4.

3. Install new retainers by engaging the retainers with the body.

Avoid over tightening the retainer screw.

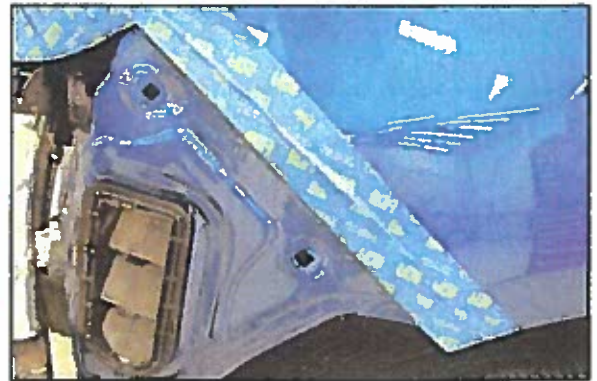
Figure 5.

Repeat for the opposite side.

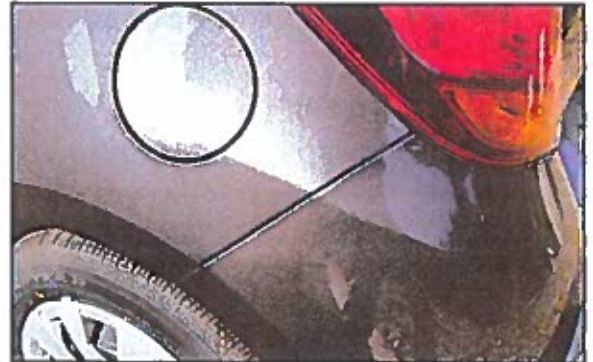
Figure 6.

- 2014 Yaris:
Vehicle Exterior – Exterior Panels/Trim – “Exterior Panels/Trim: Rear Bumper (for hatchback with Sport Package): [Installation](#)”
 - 2015 Yaris:
Vehicle Exterior – Exterior Panels/Trim – “Exterior Panels/Trim: Rear Bumper (for hatchback): [Installation](#)”
5. Confirm rear bumper gap is less than 1.6mm and is consistent.
