Technical Service Bulletin

66 Paint flakes off radiator grille or license plate holder

66 16 55 2038652/5 August 2, 2016. Supersedes Technical Service Bulletin Group 66 number 15-53 dated May 7, 2015 for reasons listed below.

Model(s)	Year	VIN Range	Vehicle-Specific Equipment
A4, A5, Q5	2013 - 2016	All	Not Applicable

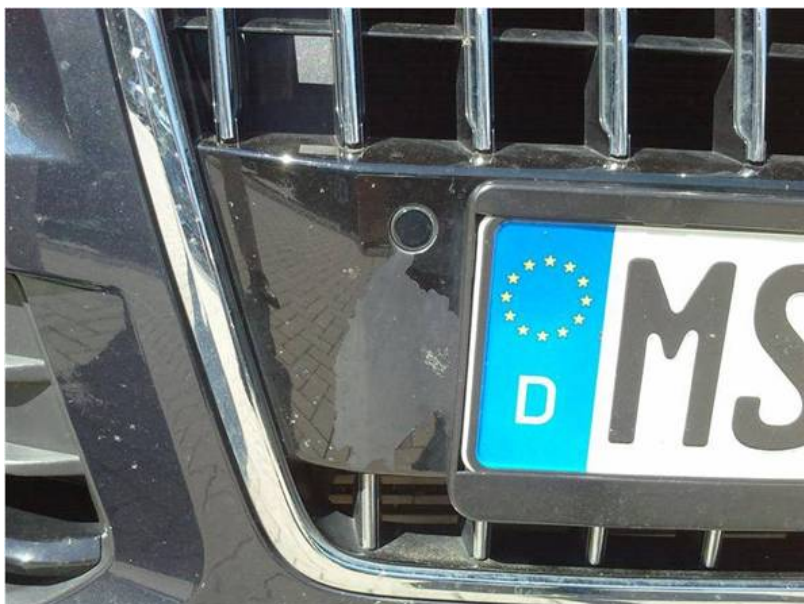
Figure 1. Example of flaked-off paint.

The paint is flaking off of the radiator grille or front license plate holder (Figure 1).

The surfaces of these components were too smooth (due to high-gloss polishing tools), which led to weak adhesion of the paint during production. Only components with color index T94 are affected.

Polishing tools have been modified to create a rougher surface for better paint adhesion. The painting application has been improved as the supplier is now using a new paint facility. The improved components that have been produced were installed on vehicles being built around May 1, 2015.

Replace the components according to the instructions in Elsa at *Repair Manual >> Body >> Body Exterior >> 66 Exterior Equipment >> Radiator Grille/Front Trim*.
