# Technical Service Bulletin

## 40 Clicking noise from wheel bearing

40 16 55 2024318/4 June 30, 2016. Supersedes Technical Service Bulletin Group 40 number 12-27 dated November 8, 2012 for reasons listed below.

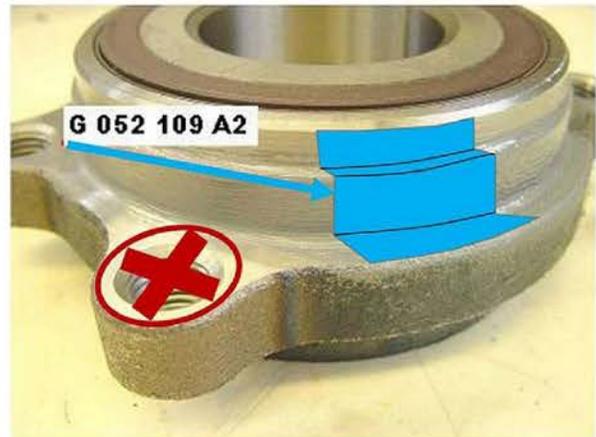
Microscopic movements between the wheel bearing and wheel bearing housing may cause the noise. (Front left and/or front right bearing can be affected.)

*Figure 1. Area to apply paste.*

1. On the affected side(s), remove any corrosion and dirt from the wheel bearing housing and the wheel bearing.
2. Using a brush, apply a thin coat of paste (part number G 052109A2) on the wheel bearing housing as shown (Figure 1). Make sure not to apply any paste on the threads.
