# Technical Service Bulletin

## 46 S4 and S5 squealing from front brakes (PR-1LJ)

46 16 34 2027636/13 April 12, 2016. Supersedes Technical Service Bulletin Group 46 number 15-22 dated September 11, 2015 for reasons listed below.

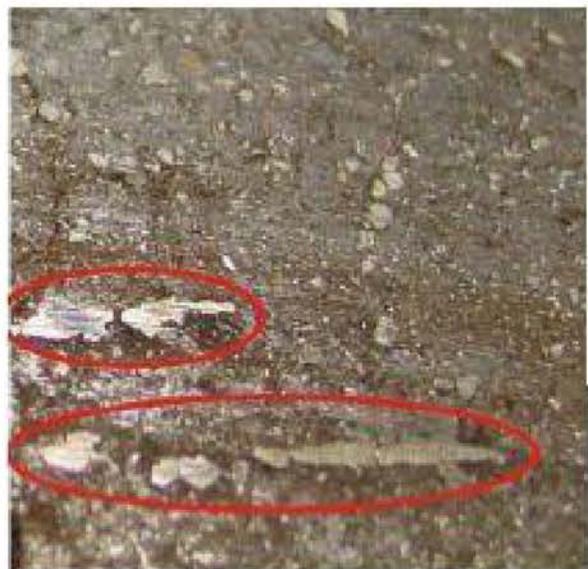
- Front brake discs or brake pads are close to their wear limit (disc wear limit: 28 mm and pads wear limit with backing plate and dampening plate: 10 mm).
- Foreign objects between brake disc and brake pad, such as small stones, grit, rust build-up, or sand.
- Un-ground or corroded friction materials.
- Metallic deposits from disc material in brake pad (Figure 1).

Figure 1. Metallic deposits.
