Technical Service Bulletin

94 Mirror turn signal - Repair Authorization

94 16 77 2043918/1 April 14, 2016.

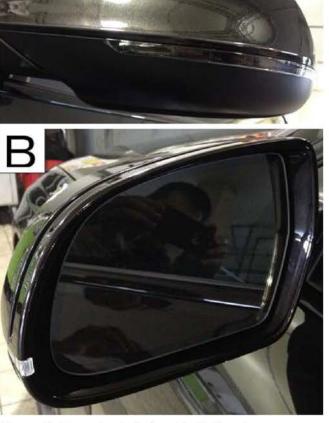
Figure 1. Example of photos of exterior mirrors.

- 1. Verify the condition listed above.
- 2. If a DTC is present and there is no external damage:
 - Create a TAC ticket.
 - Attach photos of the exterior mirror housing to the TAC ticket. Photos must show the complete mirror housing (front and back) with no signs of external damage (Figure 1, A and B).
 - · Do not disassemble the mirror housing.
