# Technical Service Bulletin

## 97 Electrical complaints in rear trunk area

97 16 55 2043968/1 April 25, 2016.

Model(s)	Year	VIN Range	Vehicle-Specific Equipment
A3	2015 - 2016	All	Not Applicable

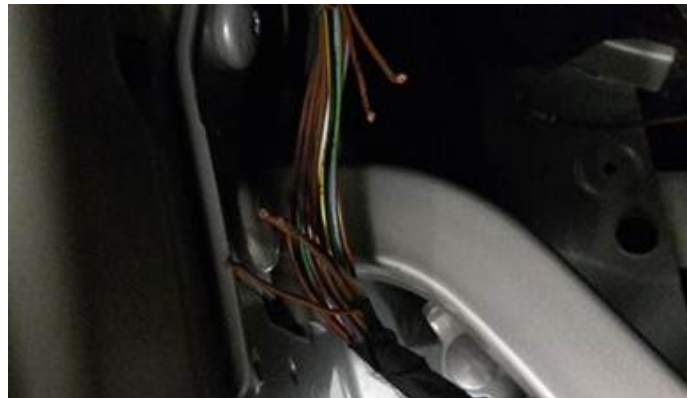
When the rear lid is opened or closed, a wire (or wires) can break in the area of the trunk hinge of the left or right rear lid wiring harness.

*Figure 1. Wire damage at trunk hinge.*

1. Check the rear lid wiring for damage in the area of the trunk hinge (Figure 1 - Figure 3).

If the wiring harness is damaged in the area of the trunk hinge, it must be replaced. Follow the instructions below.

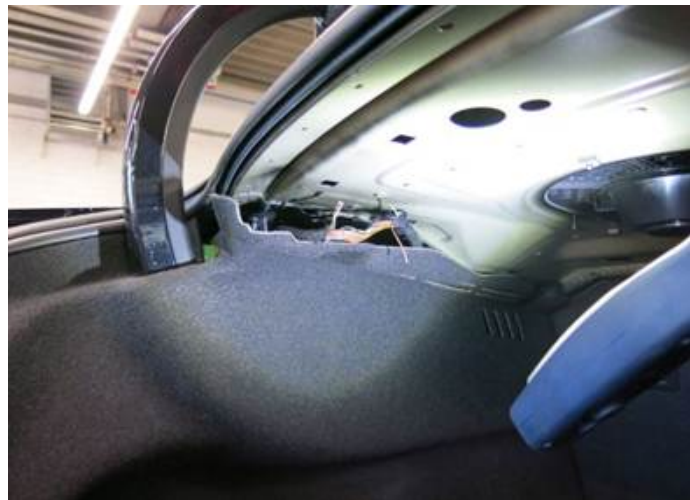
*Figure 2. Wire damage at trunk hinge.*

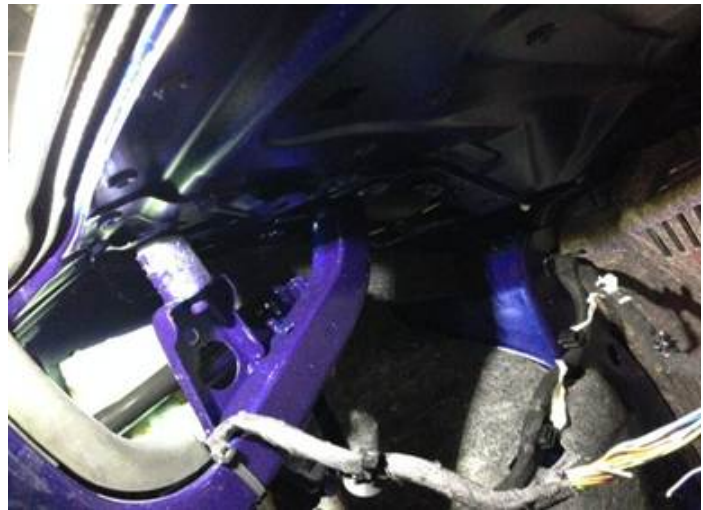
**Figure 3.** Incorrect wire routing at trunk hinge.

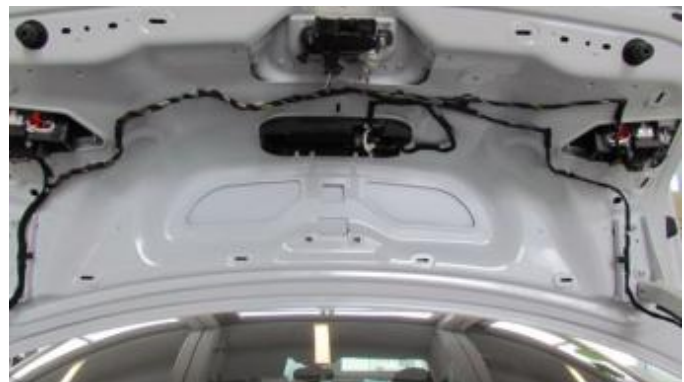
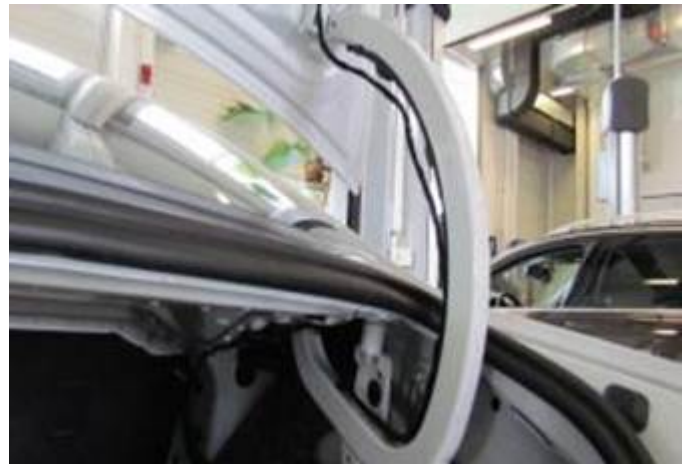
**Figure 1.** Examples of photographs of the routing of the wiring harness. The routing may differ depending of vehicle.

1. Disconnect battery.
2. Remove the right rear lid trim and right locking element of the rear lid hinge according to the Elsa repair manual.
3. Take photographs of the routing of the wiring harness reversing camera from the rear lid to the right reversing camera control unit (Figure 1). These photographs will be used for reference later.

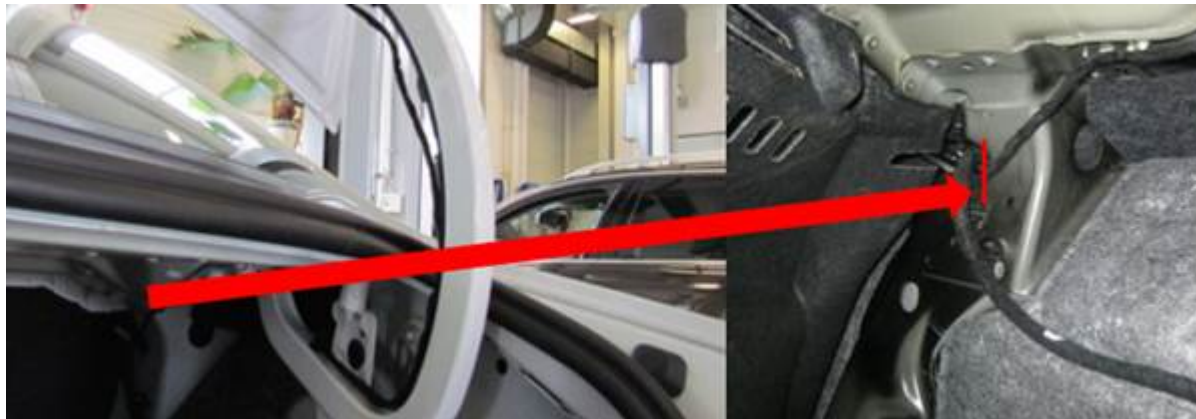
**Figure 2.** Cut cable off on the junction of the main wiring harness (red separation line).

4. Loosen the wiring harness to the reversing camera control unit and cut it off on the junction of the main wiring harness (Figure 2). Wrap textile adhesive tape around cut-off cable.

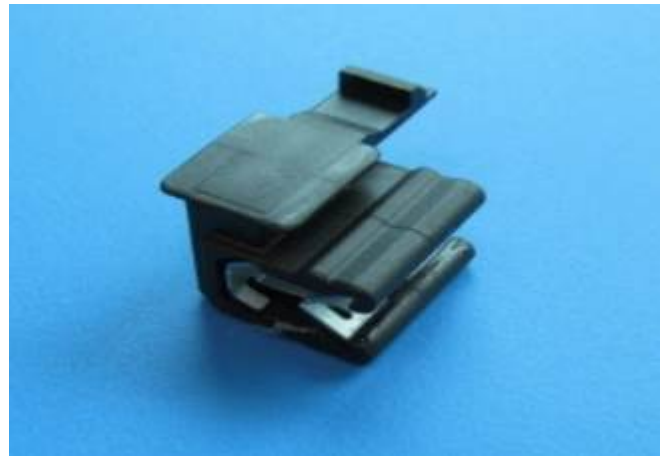
Figure 3. Clip supplied with wiring harness.

- Before fitting the service wiring harness, place the clips supplied with the wiring harness (Figure 3) on the body in such a way that the wiring harness does not touch any edges or could be trapped by the mountings of the trim.

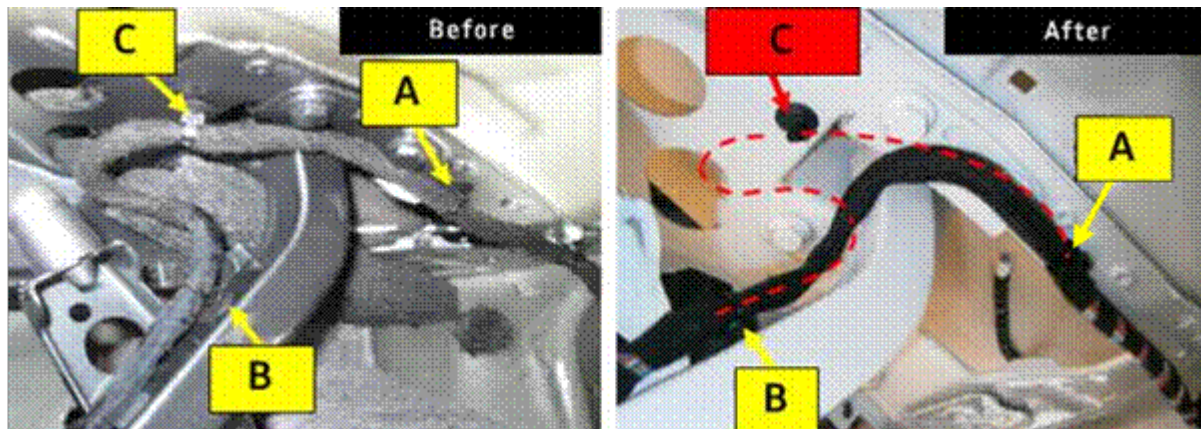
Figure 4. Note that clip "C" in the image above is not needed when the service wiring harness is fitted.

- Fit the service wiring harness. For correct routing, refer to the photographs taken in step 3. Note that one of the clips from the previously-fitted harness is no longer needed (Figure 4).

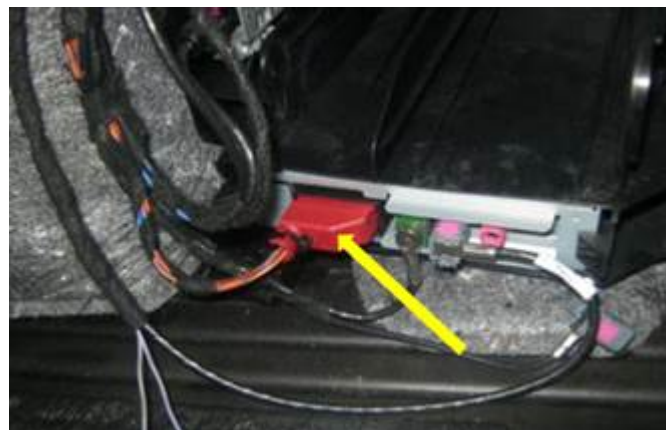
Figure 5. Loosen red connector T20i.

- Loosen the red connector T20i on the reversing camera control unit (Figure 5). Remove the cable tie on the connector.

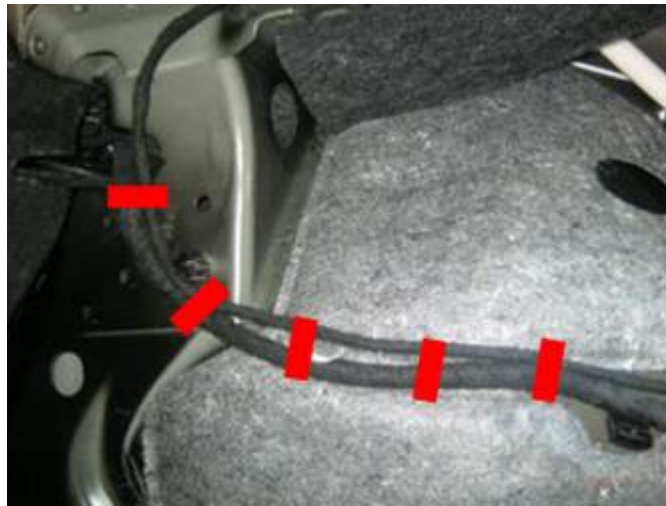
**Figure 8.** Wrap the wiring harness with textile adhesive tapes at red marks.

15. Wrap the wiring harness with textile adhesive tape on the main wiring harness (Figure 8).

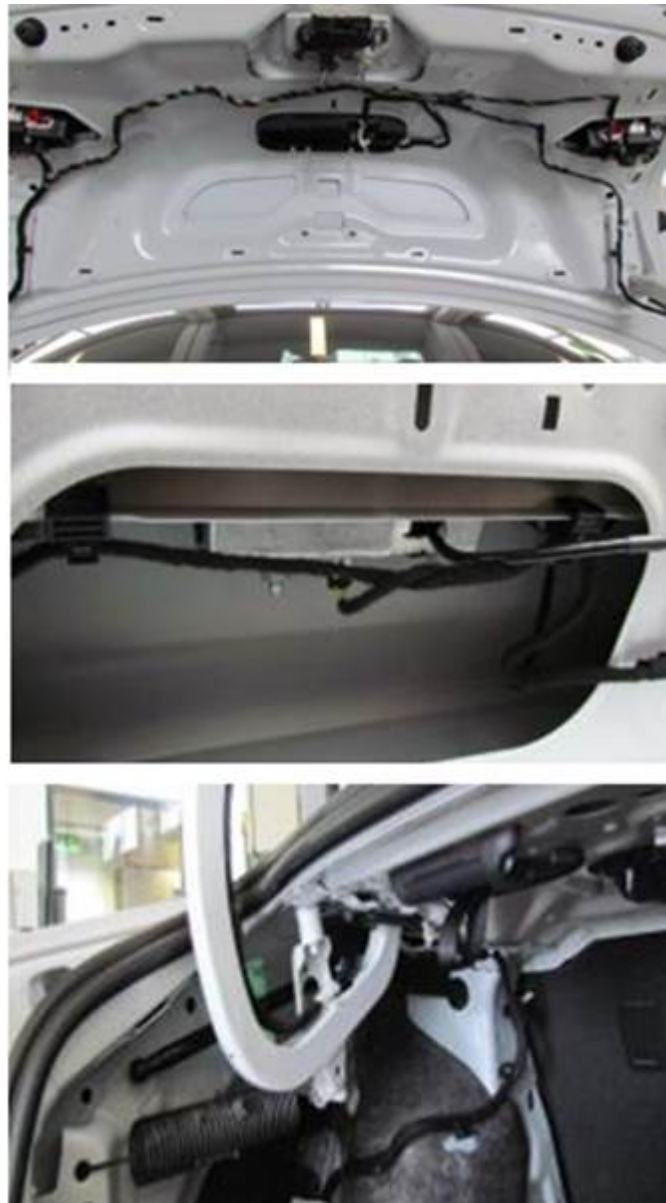
**Figure 8.** Examples of photographs of the routing of the wiring harness. The routing may differ depending of vehicle.

4. Take photographs of the routing of the rear lid wiring harness (Figure 8). These photographs will be used for reference later.

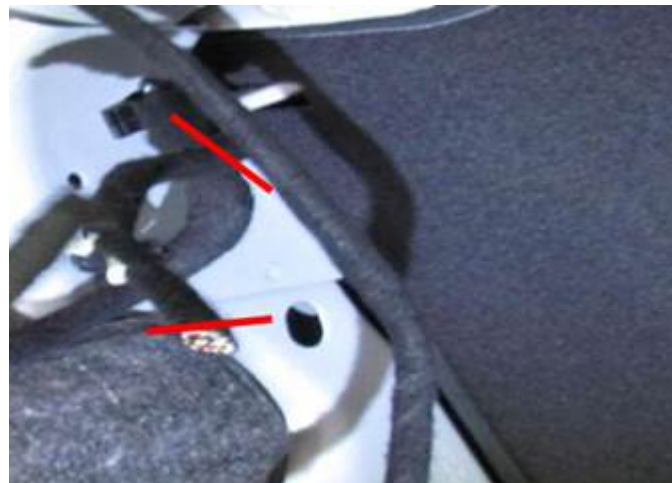
**Figure 10.** Open the winding of the cut-off vehicle wiring harness to the junction of the main harness on separable area (red marks).

6. Open the winding of the cut-off vehicle wiring harness to the junction of the main wiring harness on separable area (Figure 10).

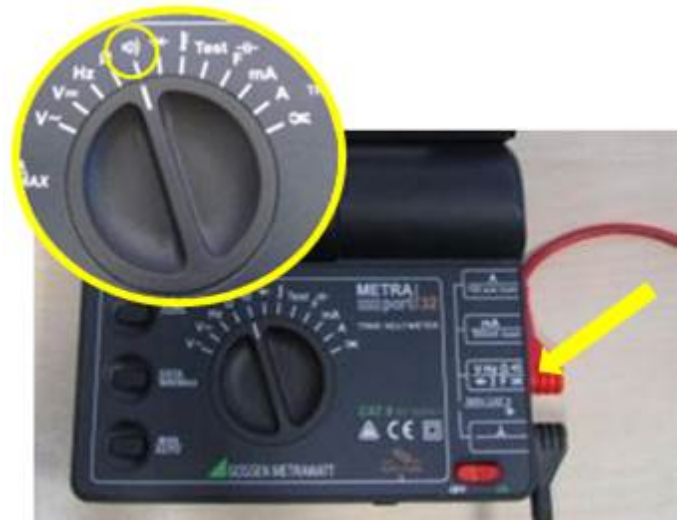
**Figure 12.** Set the VAG 1526 C to current flow check and connect the probe cables.

- Set the VAG 1526 C to current flow check and connect the probe cables to the VAG 1526 C (Figure 12).

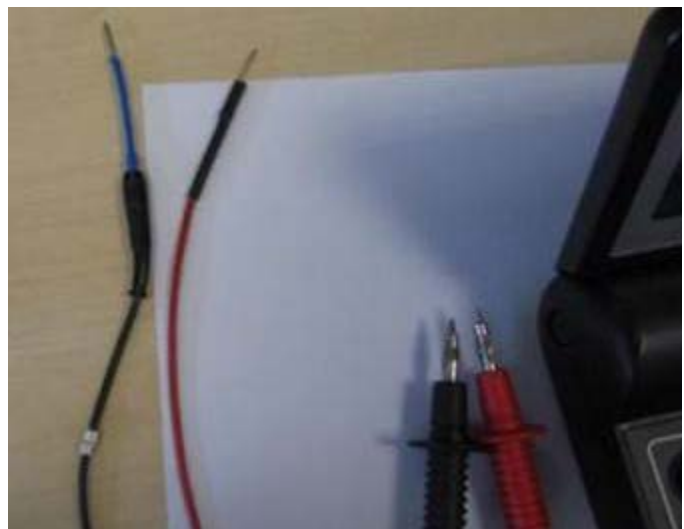
**Figure 13.** Required meter probes from VAG 1594 C.

- Connect the meter probes of the VAG 1594 C to the probe cables of the VAG 1526 C. The required meter probes from VAG 1594 C are number 18 and number 12 (Figure 13).

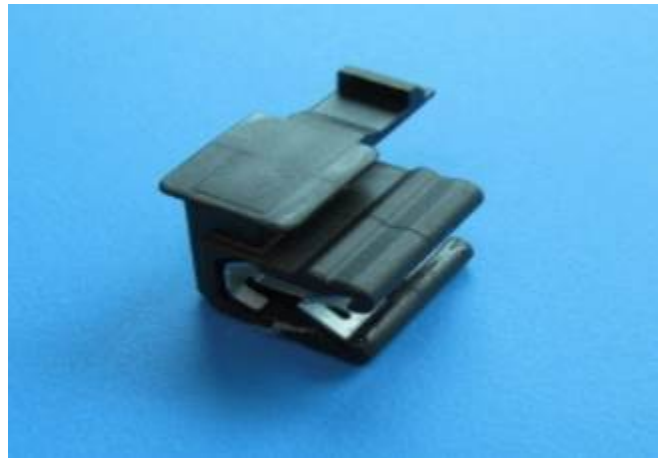
**Figure 14.** Clip supplied with wiring harness.
