Reference	SSM72858
Models	XF / X260
Title	17 MY X260 rear plate plinth detached
Category	Body
Last modified	05-Jul-2016 00:00:00
Symptom	108000 Ext. Trim/Accessories
Attachments	Plinth fixings position.pdf (Plinth fixings position.pdf)

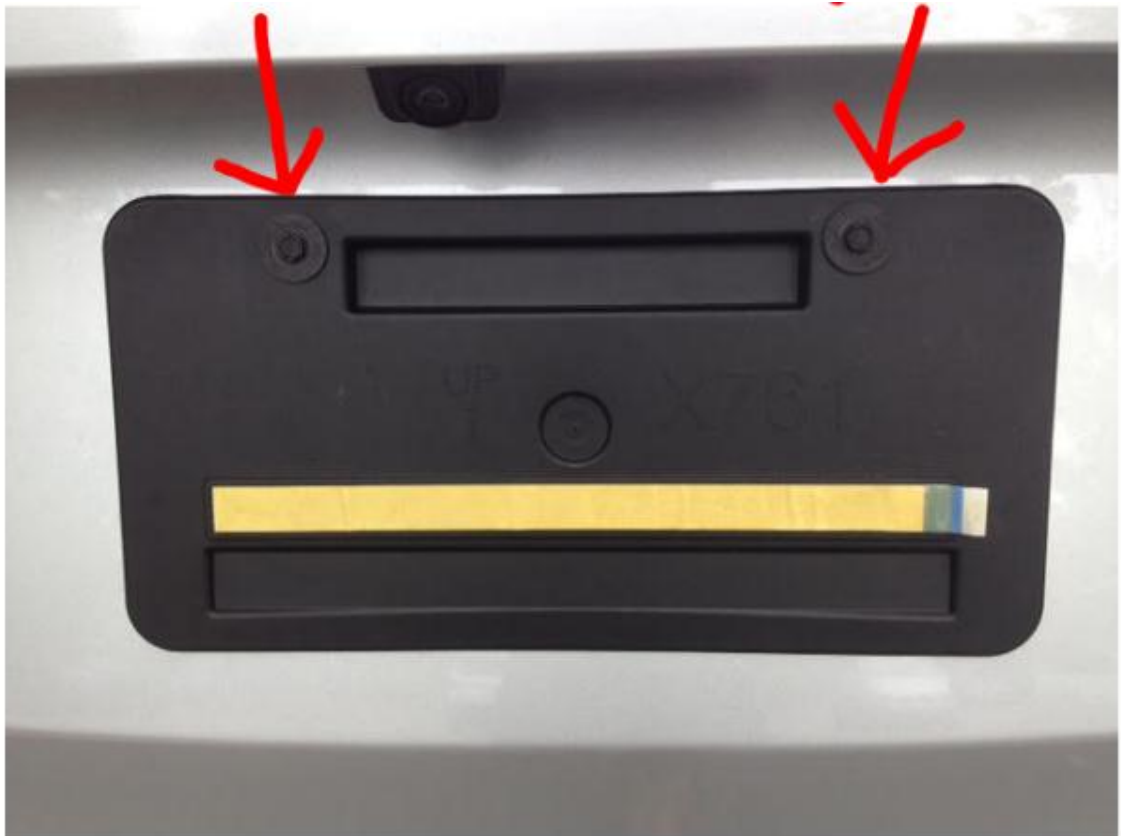
Issue: USA Port of Entries have seen a recent spike in X260 rear plate plinths losing adhesion, and falling off the vehicle.

Cause: The root cause is still under investigation, however initial results are suggesting the adhesive tape is failing Plinth side and not body side.

Action: Please be aware as containment action from Castle Bromwich, number plate plinths will be secured into position with 2x mechanical fixings until further notice. See attachment for location of the fixings.
