TECHNICAL BULLETIN  
JTB00505NAS2  
19 SEP 2016

**SECTION: 501-17**

Roof Opening Panel Air Deflector Spring(s) Out Of Position

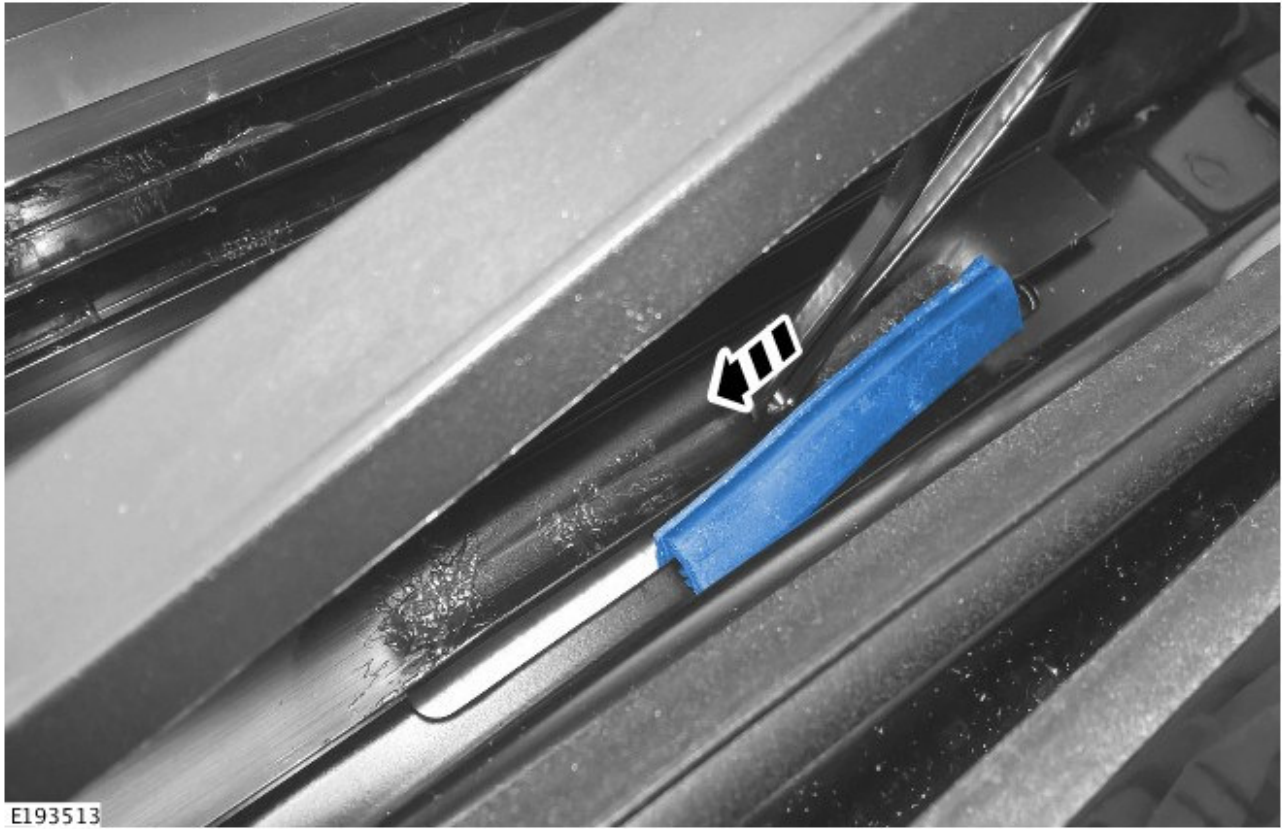
**NOTE:** Right-side shown; left-side similar.

**NOTE:** Seal length - 80 mm.

Install the rubber seal

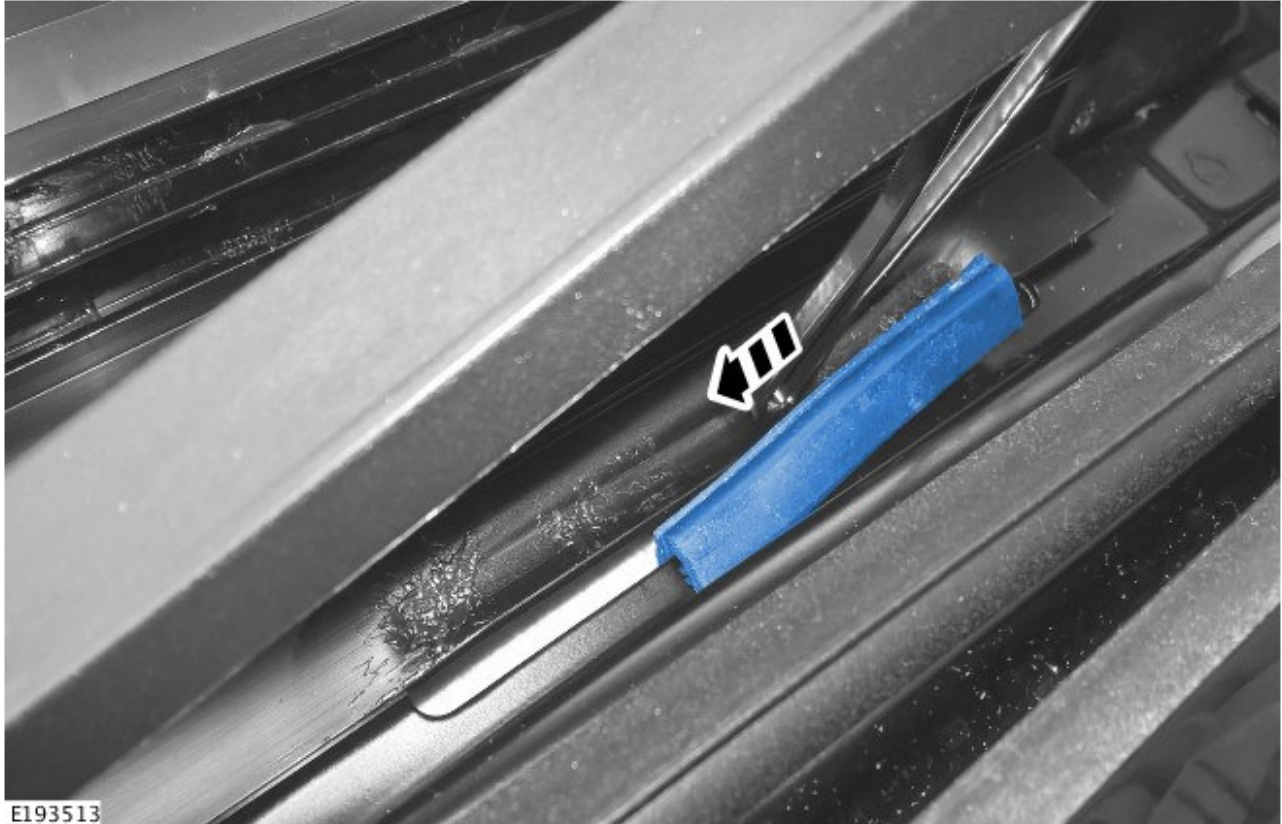
**NOTE: Right-side shown; left-side similar.**

**NOTE: Seal length - 60 mm.**

Install the rubber seal

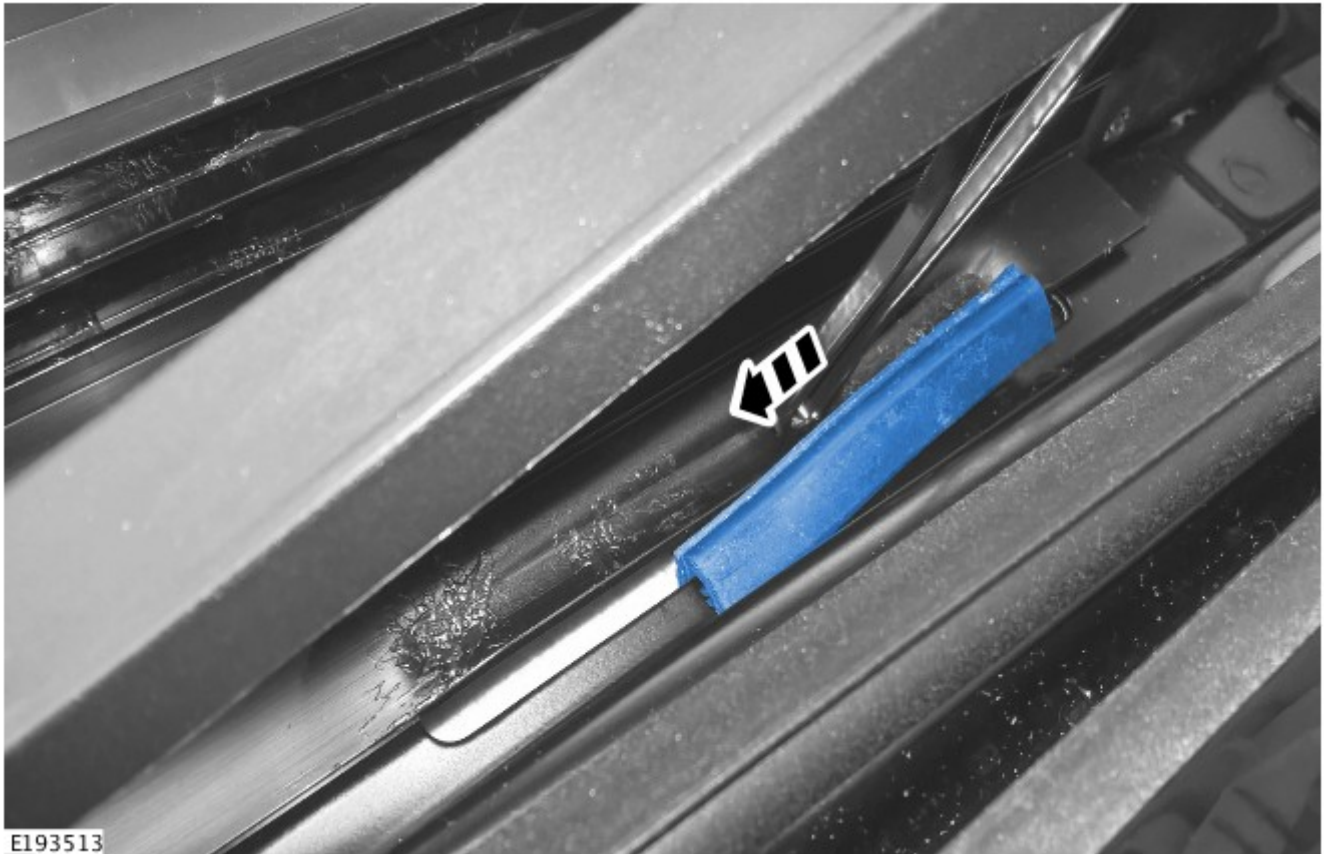
E193513

**NOTE: Right-side shown; left-side similar.**

**NOTE: Seal length - 80 mm.**

Install the rubber seal

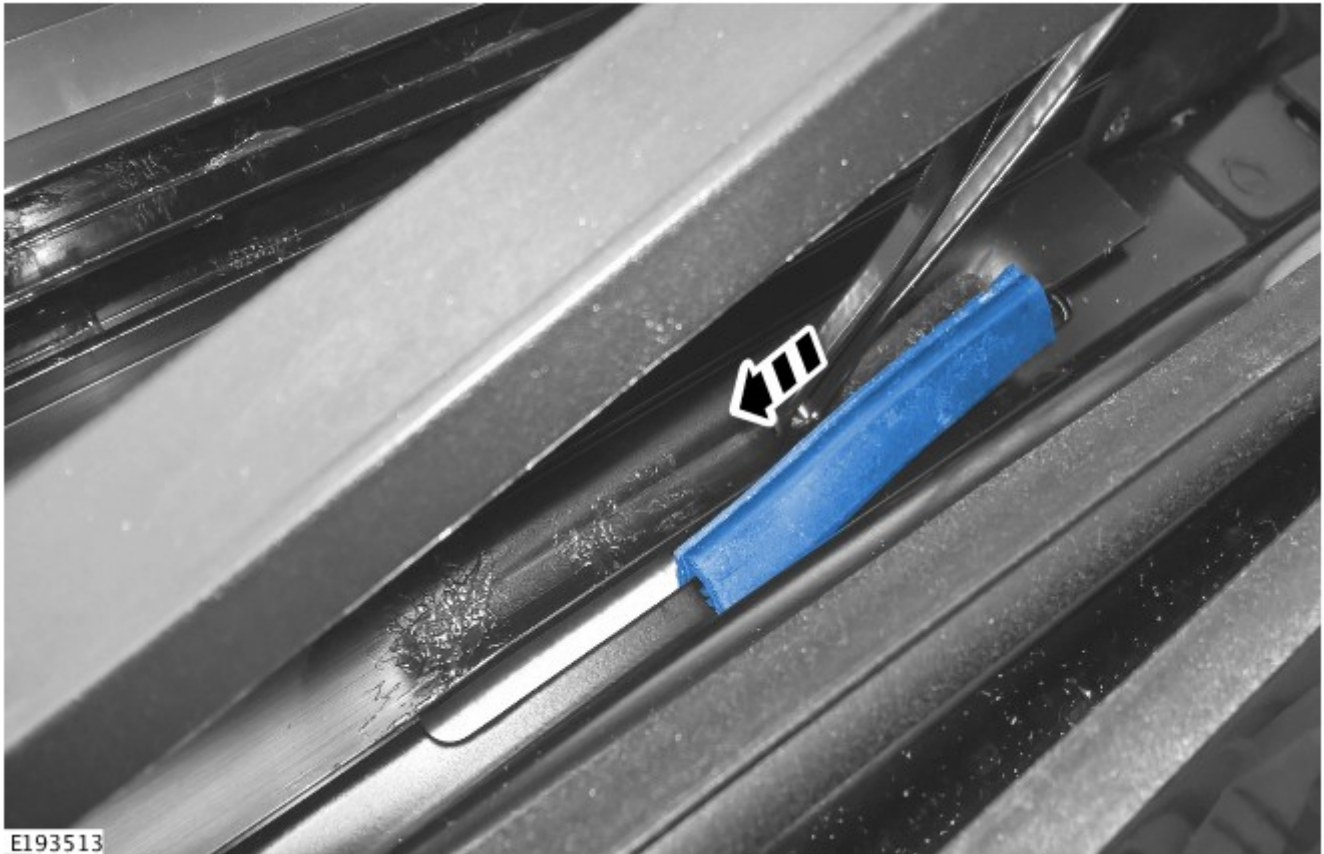
**NOTE: Right-side shown; left-side similar.**

**NOTE: Seal length - 60 mm.**

Install the rubber seal
