TECHNICAL BULLETIN

JTB00529NAS1

Interior Lamp Flickers and/or Windshield Wipers Single Sweep

XF (X250)

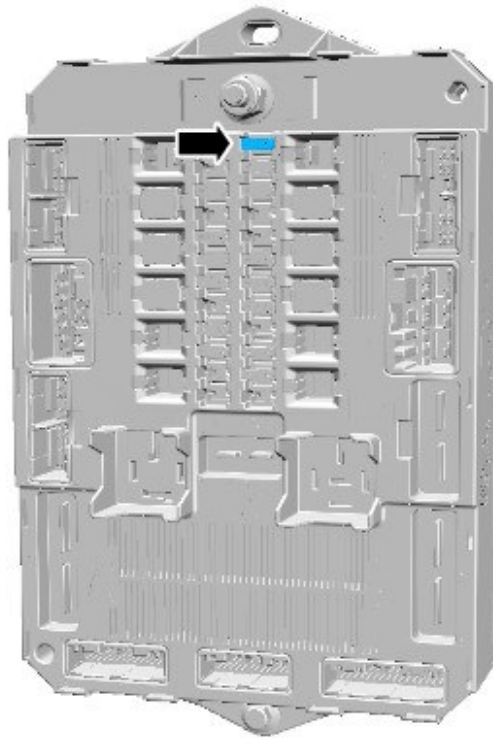
E194045

10. Remove the power supply fuse (F36) from the CJB.

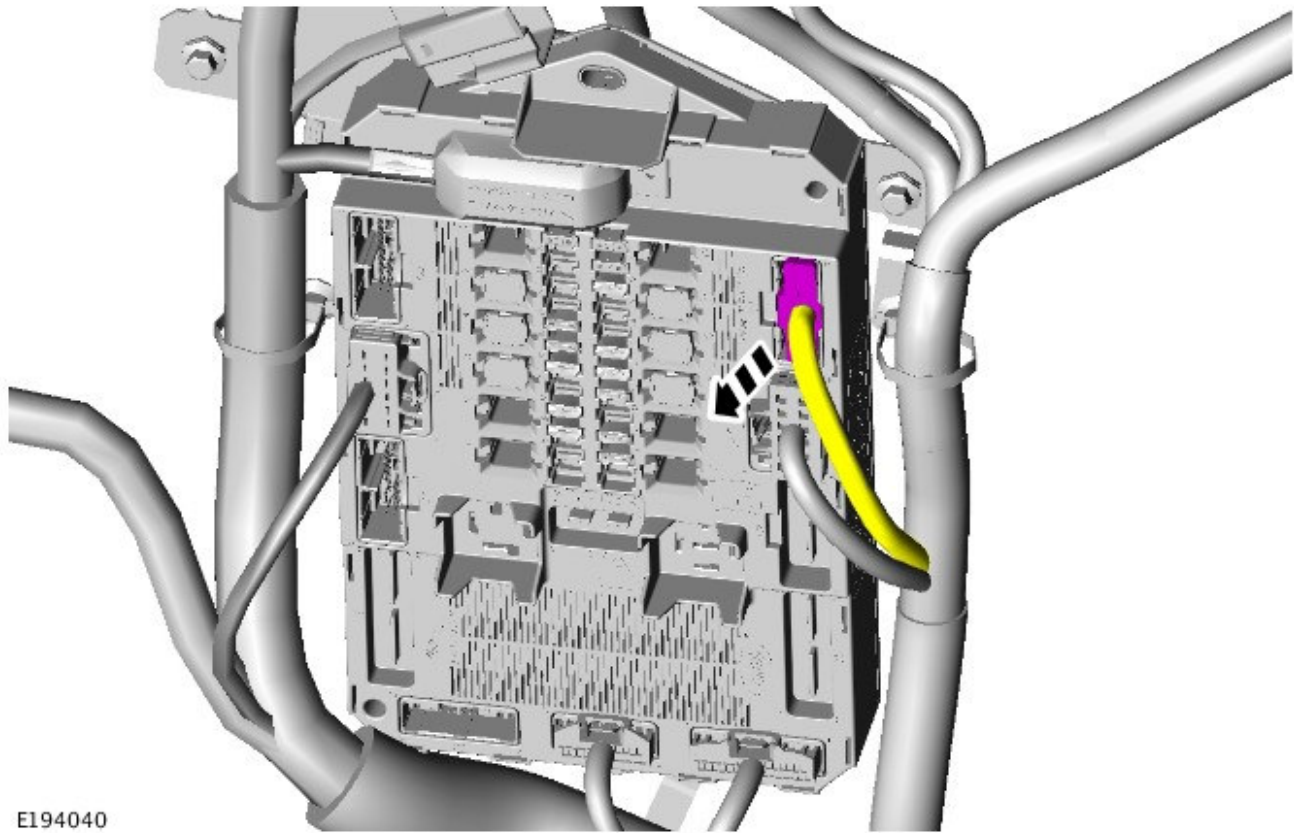
E194040

11. Disconnect connector C3BP01D from the CJB.

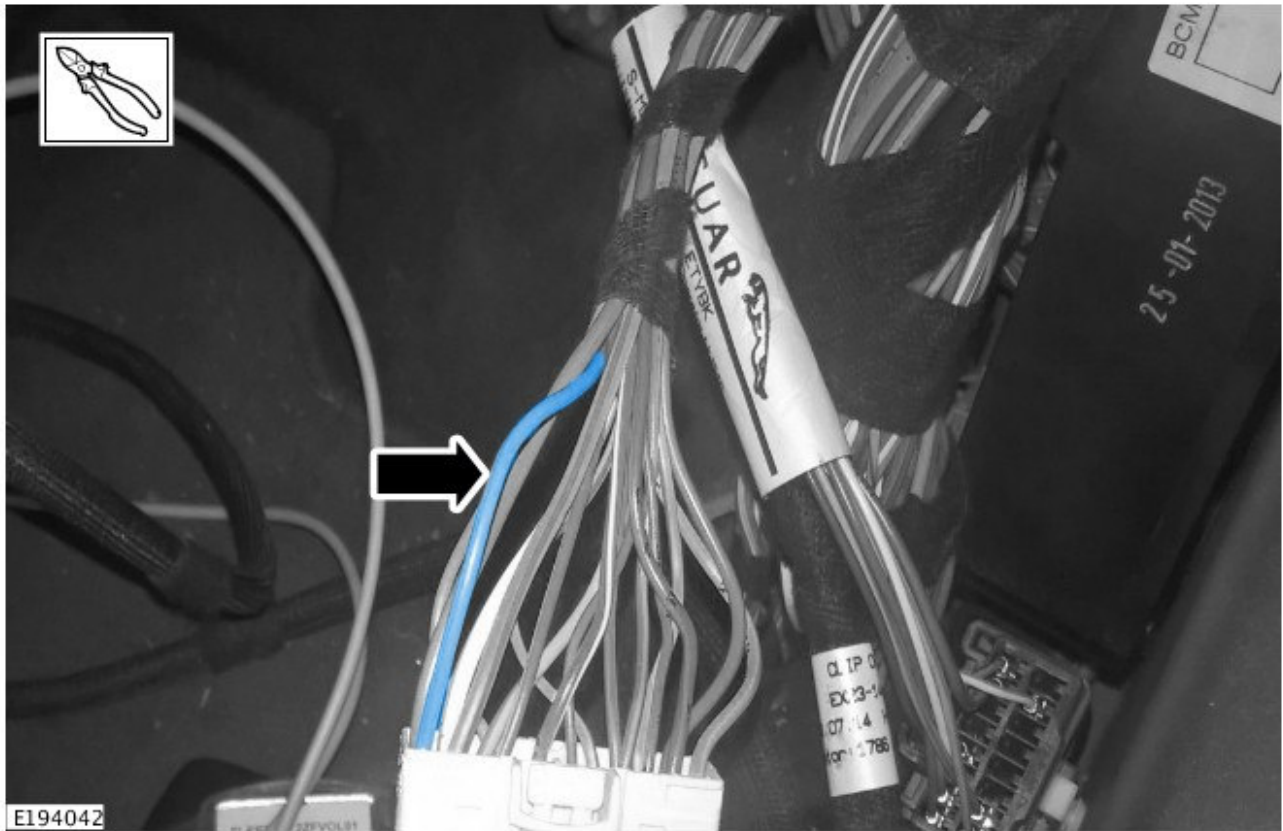
12. Using a suitable tool, cut the wire at pin 8 (GN/RD) of connector C3BP01D.

1. Tape the cut end of the wire from the connector.

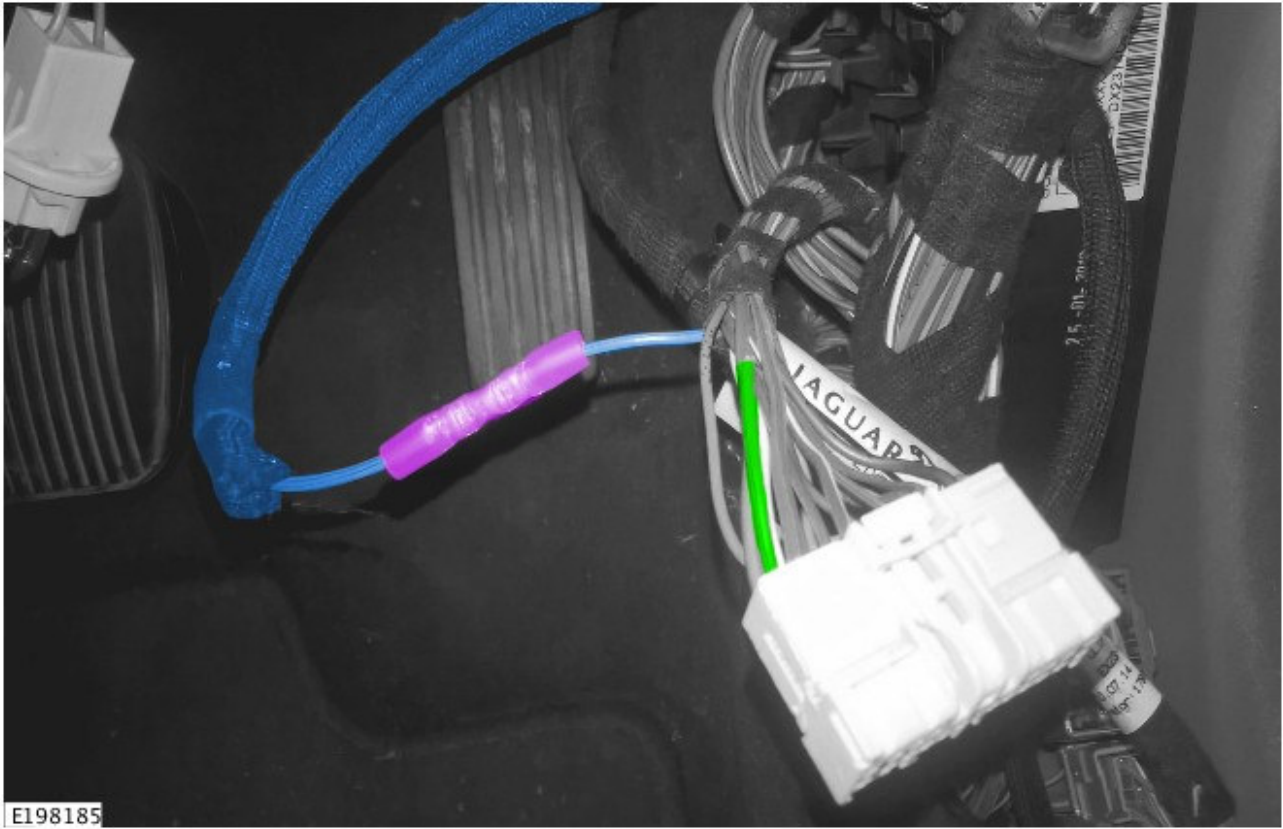
E198185

**NOTE: Tape the cut wire (shown in green) that is no longer used.**

Connect the new wiring harness to the harness-side of the wire cut in Step 12.

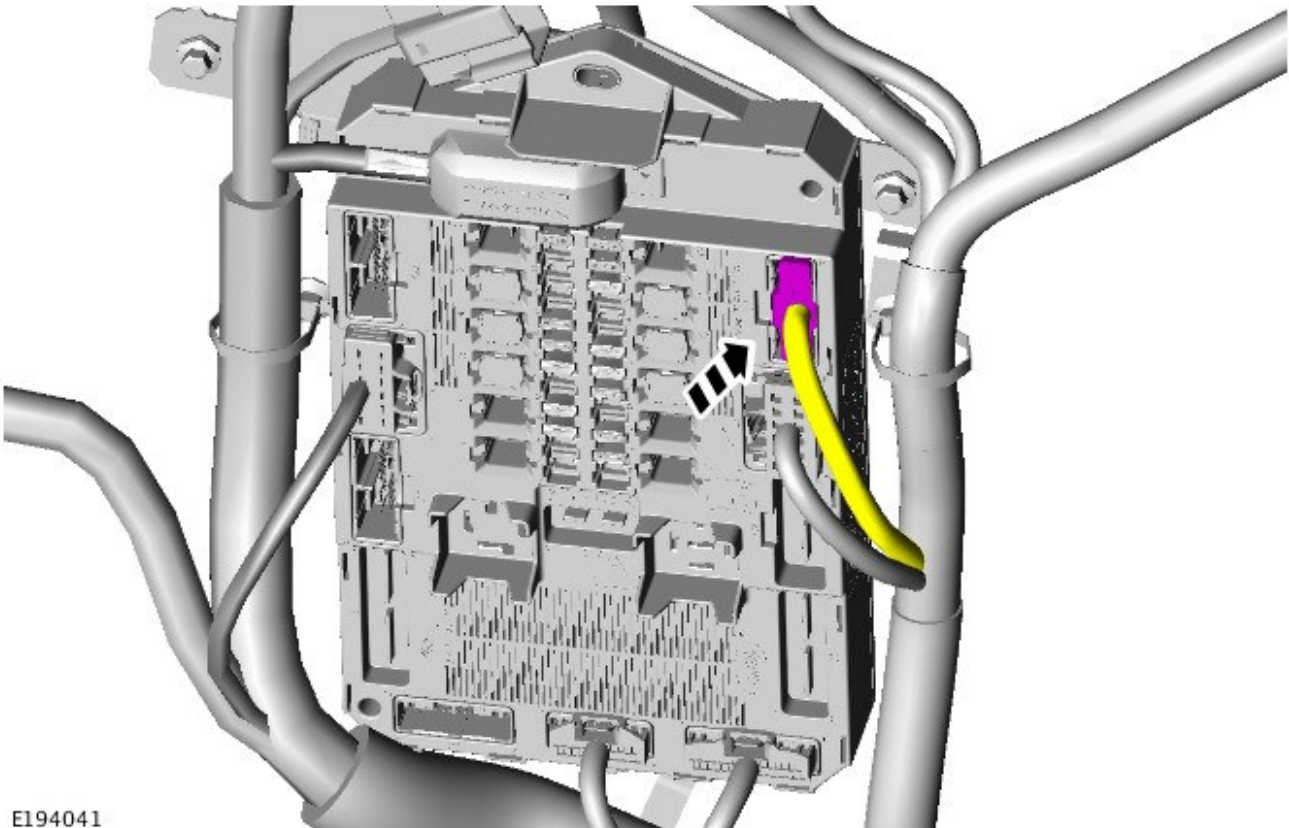
E194041

14. Connect connector C3BP01D to the CJB.

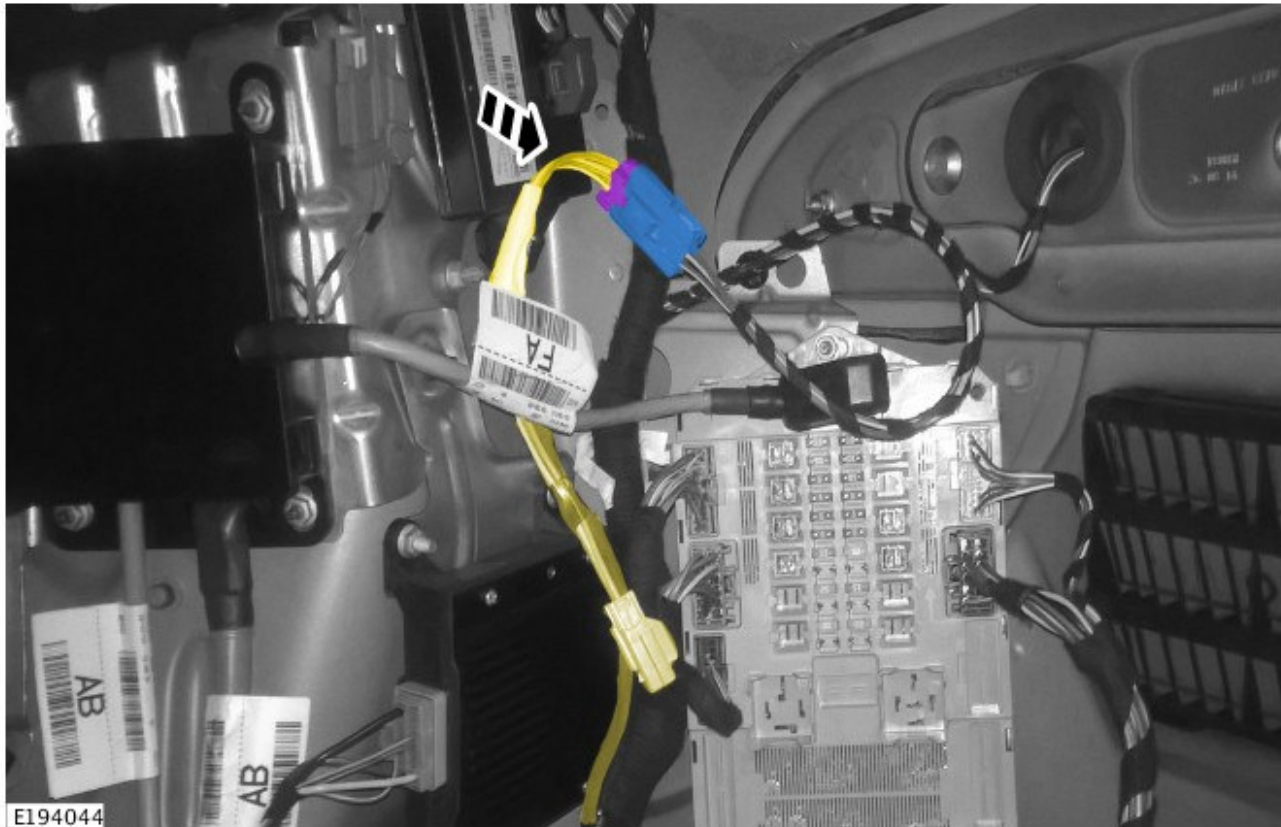
**NOTE: If the vehicle does not have a towbar fitted, this connector is not used. If the vehicle has a towbar fitted, this connector must be disconnected and the new harness connectors installed inline.**

Connect the new harness to the existing trailer connector C4DC10.
