MIL "ON" DTC P0A80 or P0A7F Due to Dust or Debris in the HV Battery Cooling Fan

Service Category Engine/Hybrid System

Section Hybrid/Battery Control System

YEAR(S)	MODEL(S)	ADDITIONAL INFORMATION
2013 – 2014	Camry HV

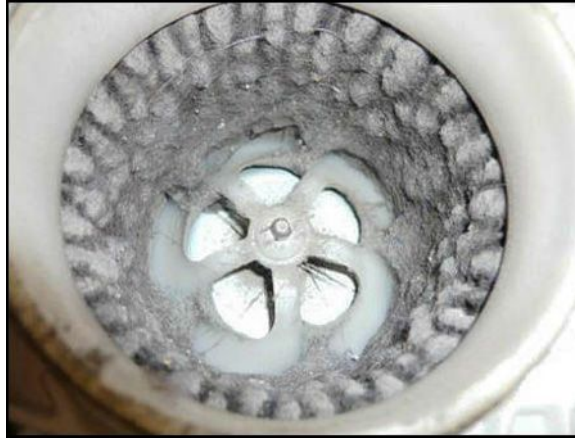
Figure 1.

2. Clean any dust, lint, or debris buildup from the HV battery cooling fan blades, module, and ducts using a vacuum and/or compressed air if necessary.

- Do NOT attempt to clean the HV battery cooling fan while it is installed in the vehicle. Doing so may cause dust or debris to enter the HV battery case.
- Secure the fan blades from spinning while cleaning. Spinning the fan blades while cleaning can result in electronic circuit failure due to excessive fan blade speed.

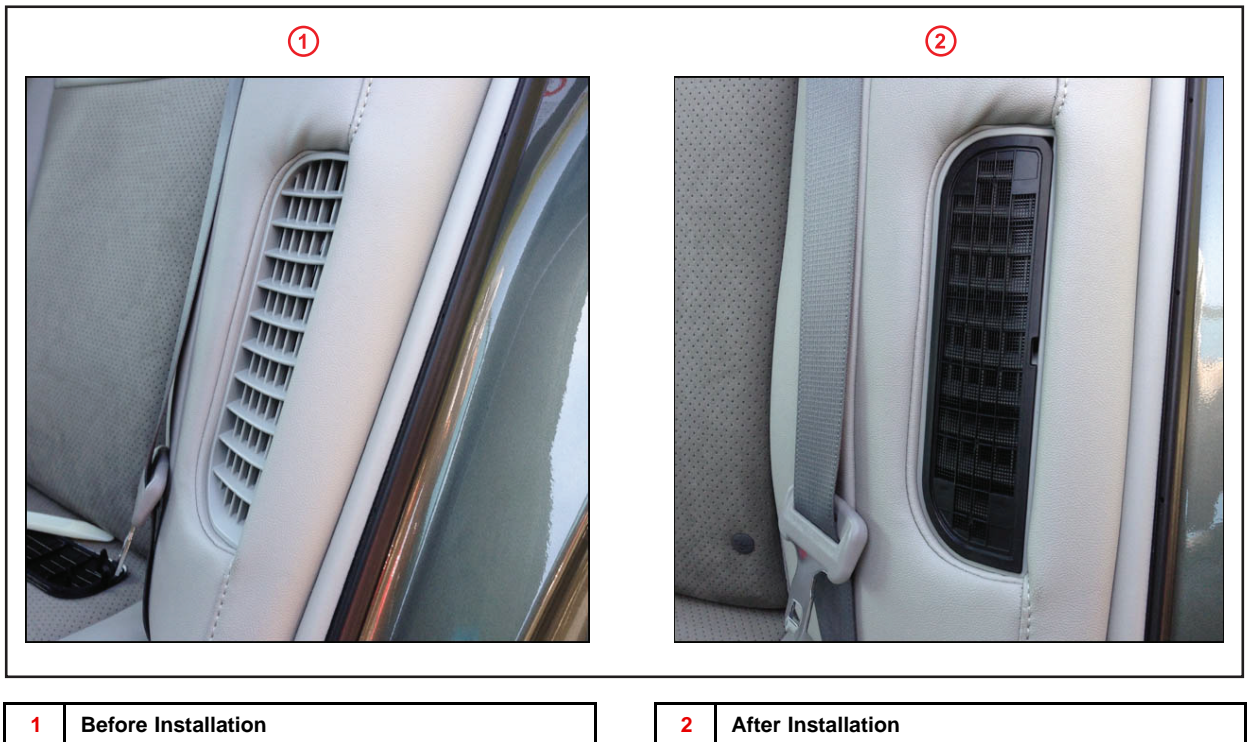
Figure 2.

4. Install a new HV Battery Intake Filter No. 1 (P/N G92DH-33020) as shown.

The filter should be cleaned when dust begins to appear on the surface.

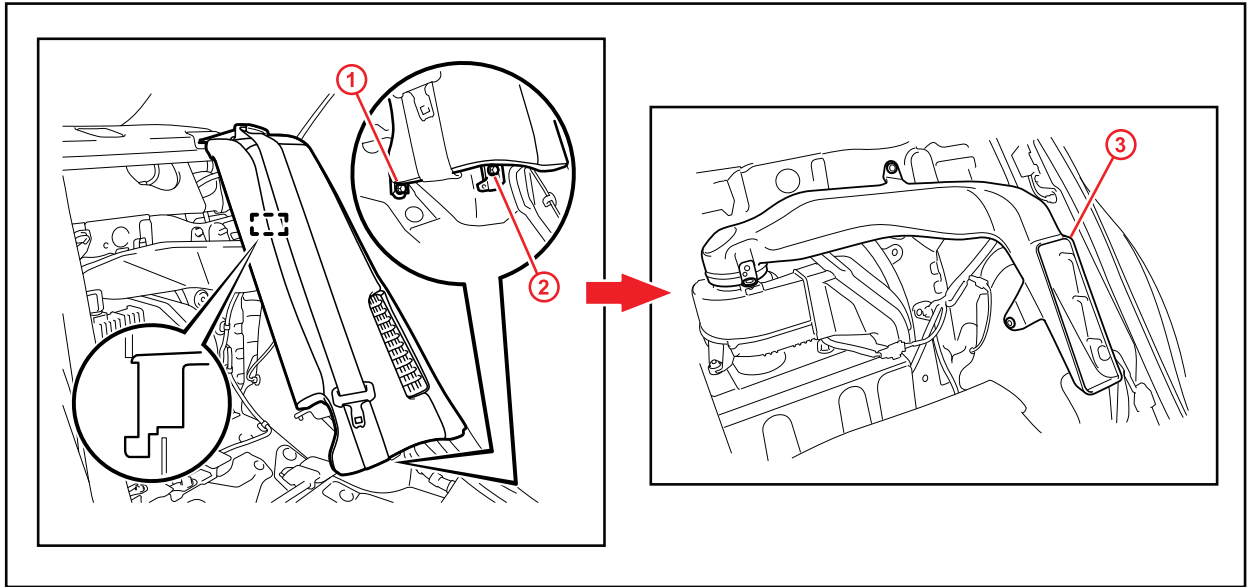
Figure 3.

1. Is the internal filter clogged with dust or debris buildup?

1	This Bolt Does Not Need to Be Removed
2	Remove This Bolt

3	Filter Installation Position
---	------------------------------

NOTE
 Seatback does NOT need to be removed though it's not shown in the Figure above.

2. Check the physical condition of the internal filter.
 - A. If the filter is damaged, replace the HV Battery Intake Filter No. 1 (P/N G92DH-33040).
 - B. If the filter is physically OK, clean using vacuum and make sure no contaminants enter the HV Battery cooling system including fan.

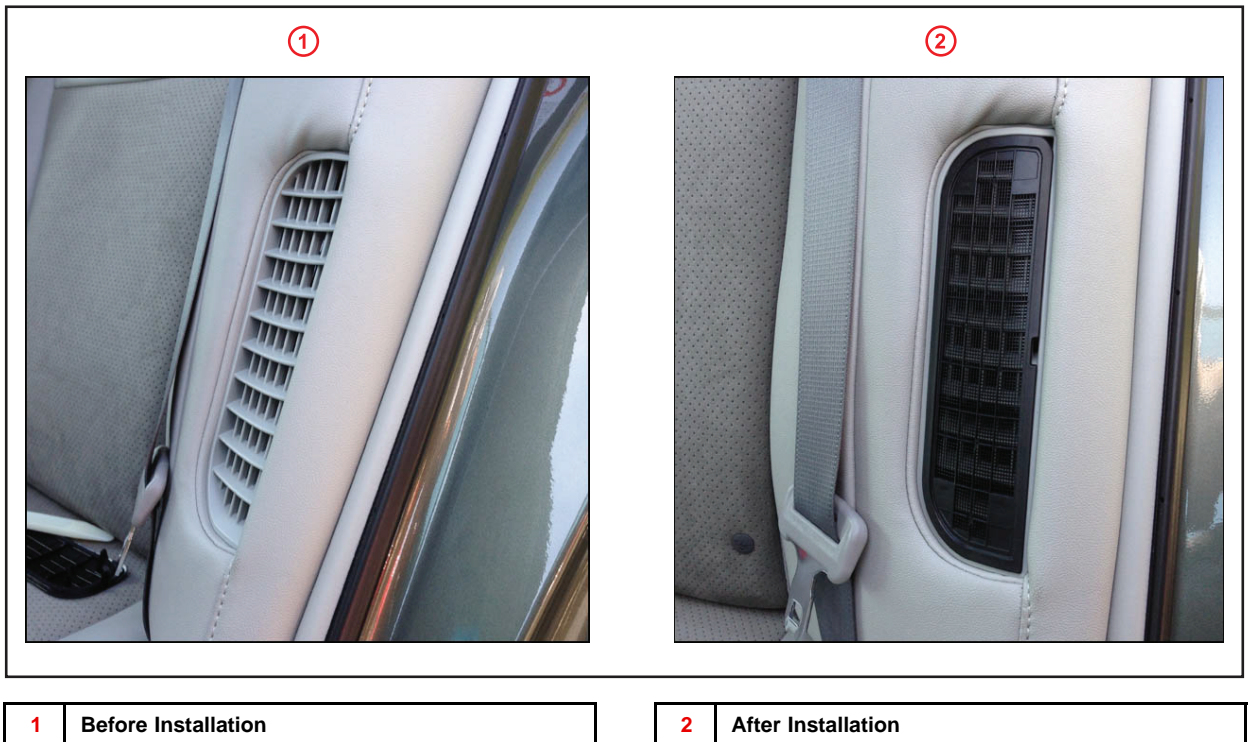
Figure 4.

3. Install a new HV Battery Intake Filter No. 1 (P/N G92DH-33020) as shown.

The filter should be cleaned when dust begins to appear on the surface.
