# Multi-Display Coating Damage

**Section** Navigation/Multi Info Display

Some 2014 – 2015 Lexus IS 250/350 and 2015 RC 350/F vehicles may exhibit damage to the multi-display anti-reflective coating. A display lens with revised anti-reflective coating has been developed to address this condition.

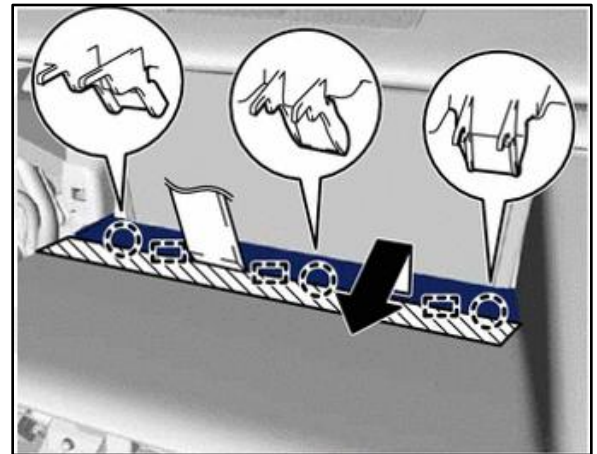
**Figure 1.**

1. Remove the No. 2 instrument cluster finish panel sub-assembly.

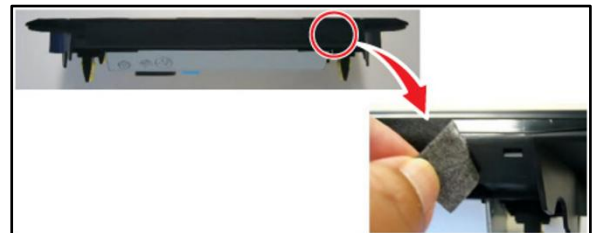
Figure 6.

1. Remove the insulator attached on the top of the display slowly from the edge.

Remove the insulator completely.

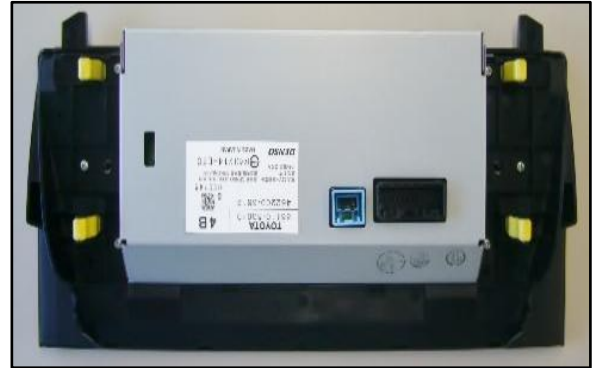
**Figure 7.**

- Put the display down on the table with the front lens facing downward and the upper side to the front.

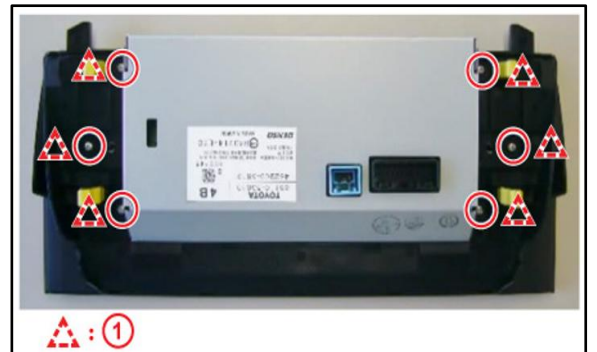
**Figure 8.**

- Remove the 6 screws from the back of the display.

<b>1</b>	<b>Screw</b>
----------	--------------

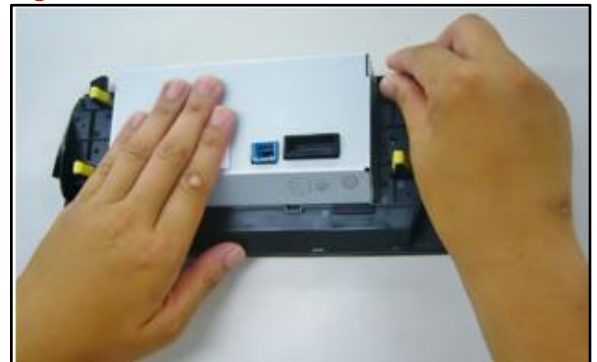
**Figure 9.**

- Separate the rear cover (with yellow clips) from the display.

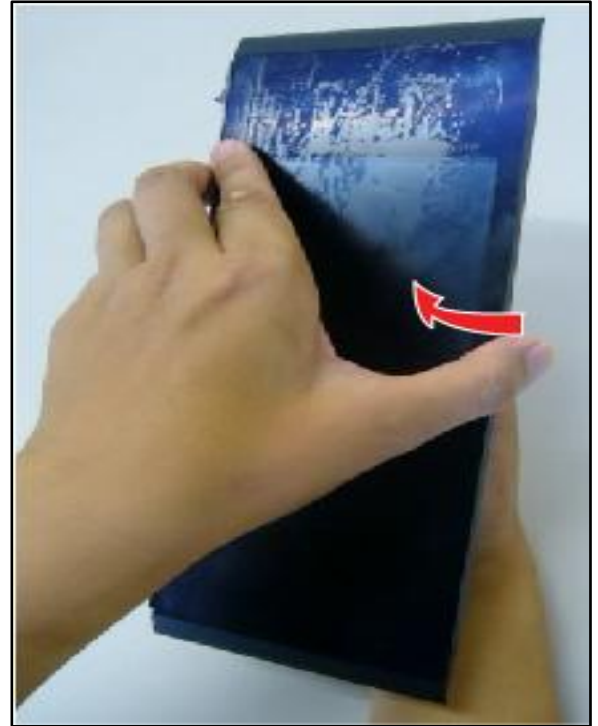
Figure 12.

6. Remove the upper part of the front lens from the LCD panel assembly.

Using the 3 claws at the bottom as a supporting point, pull open the front lens as shown.

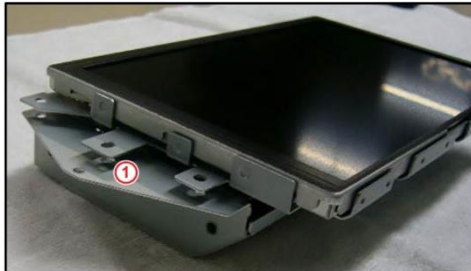
1 Separated state

Before assembly, do NOT put the display on the table, etc. because the LCD panel assembly and the rear cover could become separated.

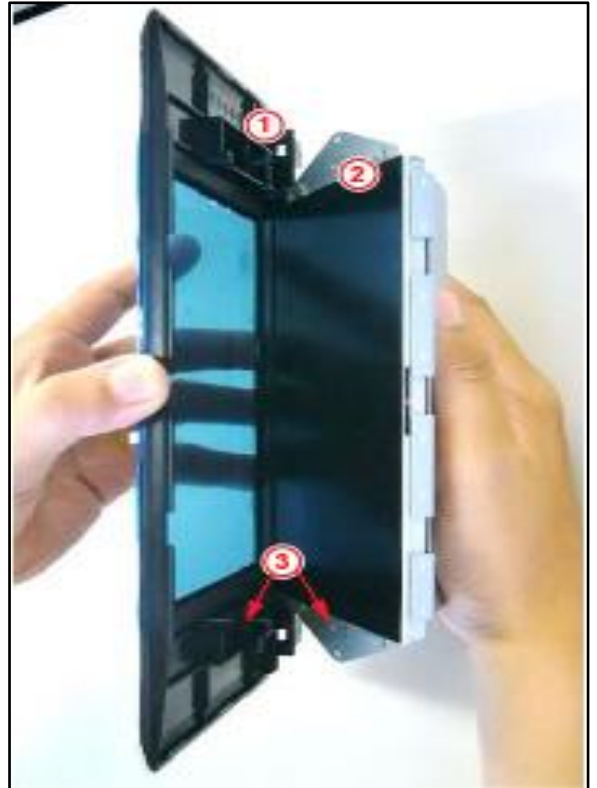
**Figure 15.**

9. Fit the NEW front lens on the LCD panel assembly.

<b>1</b>	<b>Positioning Boss</b>
<b>2</b>	<b>Positioning Hole</b>
<b>3</b>	<b>Supporting Point</b>

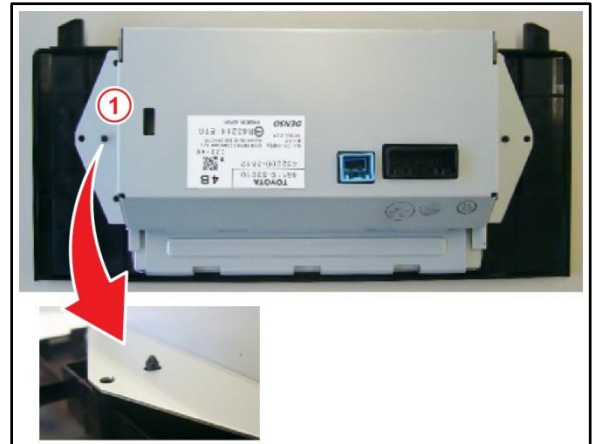
**Figure 16.**

10. Put the display down on the table as shown.

Make sure the positioning boss is protruding.

<b>1</b>	<b>Positioning Boss</b>
----------	-------------------------

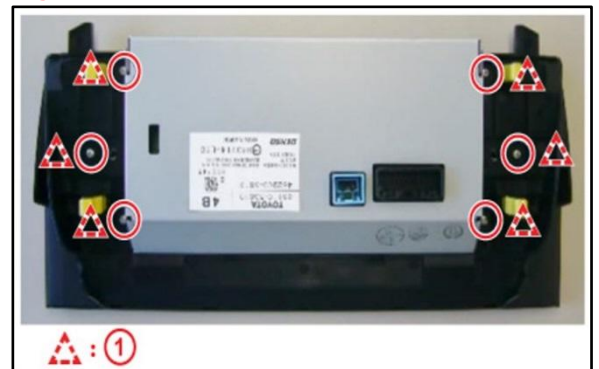
Figure 20.

- Secure the rear cover by installing the six new screws provided in the repair kit.

1	Screw
---	-------

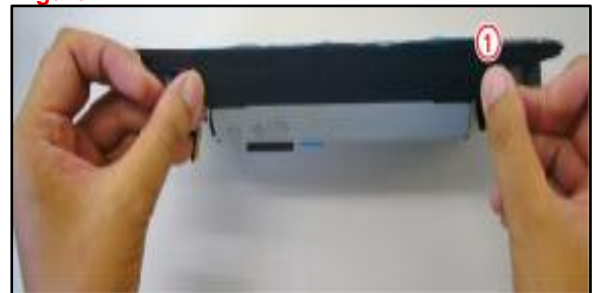
Figure 21.

- Attach the new insulator provided in the repair kit.

1	Attachment Start Point
---	------------------------
