Rattle Noise From Rear of Vehicle

Service Category Brake

Section Parking Brake

Some 2014 – 2016 model year IS vehicles may exhibit a rattle type noise from the rear parking brake assemblies when driving over bumps. Follow the procedure in this bulletin to address this condition.

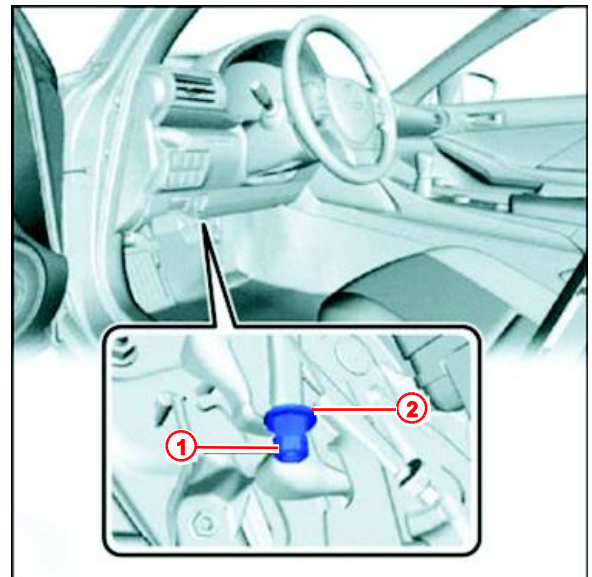
Figure 1.

Make sure the No. 1 Wire Adjusting Nut is completely loose during parking brake adjustment. This will ensure there is no gap between the shoe and anchor inside the parking brake assembly. If a gap is present, a rattle type noise may occur.

| 1 | Lock Nut |
| 2 | No. 1 Wire Adjusting Nut |

1. Adjust the parking brake.

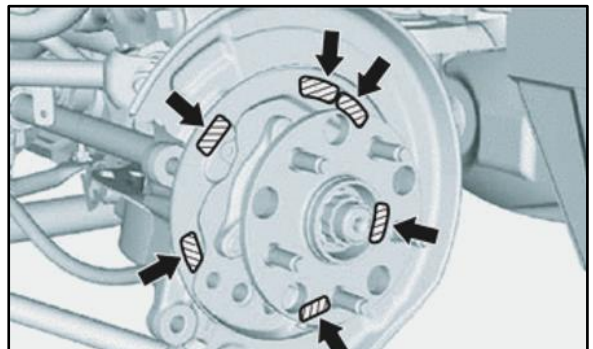
Figure 2.

- Clean up parking brake shoes, parking brake shoe lever sub-assembly, and backing plate.

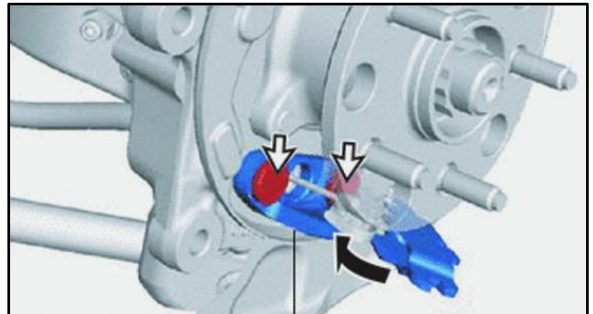
Figure 3.

- Apply Disc Brake Grease to the areas of the parking brake plate which make contact with the shoe and anchor block sub-assembly.
