## Service Campaign 66-07

**AFFECTED:** 2013, 2014 & 2015 Winnebago Journey and Itasca Meridian models  
2014 & 2015 Winnebago Forza and Itasca Solei models

**DATE:** October 21, 2016

**SUBJECT:** Engine Air Water Separator Enhancement

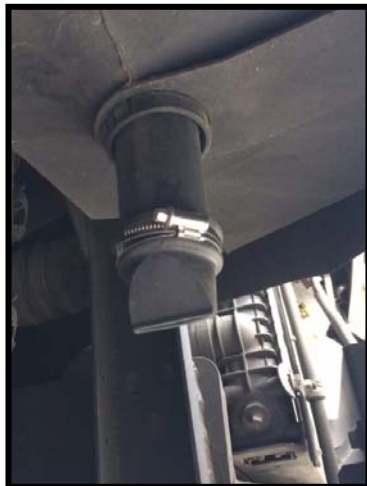
**Figure 1 - Correct Installation**

If a vacuator drain valve is installed as shown in Figure 1, the campaign will not need to be completed.

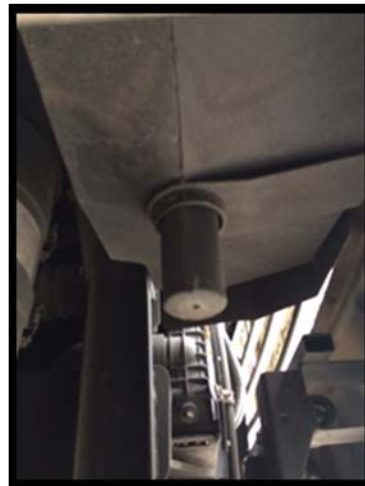
**Figure 2 - Perform Campaign**

Winnebago Industries is conducting a Field Service Campaign on certain 2013, 2014 and 2015 Winnebago Journey and Itasca Meridian models and 2014 and 2015 Winnebago Forza and Itasca Solei models. The engine air water separator drain may be susceptible to blockage. This campaign is to inspect the engine air water separator installation and correct if necessary. **We are sending a Second Notice to stress the importance of having this campaign performed. The water separator installation may be susceptible to foreign material entering the intake and restricting this drainage circuit. Should a complete blockage occur, water can accumulate in the water separator, and over time migrate into the air cleaner assembly causing damage to the engine.**

If the drain circuit resembles Figure 2, the campaign will need to be completed.

1. Place bucket/collection device beneath the water separator to collect any water retained in separator.
2. Probe drain hole and empty any contents.
3. Measure and remove 14mm ( $\frac{1}{2}$ " ) of the lower portion of the plastic drain tube to expose the inside diameter of the tube. This can be performed using a cut-off wheel or saw blade. May also use 37mm ( $1\frac{1}{2}$ " ) drill bit as shown in Figure 3.

**NOTE:** The balance of the drain tube remaining **must** be a minimum of 100mm (4") in length prior to the installation of a the vacuator valve.

4. Inspect the water separator drain circuit for the presence of foreign material. Clean as necessary.
5. Install the vacuator valve to the end of the drain tube using the provided hose clamp, Figures 4 and 5.

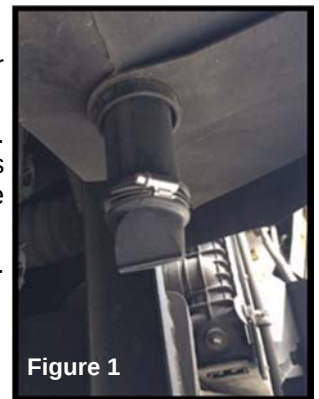
Figure 1

- If the drain circuit resembles Figure 1, the campaign does not need to be completed. You can notify us by completing the postcard included with this letter or contacting us at [or@wgo.net](mailto:or@wgo.net) or (800) 537-1885 with your Winnebago Body Serial Number and we will remove your coach from the campaign.
- If the drain circuit resembles Figure 2, the campaign will need to be performed. Contact your Winnebago Industries, Inc. dealer to arrange for a service appointment.
