Service Bulletin 530

Subject: Brake Hose Retaining Clip Removal				
Bulletin Number	Models Affected	VIN Range		Markets Affected
530	Street Twin	Up to	753869	All Markets
	Bonneville T120	Up to	753869	All Markets
	Bonneville T120 Black	Up to	753869	All Markets

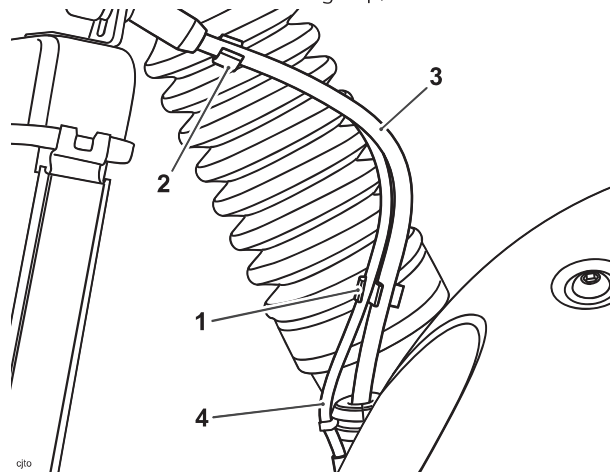
Internal investigations have identified a need to remove one of the front brake hose clips to prevent potential scratching of the front mudguard.

1. Lower brake hose retaining clip
2. Upper brake hose retaining clip
3. Front brake hose
4. ABS sensor cable

Remove the lower front brake hose clip following the procedure described below. If the front mudguard or front brake hose is damaged, contact Triumph Warranty Technical Support for repair instructions.

1. Remove and discard the lower brake hose retaining clip, item 1 as shown in the illustration.
