TECHNICAL BULLETIN
JTBO0432NAS3
05 FEB 2016

Vibrations and/or Rattles When Listening to the Entertainment System

F-TYPE (X152)

Door vibration or rattle insulation procedure

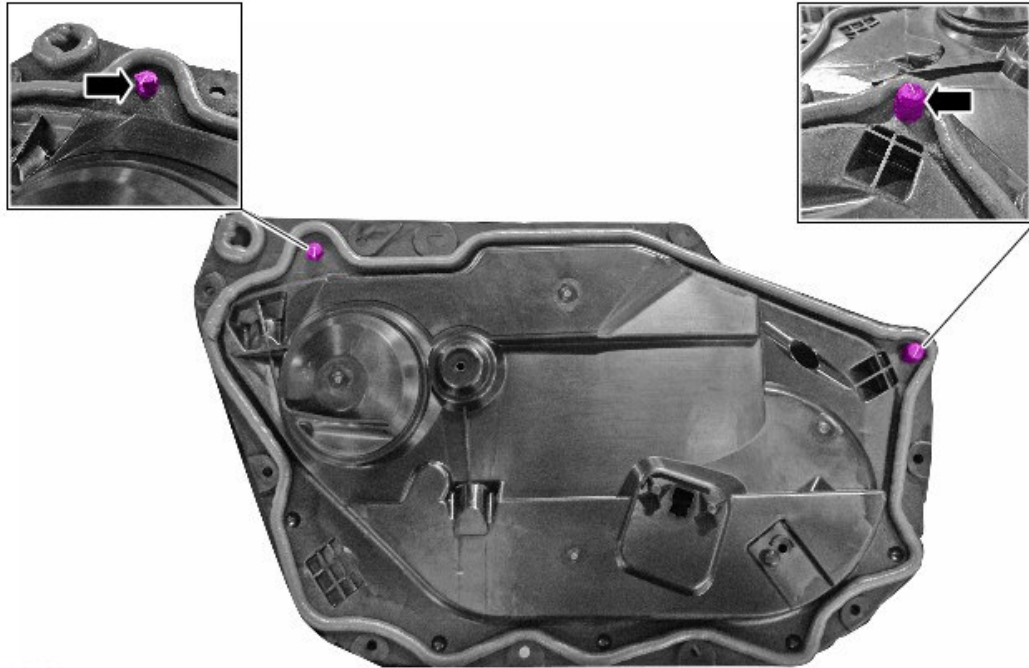
E179789

16. When installing the door panel, make sure that the locating lugs

are correctly located into the door.

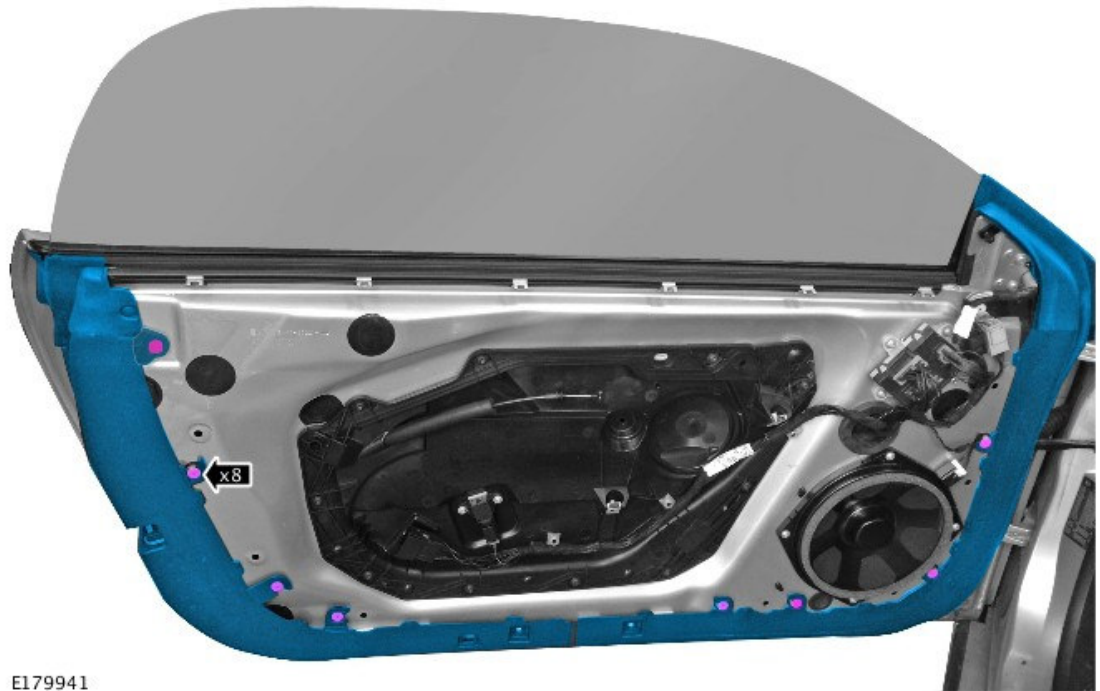
E179941

20. Remove the door trims.

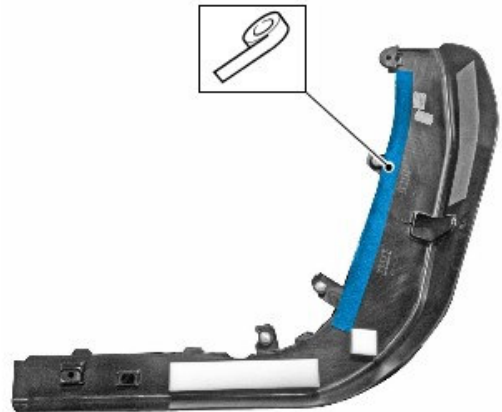
E179792

21. Install 0.5mm felt insulation tape to the door trim as shown.

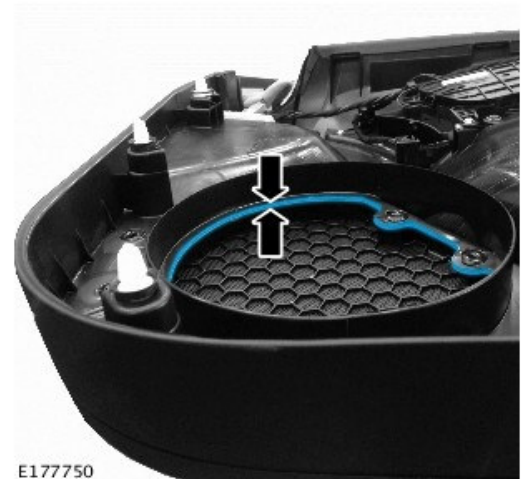
E177750

25. Inspect the speaker grille on the door trim panel.

- Using a suitable feeler gauge check the clearance between the speaker baffle and the door trim panel.
- If a clearance is found proceed to step 6. If no clearance is found proceed to Step 7

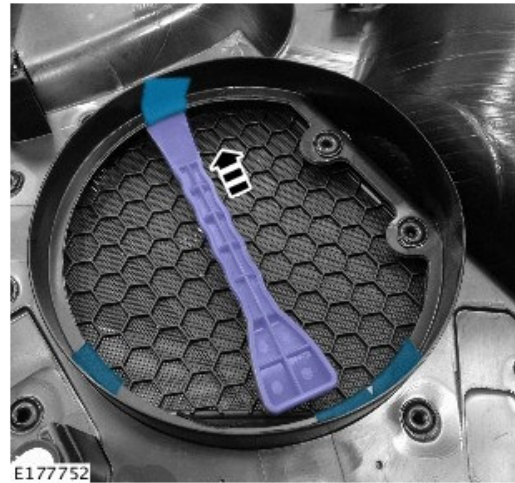
26. Using a suitable trim tool, install felt tape between the speaker baffle and the door panel trim.

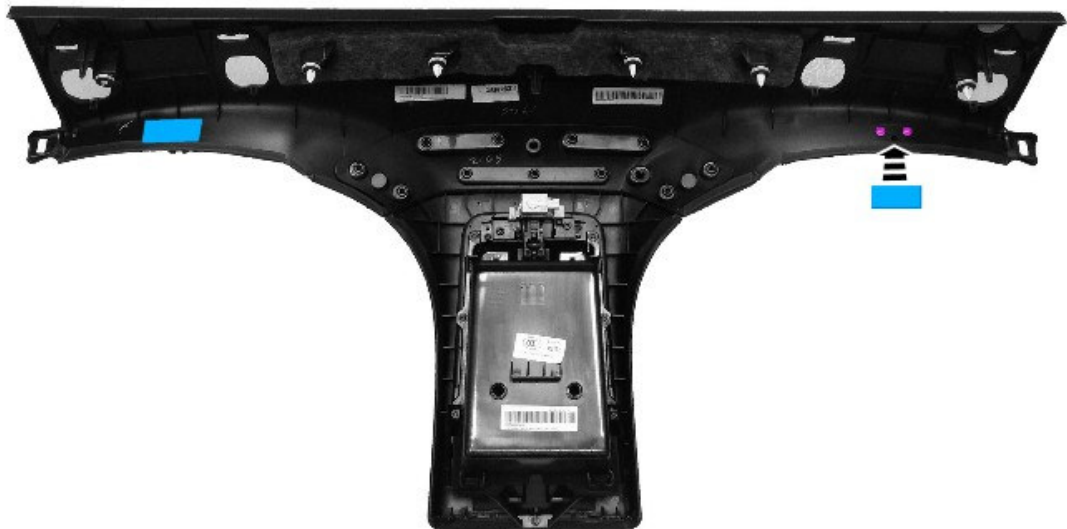
E177756

**NOTE:**
Convertible
shown;
Coupe
similar.

When the parcel shelf is removed, install foam pads to the contact areas shown.

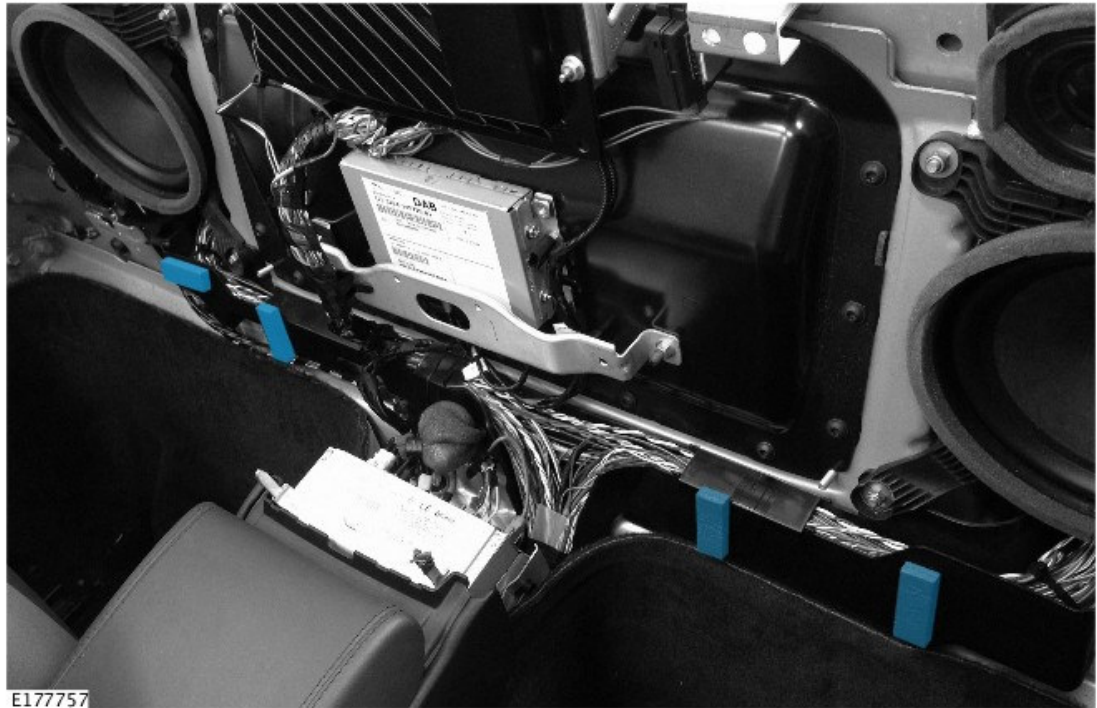
7. Install the foam pads on the electrical wiring harness conduit.
