TECHNICAL BULLETIN LTB00997NAS1 20 OCT 2016

Range Rover Evoque (LV)Model Year:2016 OnwardsVIN:137551 OnwardsAssembly
Plant:Halewood

Situation: A sill treadplate may be loose.

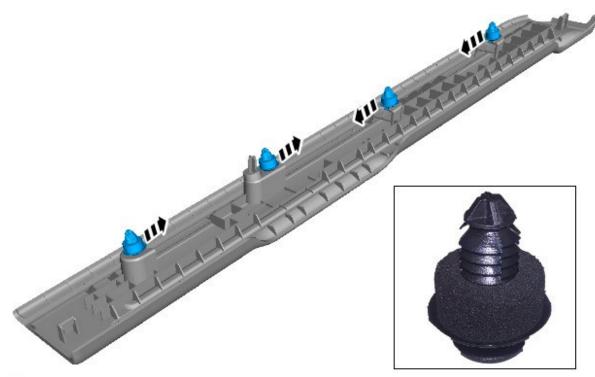
E196647

2. Remove and discard all retaining clips from the treadplate.

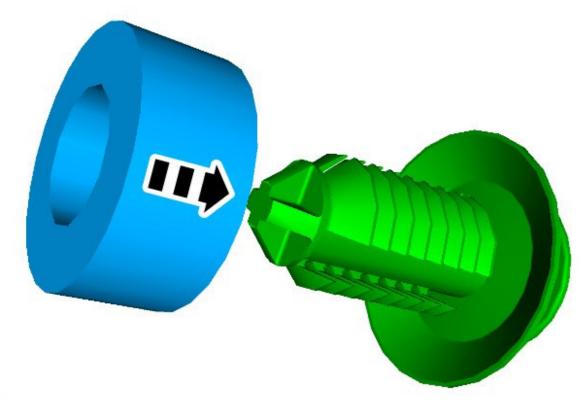
E196790

3. Assemble the new retaining clip and washer together as shown.

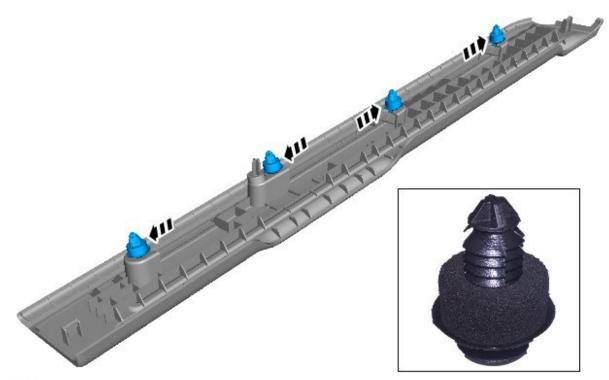
E196646

4. Install the new retaining clips to the treadplate.
