Service Bulletin

Bulletin No.: 16-NA-111

Subject: Diagnostic Tip for Malfunction Indicator Light (MIL) Illuminated, DTC P0420 and P0430 Set

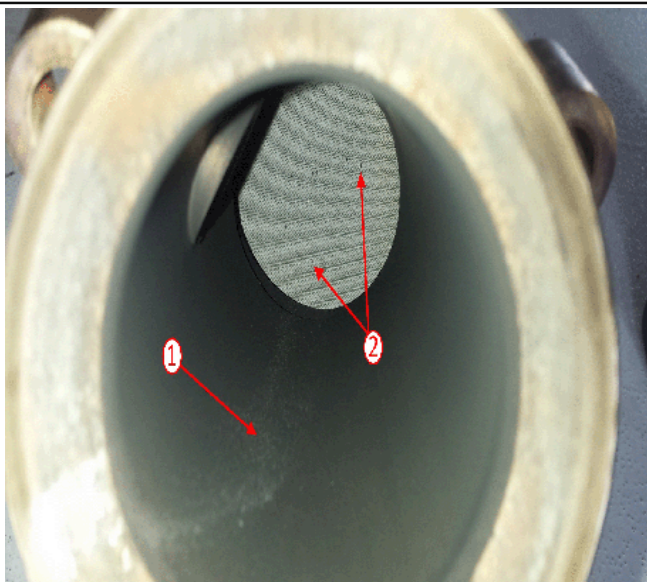
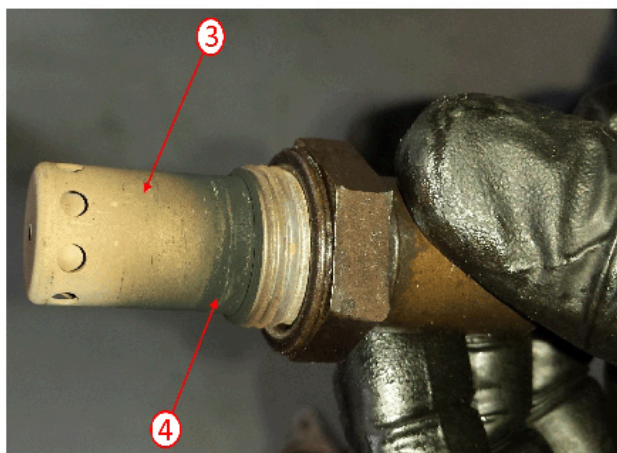
This may be caused by excessive sand and/or debris entering the air filter box and bypassing the seal of the air filter, due to not properly sealing, causing damage to the HO2 sensor element (3) and the catalytic converter to become blocked with sand and debris particles (1, 2).

Do not replace any of the parts until the air filter housing has been validated to be completely sealed.

If the condition is evident, inspection of the air box and air filter seal must be done.

Follow the Service Procedure steps in order to verify the sealing of the air filter to housing surface.

After validating the air box has been sealed, repair the P0420 and the P0430 codes **as needed**.

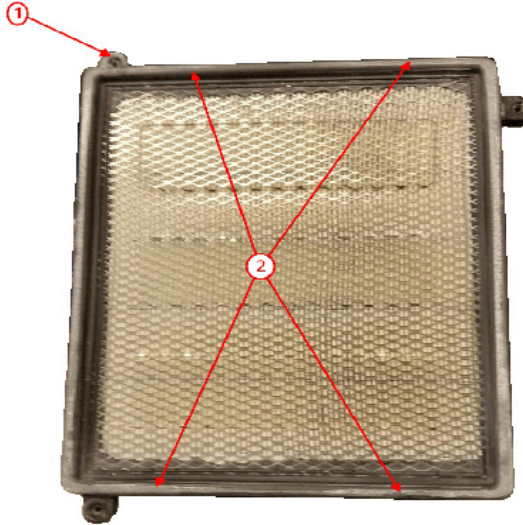
4484793

1. Inspect the all the air housing cover for any missing tabs and/or fasteners (1).
2. Remove the air filter housing cover and inspect the seal around the air filter (2).

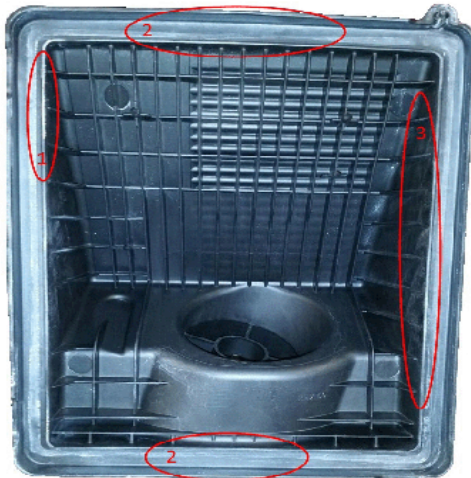
4484775

3. Inspect the air filter sealing surface for signs of not contacting the air filter seal (1, 2).
4. Inspect the air filter housing cover for dirt and/or debris bypassing the air filter (3).
5. Inspect the air cleaner outlet duct for any dirt and/or debris.
 - If dirt and debris has been found bypassing the air filter due to a faulty seal, replace the air filter as necessary.
 - If the air filter housing has been found not properly sealing, refer to the *Air Cleaner Assembly Replacement* in SI.
