## SERVICE ADVISORY # 16-263

### Sprinter TV Strap

| <b>Model Included:</b> | 2016 & 2017 Sprinter - ST353FWDEN |

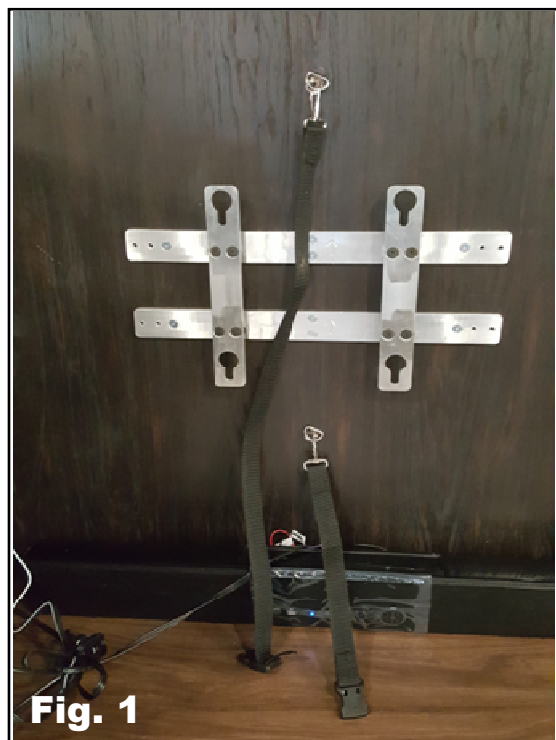
**Fig. 1**

After the TV is removed from the bracket, install the strap approximately 6 inches above and six inches below the TV bracket, Figure 1.

Reinstall TV on the bracket and clip strap around TV from top to bottom. Cut off any extra length of strap not needed, leaving enough for future adjustment if needed.
