# TECHNICAL BULLETIN

## LTB00960NAS1

### Loadspace Cover Support Peg(s) Broken

#### **Range Rover (LG)**

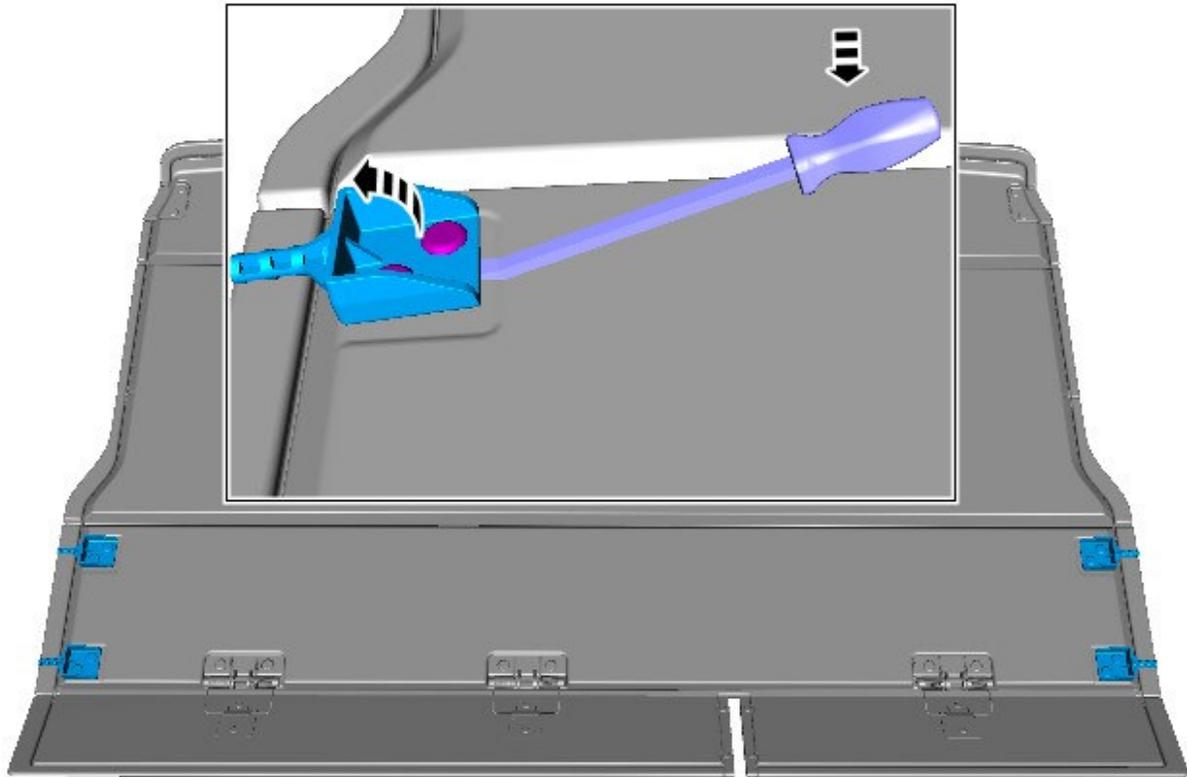
E193116

3. Using a suitable tool, lever off the affected loadspace cover support peg.

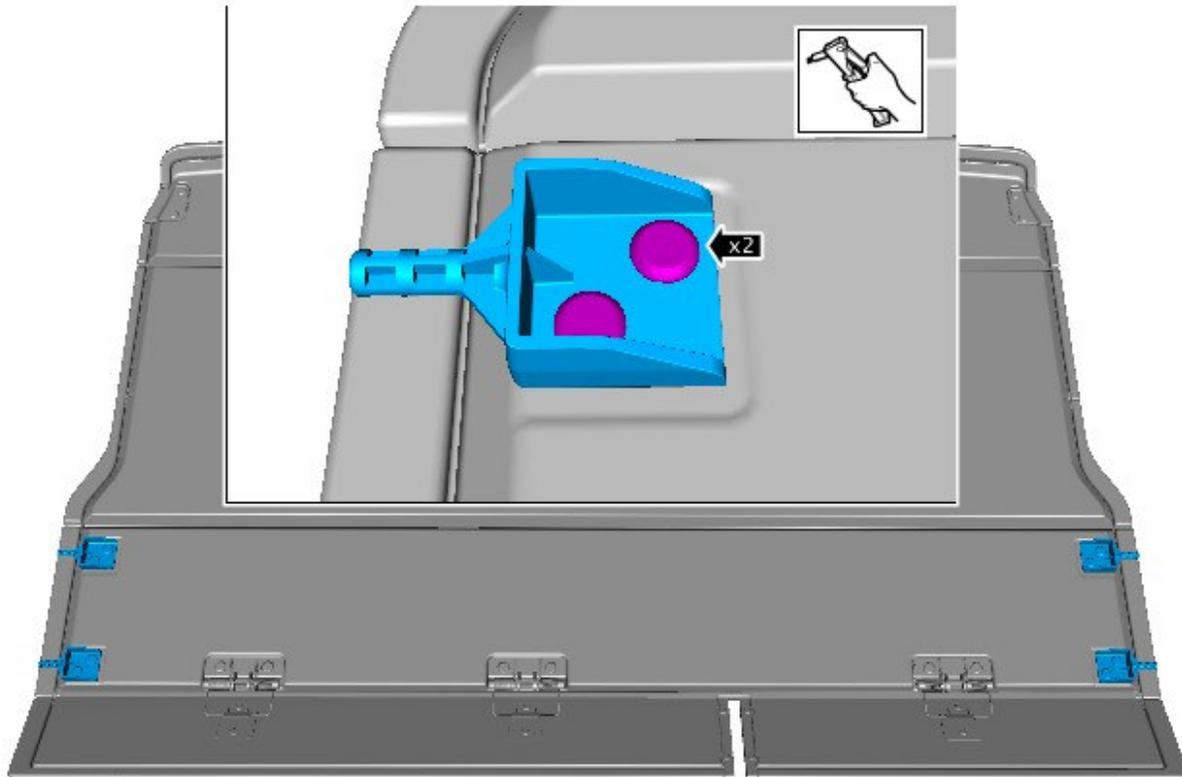
E193117

4. Using a suitable tool, install the new loadspace cover support peg.
  - Use the rivets supplied in the Service Repair kit.
