December 8, 2016

05335 Version 1

Right Rear Seat Does Not Fold Properly

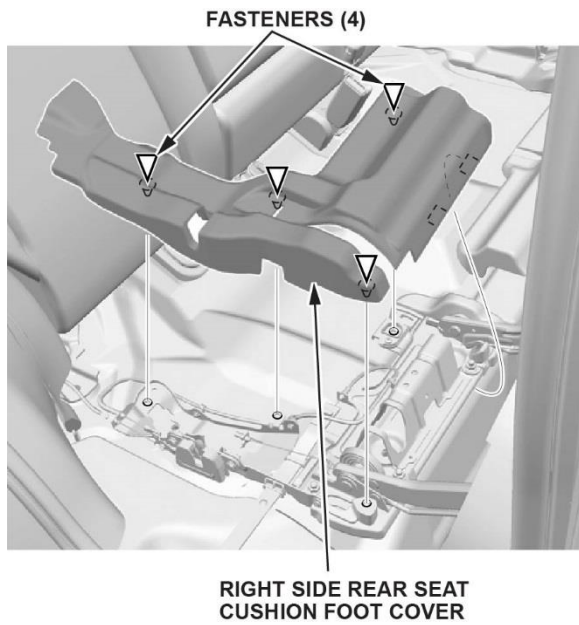
1. Remove the right side rear seat cushion foot cover.

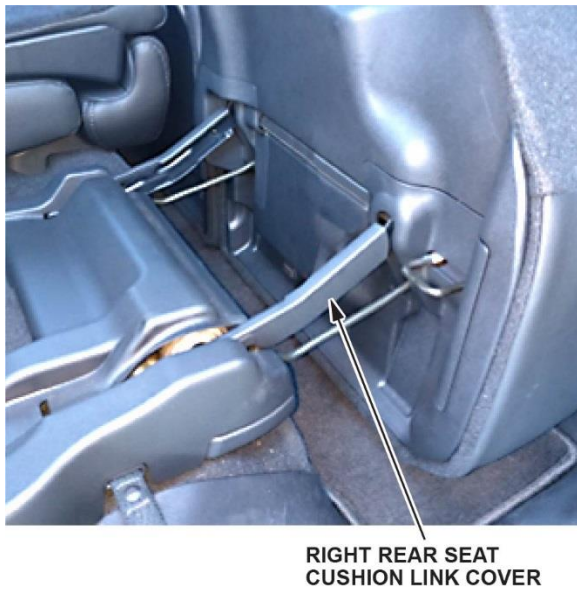
2. Remove the right rear seat cushion link cover.

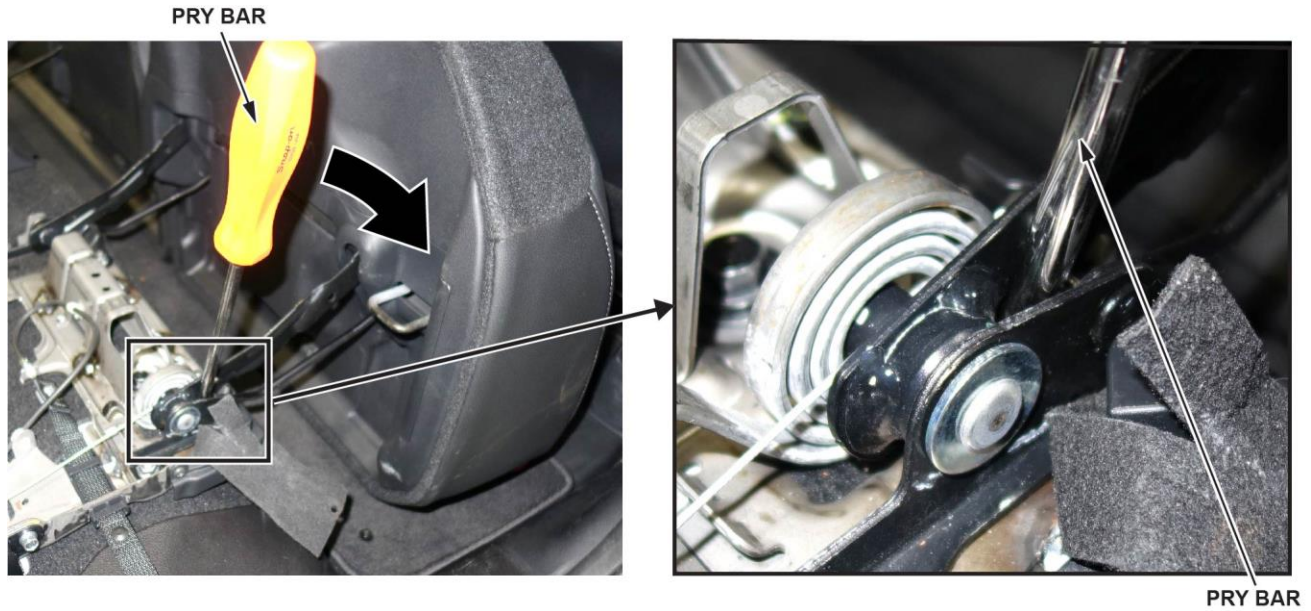
3. Place a pry bar between the right seat cushion outer link and the bracket, and apply pressure in the direction shown.

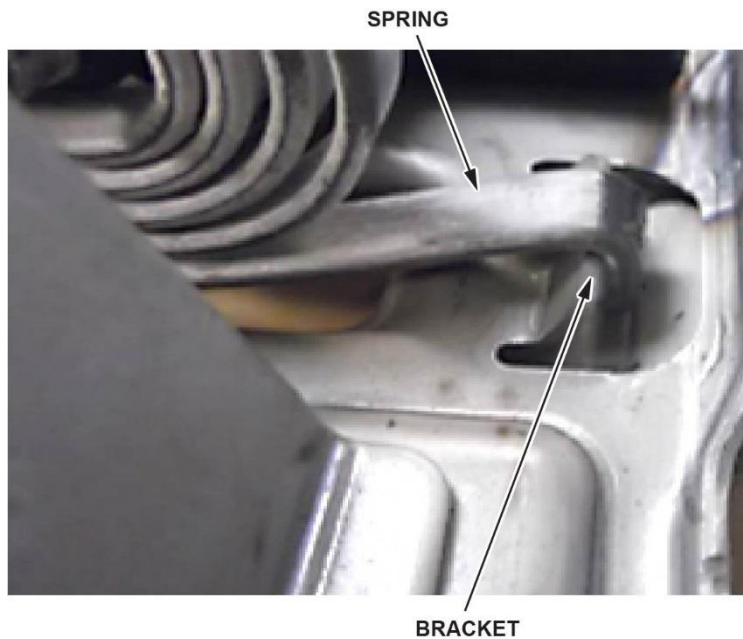
4. Check that the seat drops freely. Lift the seat bottom until the spring touches the bracket, then let the seat bottom drop.
- If the seat drops freely, the repair is complete.
 - If the seat does not drop freely, repeat steps 3 and 4 until the seat drops freely.
