March 29, 2016

03605 Version 1

Noncompliance Recall: 2004–07 Accord Front Passenger Airbag

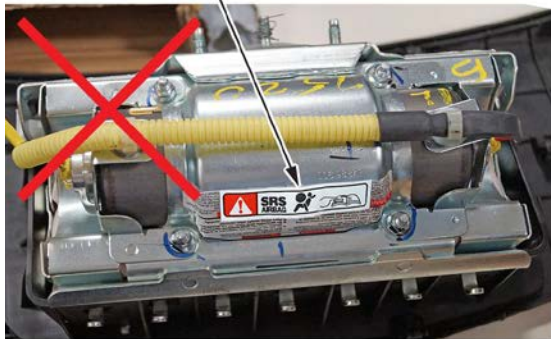
NON-STANDARD SAFETY LABEL

- If there is nothing unusual about the airbag or the inflator, go to step 6.
- If there are any unusual markings, like an incorrect label or a model year written in marker, the airbag and inflator may be a counterfeit part. For more information about counterfeit airbags, you can refer to safercar.gov, enter keywords **MANAGING COUNTERFEIT**, and select **Recommended Dealer Guidance for Managing Counterfeit Air Bags** from the list. **If you suspect that the airbag or inflator is counterfeit, do not continue this procedure.** Contact your DPSM for assistance.

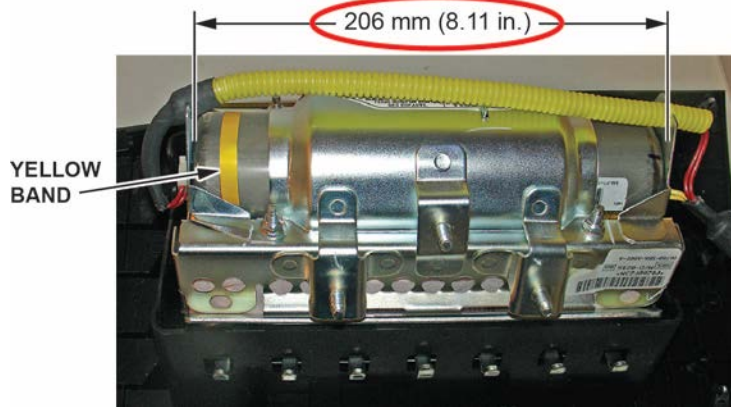
6. Measure the length of the airbag inflator and check for a yellow band around the inflator.
- If the inflator is **206 mm (8.11 in.)** long and has a **yellow band** around it, the vehicle is OK and no further action is needed. Reinstall the airbag in the reverse order of removal.

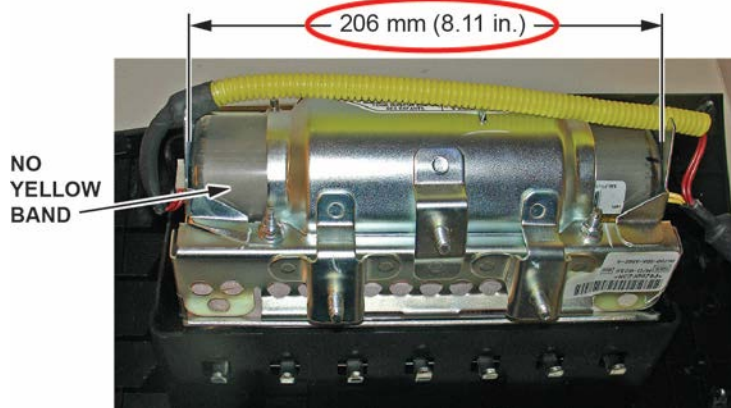
- If the inflator is **206 mm (8.11 in.)** long but does not have a **yellow band** around it, go to **S/B 15-067** and replace the inflator under the recall. Since the airbag is already removed, start at S/B 15-067 REPAIR PROCEDURE Step 6.

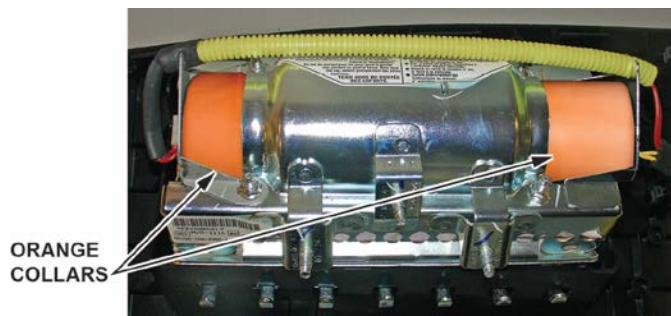
- If the inflator has **orange collars**, the vehicle is OK and no further action is needed. Reinstall the airbag in the reverse order of removal.

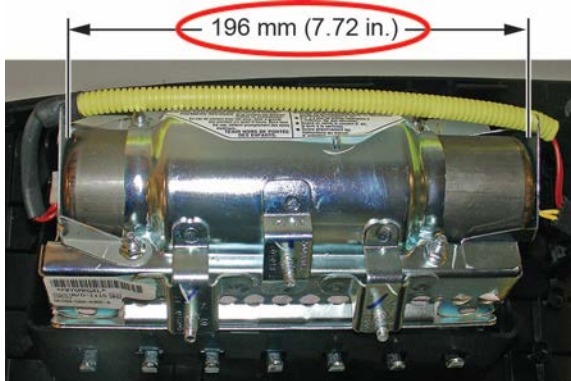
- If the inflator is **196 mm (7.72)** long, order an airbag assembly, then go to REPAIR PROCEDURE AND RETURNING THE INFLATOR.

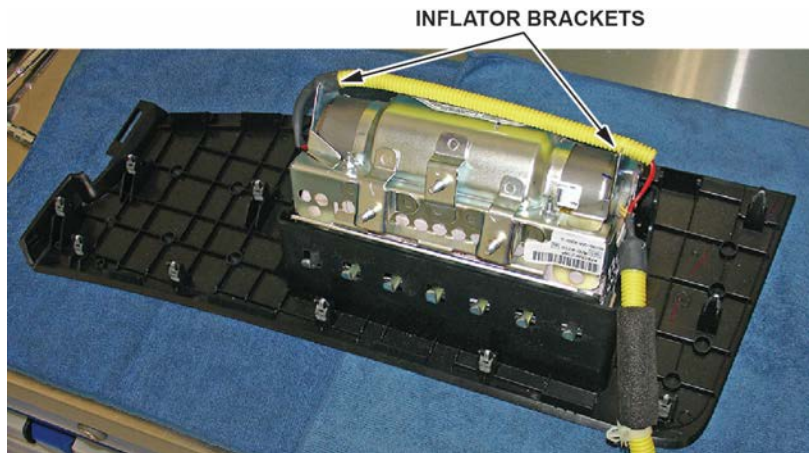
1. Remove the harness from both ends of the inflator brackets.

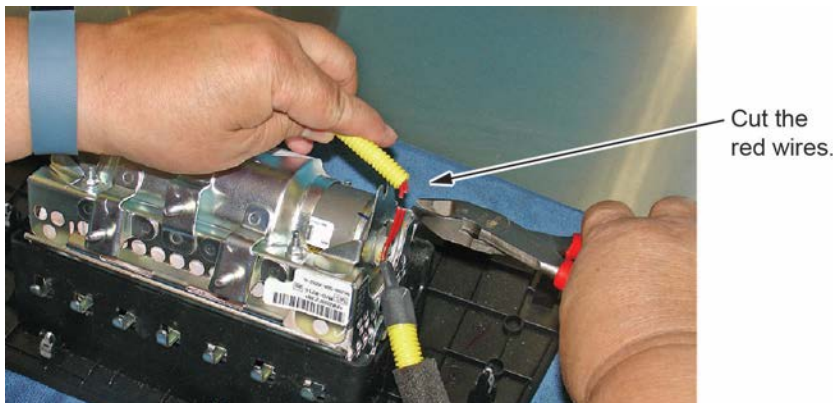
2. Short the red wires.

NOTE: **You must cut and short the wires** as indicated to prevent accidental deployment.

- Cut the red wires as shown.

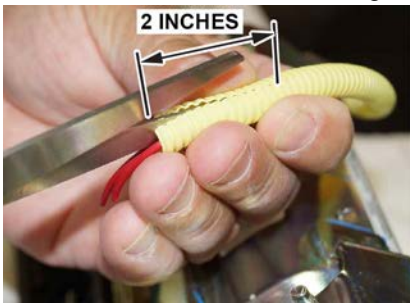
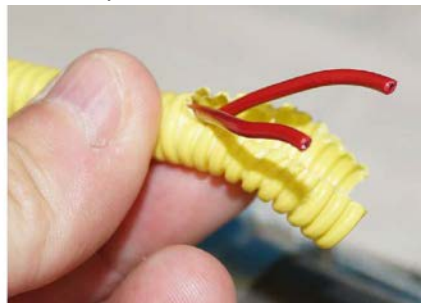
- Cut about 2 inches of the corrugated tube, then pull out the two red wires.

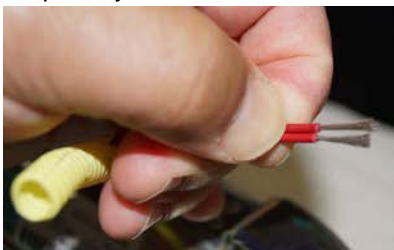
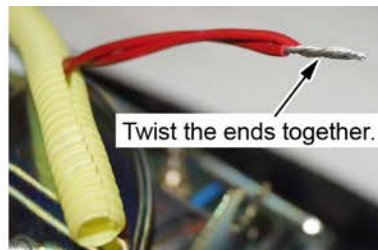
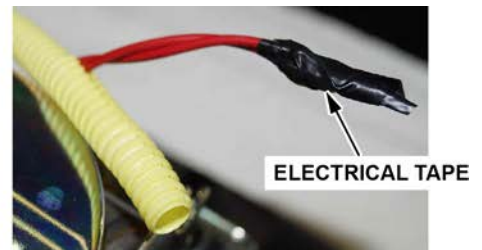
- Strip away about 1 inch of the wire insulation, then twist the wires together.

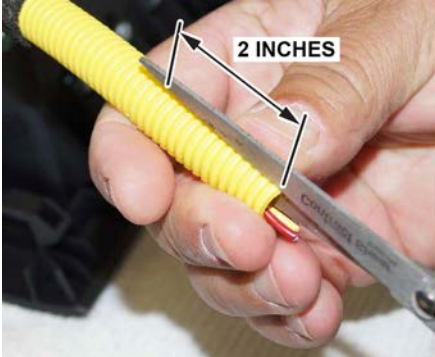
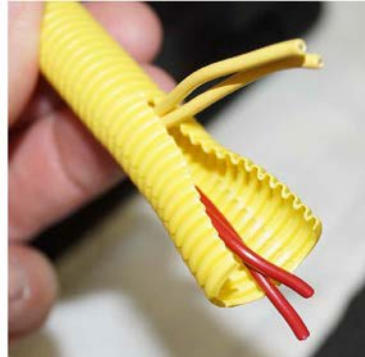
- Cut about 2 inches of the corrugated tube, then pull out the yellow wires.

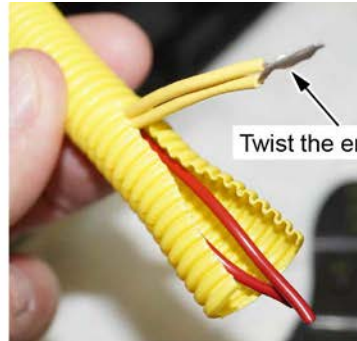
- Strip away about an inch of the wire insulation, then twist the wire ends together.

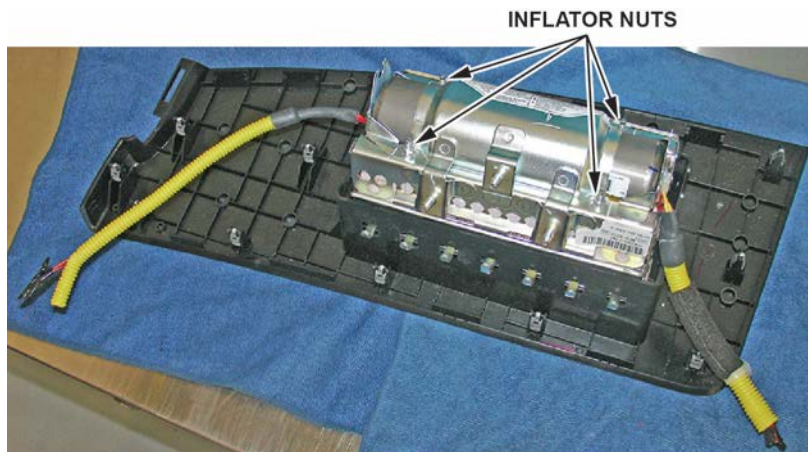
4. Remove the four inflator nuts.

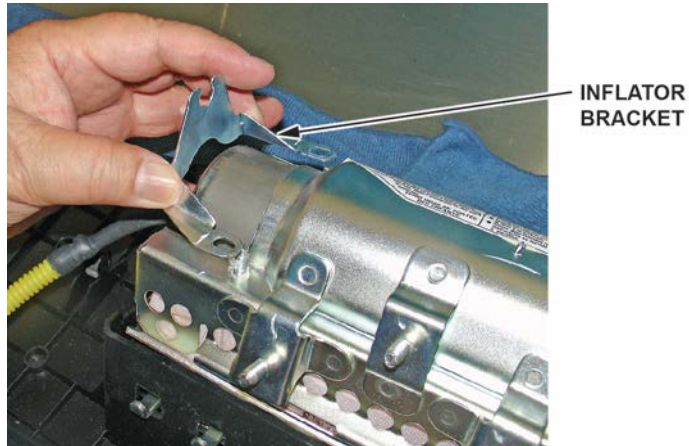
5. Remove the inflator bracket.

NOTE: You can only remove one of the brackets, as the other is welded to the airbag housing.

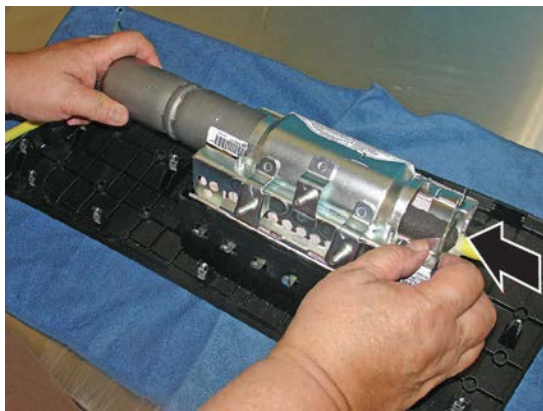
6. Remove the inflator by pushing it out.

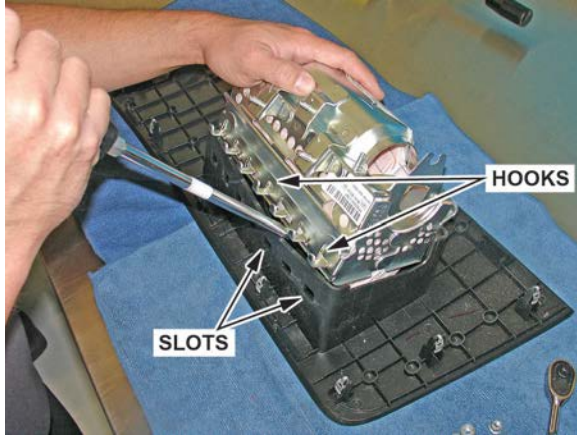
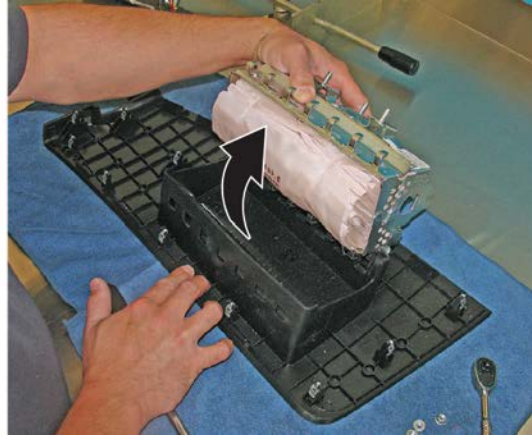
- Using an applicable tool, gently pry open the original airbag cover as shown so that the hooks can be removed from the slots, then separate the original airbag from the original airbag cover.
