03188 Version 3

Safety Recall: Piston Pin Snap Ring Inspection

AFFECTED VEHICLES

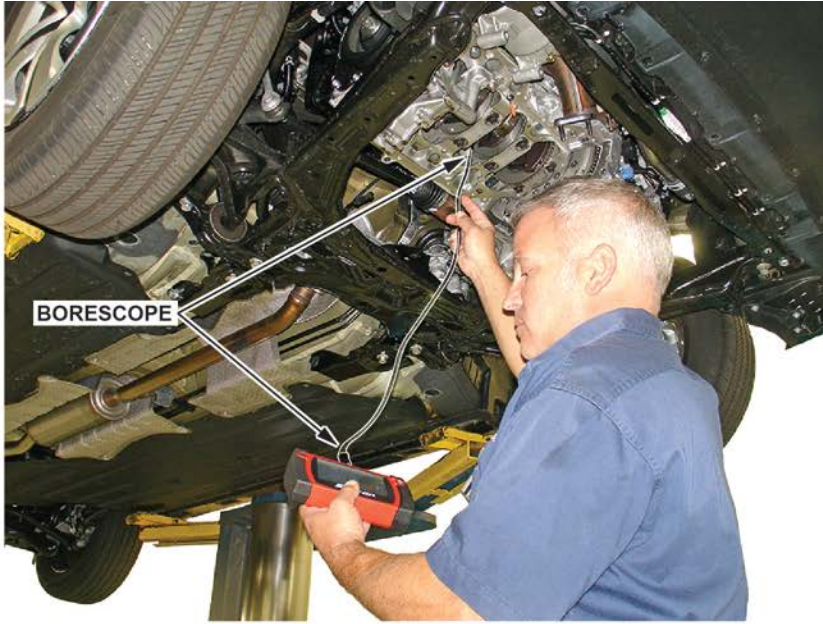
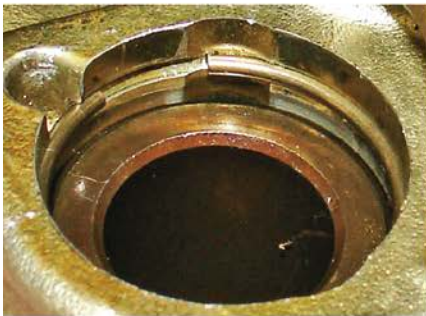
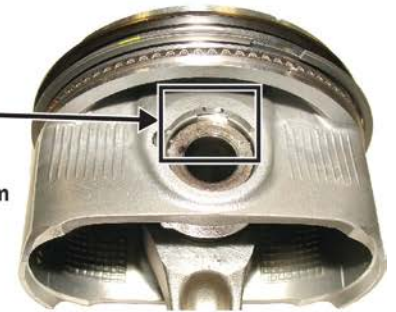
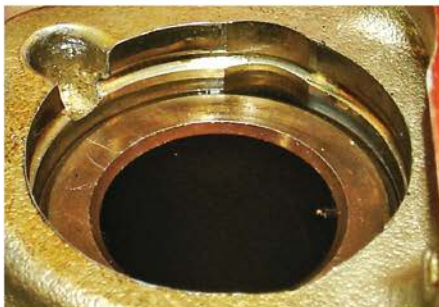
16. Using the Snap-on BK5600 with the 90-degree tip installed, rotate the engine so the No.1 cylinder is at TDC. Carefully insert the tip of the borescope and inspect cylinders No.1 and No.4. Then, rotate the engine so the No.2 cylinder is at TDC and repeat the process with cylinders No.2 and No.3.

17. Rotate the probe to confirm that the snap ring is fully engaged in the piston pin groove. A properly seated snap ring will have a 6 mm gap at the ends of the snap ring, as shown above. A misset snap ring will have a much smaller gap, around 2 mm.
18. Take a photo of each snap ring. Focus on getting a clear picture of each snap ring gap. You will need to take a picture of each side of all four pistons for a total of eight pictures.

19. Repeat for the remaining three pistons.
 - If all snap rings are installed properly, no further action is necessary. Reassemble in the reverse order of disassembly.
 - If the snap ring is misset, take a clear picture of the misset snap ring and contact Tech Line to assist you with obtaining replacement piston assemblies.
 - If a snap ring is missing and the engine cylinder wall does not have any damage, take a clear picture of the piston pin with the missing snap ring and contact Tech Line. They will assist you with obtaining the replacement piston assemblies.
 - If the snap ring is missing and the engine has cylinder wall damage, order a replacement short block.

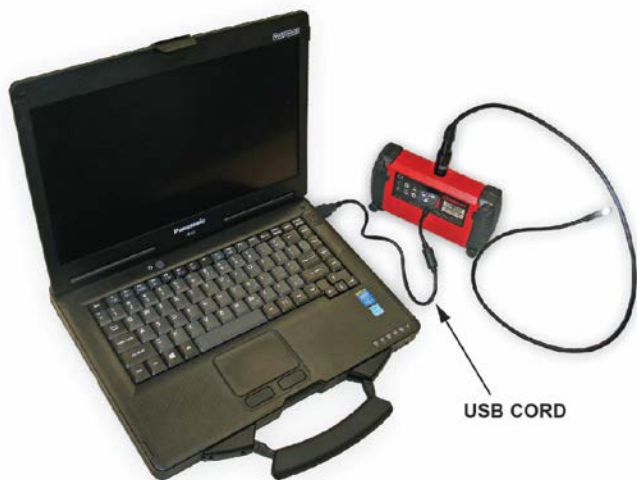
20. After all photos are taken, save them to your computer by connecting the borescope to it using the included USB cable. Give the photos to your warranty administrator for the warranty claim to be paid. Eight images of the snap rings must be included in the warranty claim or it may be rejected.
