February 26, 2016

03188 Version 5

Safety Recall: Piston Pin Snap Ring InspectionSupersedes 16-017, dated February 24, 2016, to revise the information highlighted in **yellow**.**AFFECTED VEHICLES**

Year	Model	Trim	VIN Range
2016	Civic with 2.0L engine	ALL	Check the iN VIN status for eligibility

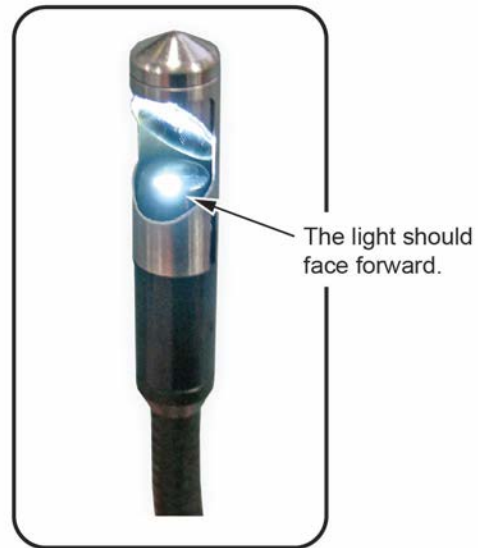
2. Install the 90-degree mirror accessory by aligning the alignment dot with the slot.

NOTE: Make sure the mirror tip is very clean before inspecting. A dirty mirror can give distorted images.

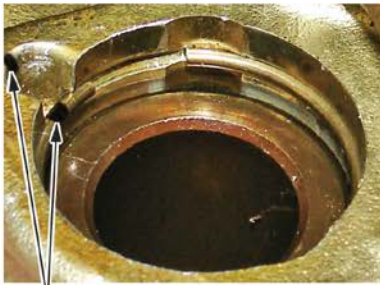
NOTE: You may notice a black mark on the snap ring and piston. This is a factory check mark and could be mistaken for the snap ring gap.

FACTORY BLACK MARKS

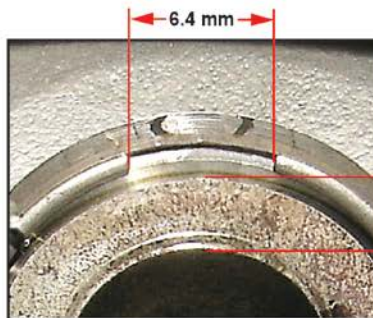
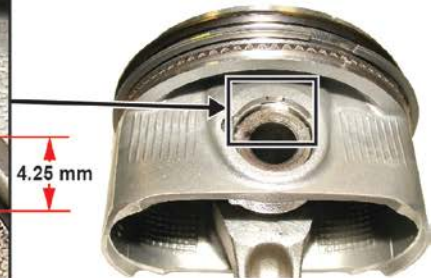
**SNAP RING MISSING - NO GOOD**

17. Rotate the probe to confirm that the snap ring is fully engaged in the piston pin groove. A properly seated snap ring will have a 6 mm gap at the ends of the snap ring, as shown above. A misset snap ring will have a much smaller gap, around 2 mm.
18. Take a photo of each snap ring. Focus on getting a clear picture of each snap ring gap. You will need to take a picture of each side of all four pistons for a total of eight pictures.

- If the snap ring is misset, take a clear picture of the misset snap ring and contact Tech Line to assist you with obtaining replacement piston assemblies.
- If a snap ring is missing and the engine cylinder wall does not have any damage, take a clear picture of the piston pin with the missing snap ring and contact Tech Line. They will assist you with obtaining the replacement piston assemblies.
- If the snap ring is missing and the engine has cylinder wall damage, order a replacement short block.

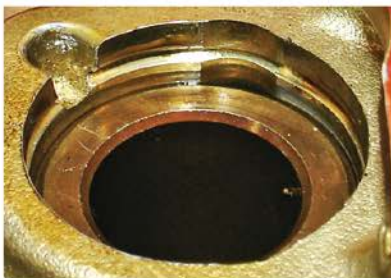
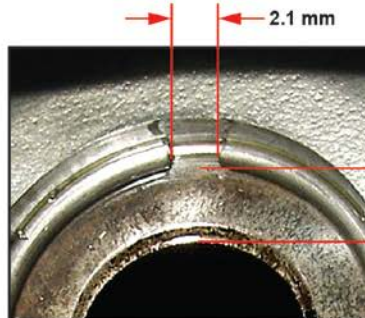
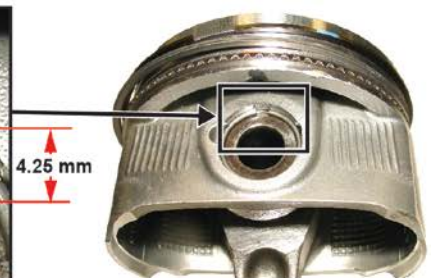
**SNAP RING OUT OF PLACE - NO GOOD**

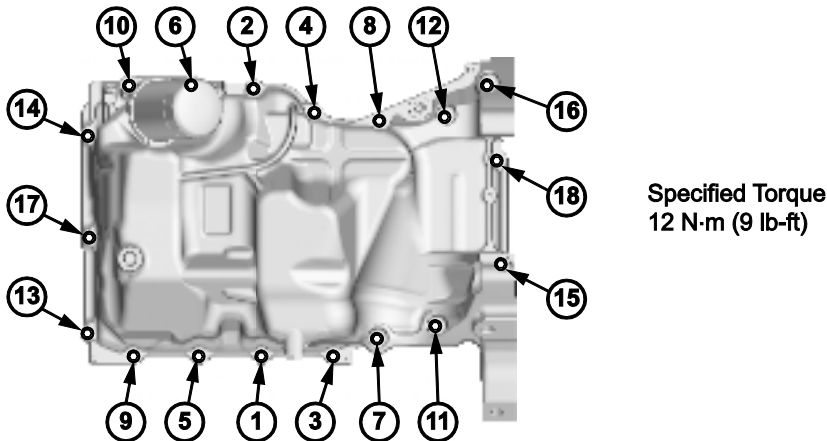
NOTE: When installing the oil pan, apply a 2.5 mm bead of Honda Bond HT to the mounting surface. Install the oil pan within 5 minutes and torque the bolts in three steps in the sequence shown below. In this specific application no cure time is required.
