Service Bulletin

SAFETY RECALL

2014 NSS300/A REAR BRAKE LINE JOINT TORQUE

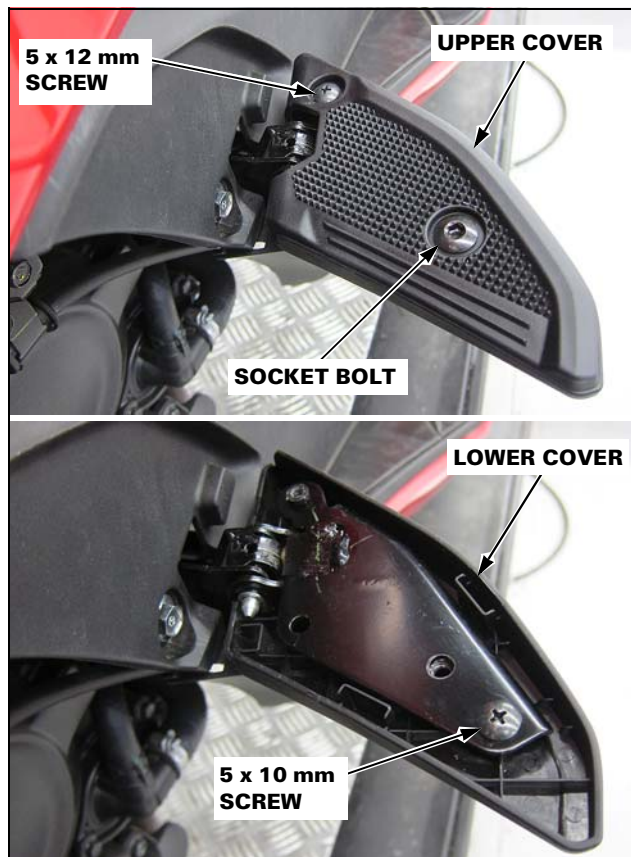
5. Remove the left and right passenger peg covers as shown.
Remove the socket bolt, 5 x 12 mm screw and upper cover.
Remove the 5 x 10 mm screw and lower cover.

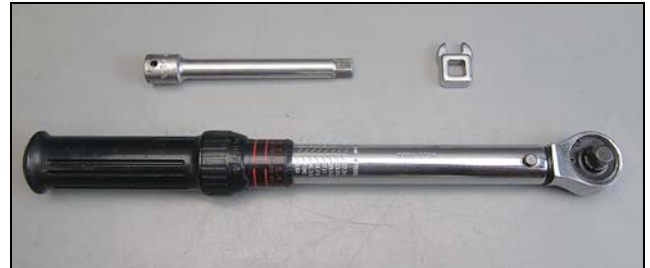
Prepare the required tools as shown:

- Torque wrench
- Extension
- Crow's foot (10 mm)

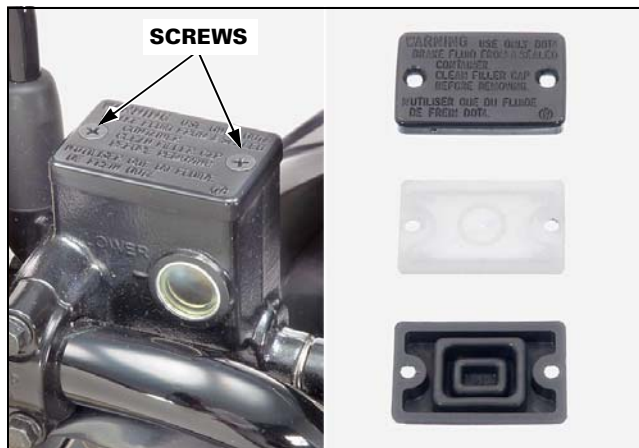
2. Support the scooter on its centerstand and turn the handlebar until the left handlebar reservoir is parallel to the ground, before removing the reservoir cap.

Remove the screws, reservoir cap, diaphragm plate, and diaphragm from the left master cylinder.

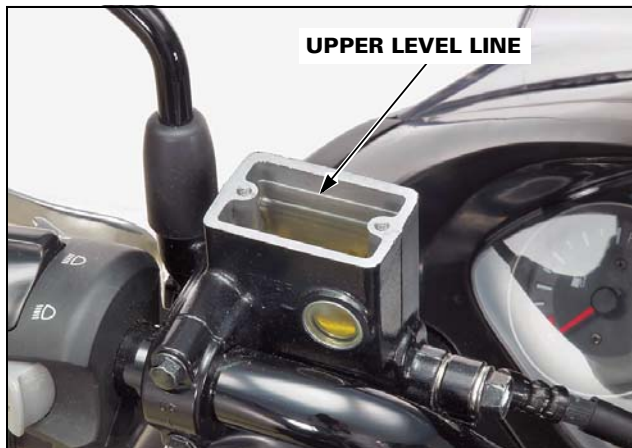
3. Fill the reservoir with DOT 4 brake fluid to the upper level mark from a sealed container.

Operate the left brake lever repeatedly until the lever feels firm.

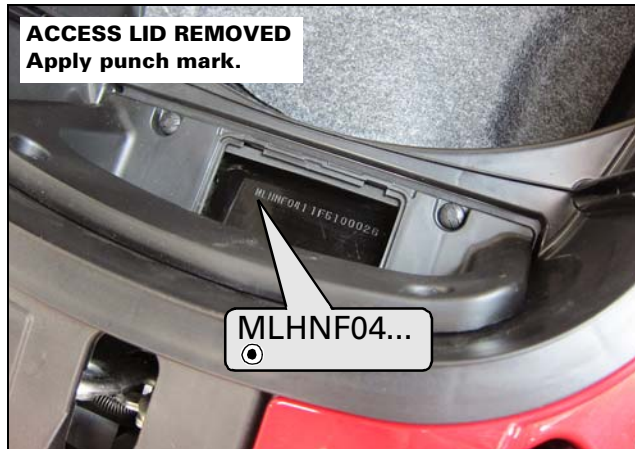
After you have completed the REPAIR PROCEDURE, apply a punch mark below the first character of the VIN located on the frame, under the Owner's Manual holder, inside the luggage box as shown.
