# Service Bulletin

Bulletin No.: 16-NA-220

**Subject:** White Cloudy Circles on Exterior of Vehicle

Brand:	Model:	Model Year:		VIN:		Engine:	Transmission:
		from	to	from	to		
Cadillac	CT6	2016	2017			All	All

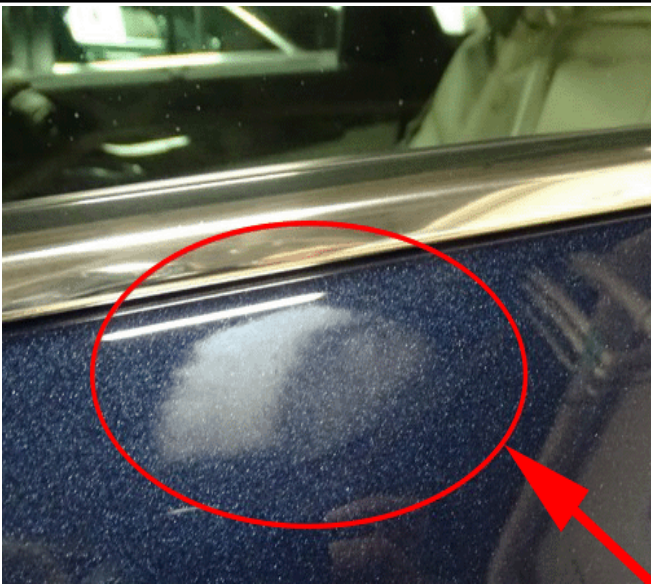
<p>4549030</p> <p>Some customers may comment on small white cloudy circles on various exterior painted body panels.</p>	
Cause	This may be due to in-plant repairs to remove dirt from the paint.

If you encounter a vehicle with the above concern, polish the areas using the following 3M products below or equivalent:

- Using a dual action orbital polisher with the following 3M products:
  - ⇒ Perfect-It 3000 Swirl Mark Remover P/N 06064
  - ⇒ Perfect-It Foam Polishing Pad P/N 05725/38
  - ⇒ Hookit DA 6-inch Backup Pad P/N 05776
- Using hand glazing/polishing with the following 3M products:
  - ⇒ Perfect-It Wax P/N 39026/39526
