# TECHNICAL BULLETIN

## LTB00773NAS2

## Hood Finisher-To-Hood Clash

#### **Range Rover (LG)**

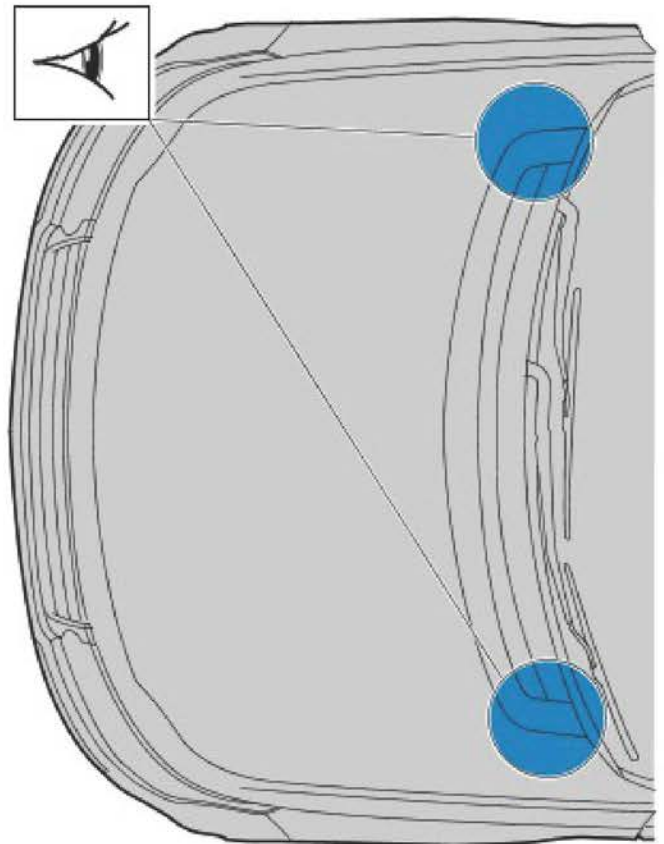
E178230

**Situation:** The hood paint may have been 'erased' away by the hood finisher.

**Cause:** This may be caused by a difference between the hood and hood finisher tolerances causing a clash condition.

1. Check the areas shown for damage.

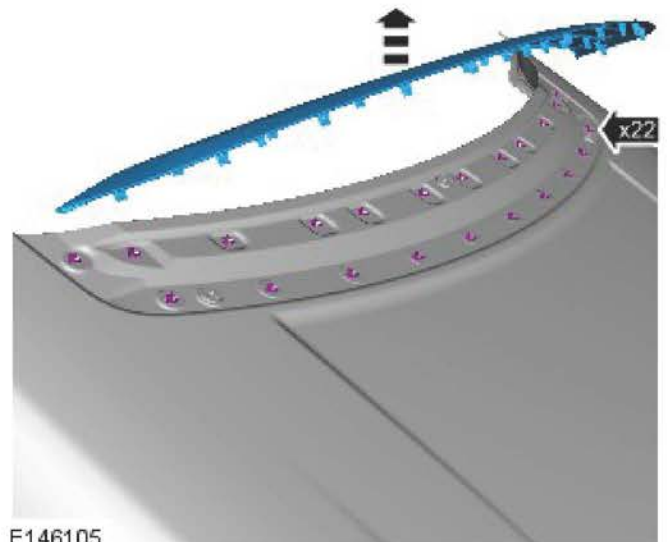
E146105

Use a suitable tool to remove the hood finisher.

**CAUTION:** Make sure no further damage is caused to the paintwork.

**CAUTION:** Make sure no damage is caused to the hood finisher when removing from the hood.

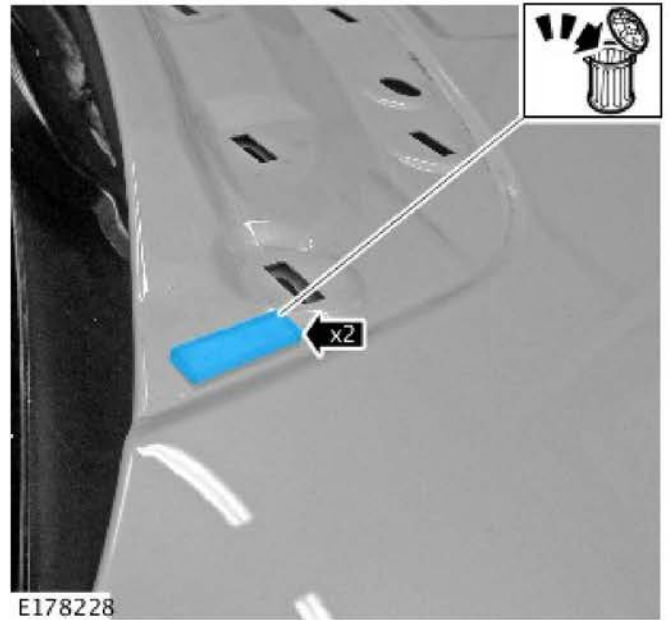
3. Use a suitable tool to remove the clear hood finisher spacers from both sides of the hood.

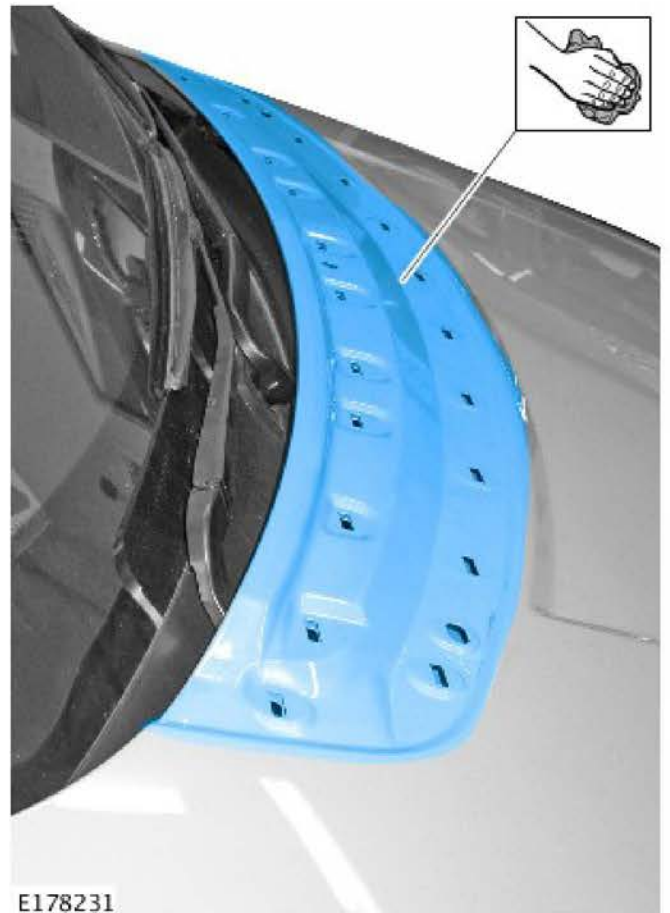
4. Use a suitable degreaser to clean the area shown.

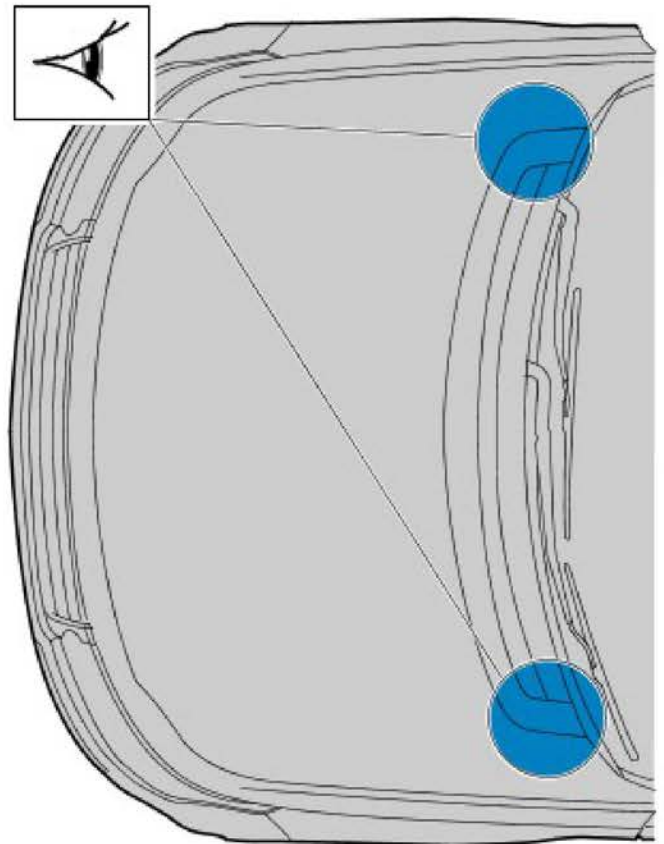
E178230

5. Repair and repaint the hood in the damaged areas shown if required.

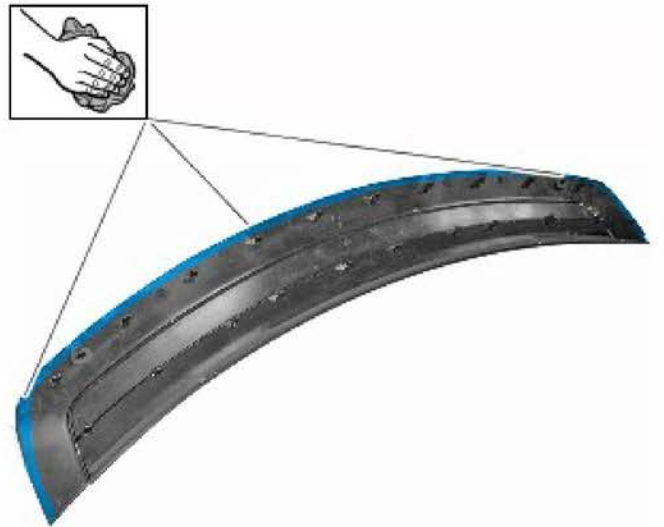
E178232

6. Use a suitable degreaser to clean the hood finisher in the area shown.

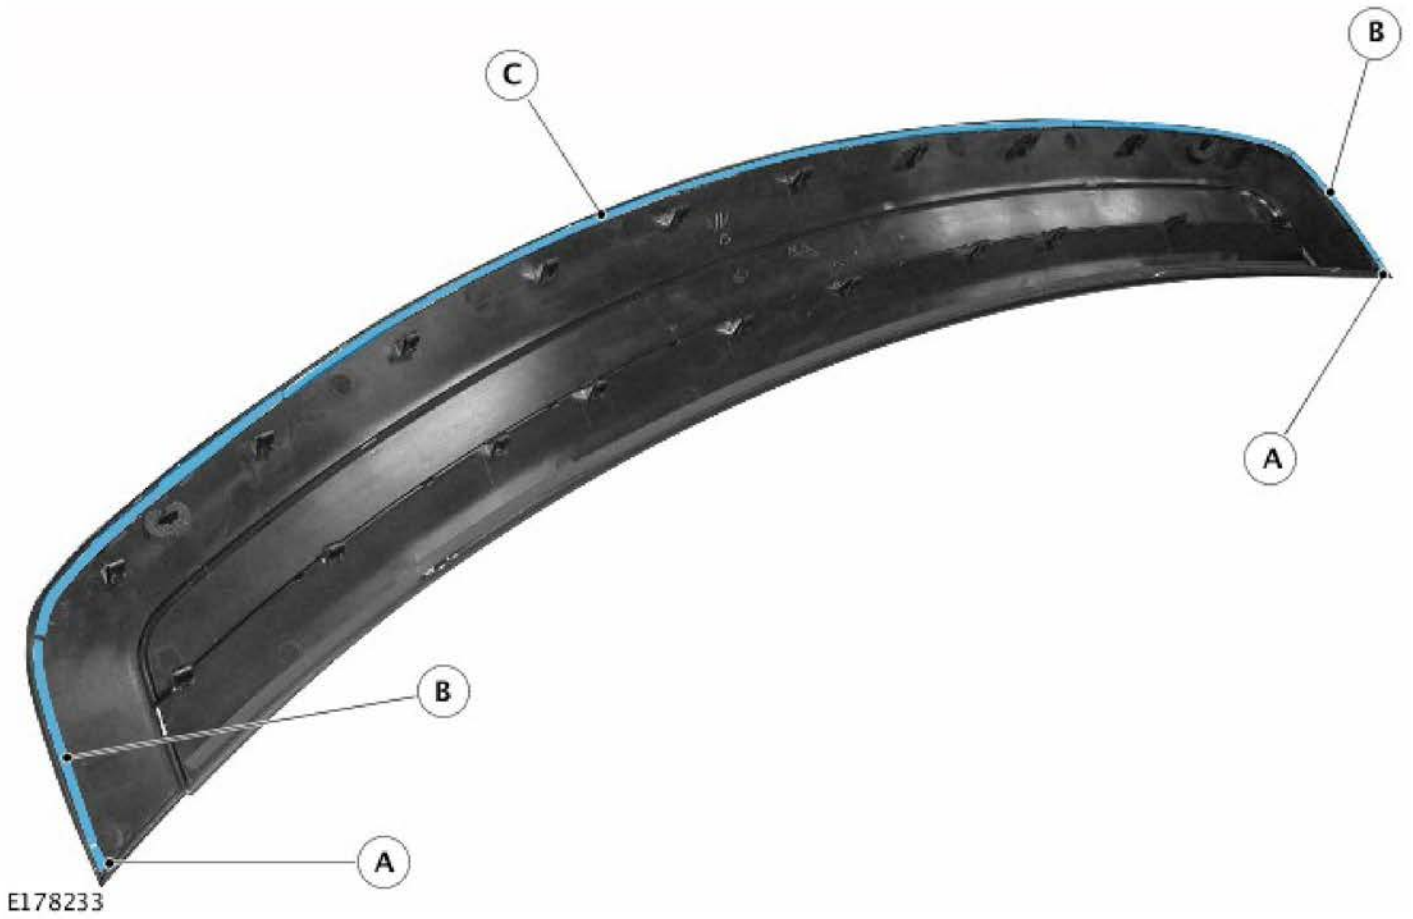
7. Install the moulding tape in the area shown.

- **A** 3mm thickness x 15mm length
- **B** 1.5mm thickness x 171mm length
- **C** 3mm thickness x 1434mm length

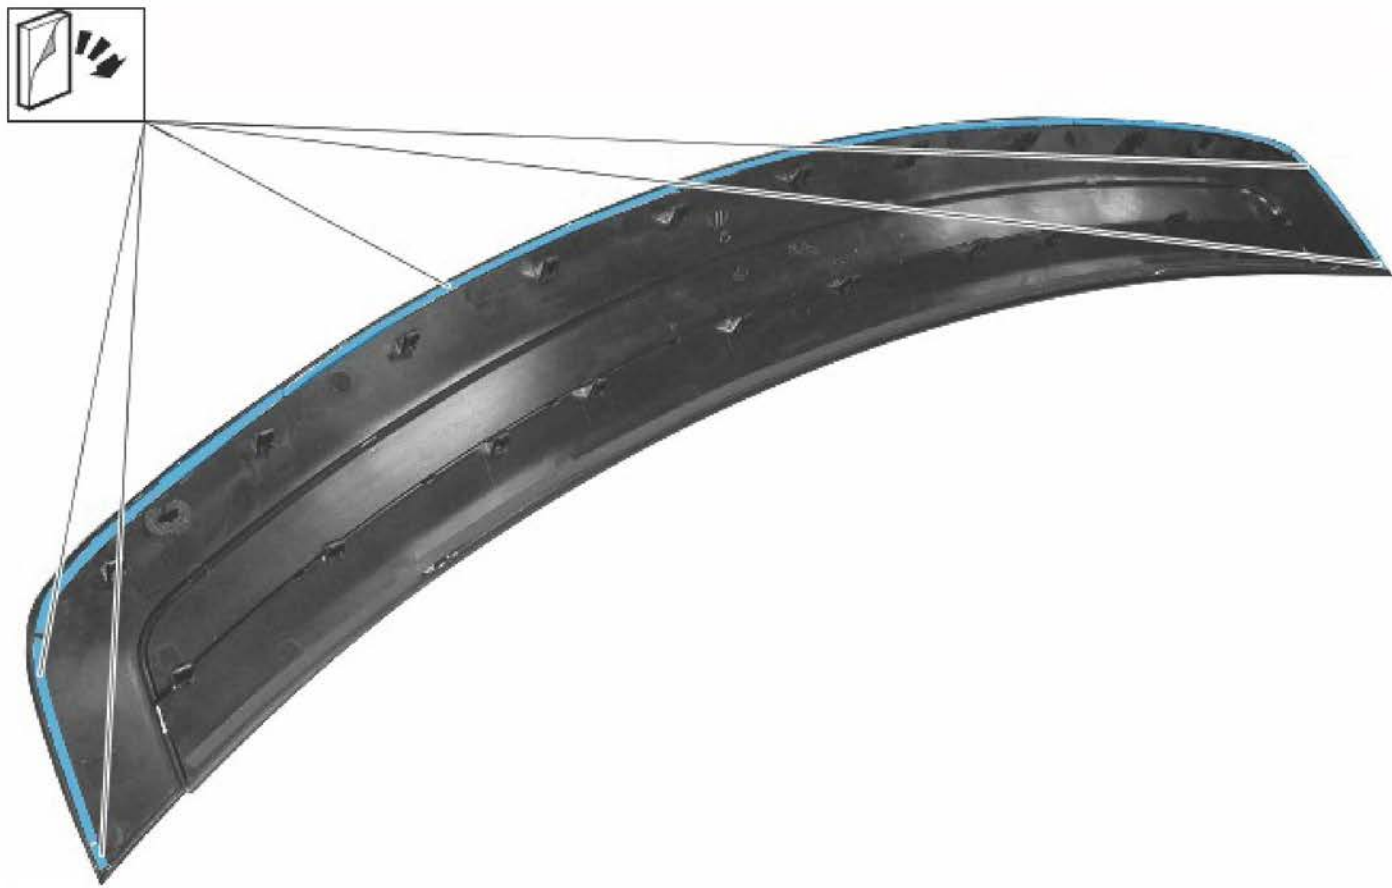
E178234

**8.** Remove the moulding tape backing in the area shown.

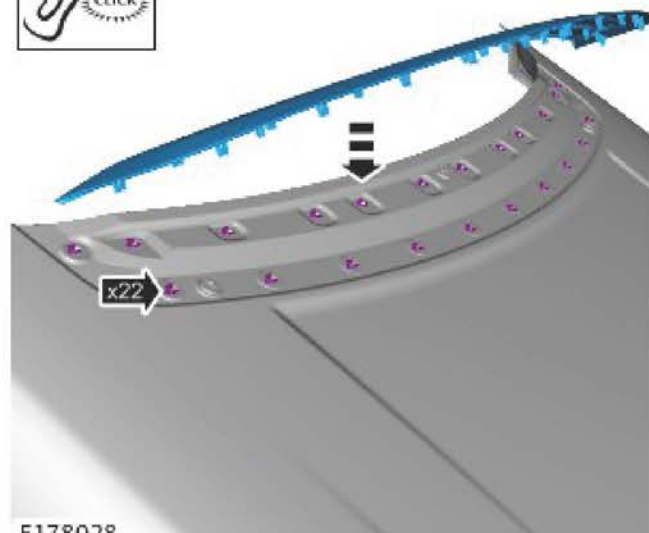
E178028

**NOTE:** Install the hood finisher clips from the middle outwards.

Install the new hood finisher.

**CAUTION:** Make sure no damage is caused to the paintwork.

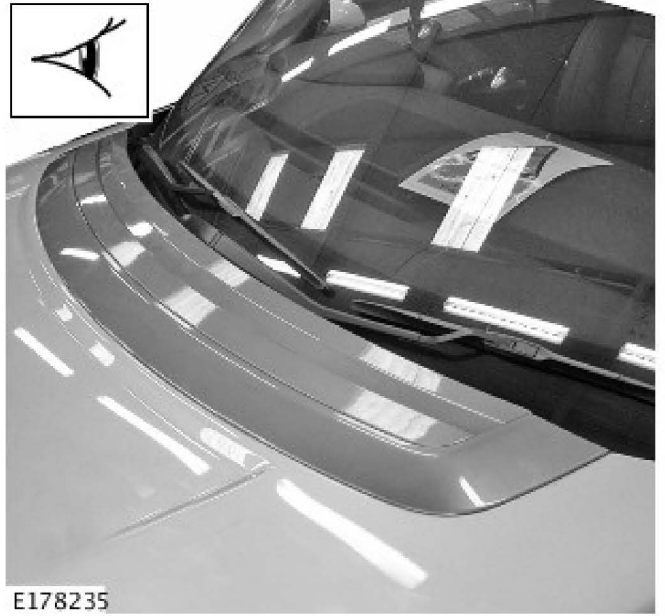
10. Verify the hood finisher is installed correctly.
