TECHNICAL BULLETIN LTB00890NAS1 28 JAN 2016

'Squeak' Noise From Tailgate Area While Driving

Discovery Sport (LC)

Model Year:
 2015-2016

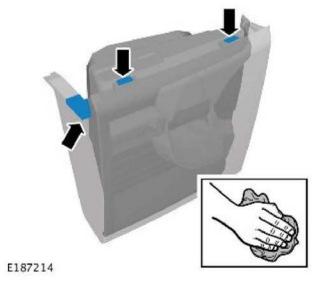
2 NOTE: repeat this step on both inner tail lamps.

Use a suitable cloth to clean the tail lamps in the areas shown.

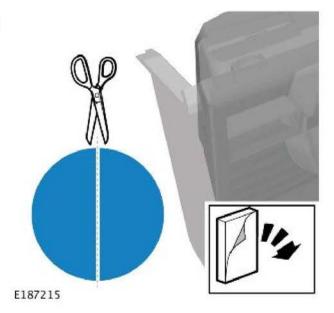
3 NOTE: repeat this step on both inner tail lamps.

Use a suitable tool to cut the supplied tape circle in half and remove the backing from the tape circle.

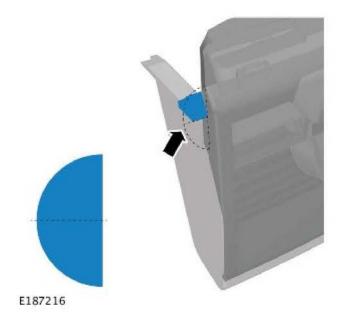
4 NOTE: repeat this step on both inner tail lamps.

Install the half-tape circle in the area shown.

The half-tape circle will fold 90° and secure under the inner tail lamp.

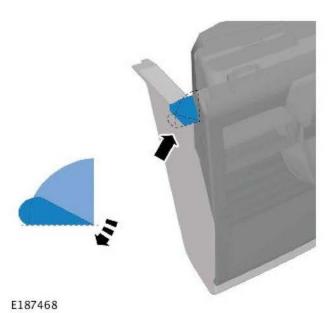
5The half-tape circle located and installed on the inner tail lamp.

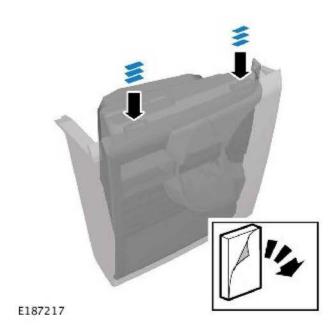
NOTE: make sure the gel pads are not visible when the tail lamps are installed.

NOTE: repeat this step on both inner tail lamps.

Cut each of the three protective gel pads in half.

- Assemble three halves as shown.Install the assembled protective gel pads on the inner tail lamps as shown.
