TECHNICAL BULLETIN LTB00989NAS1 31 MAY 2016

SECTION: 501-08

'Sport' Badge Red Paint Delamination

Range Rover Sport (LW)

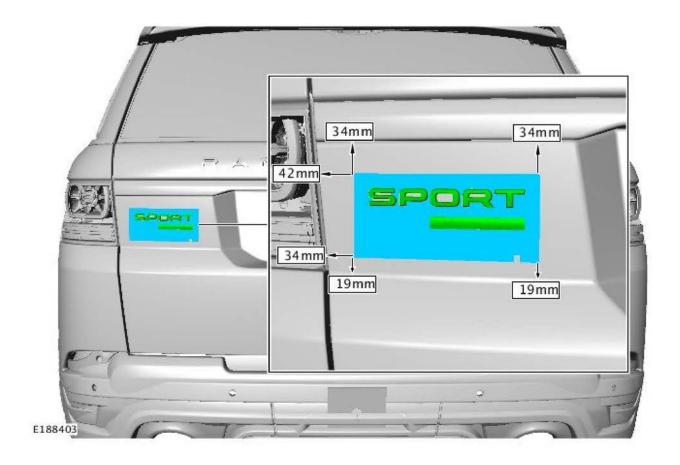
- 2. Clean the area prior to installation of the new tailgate badge.
- 3. NOTE: The new tailgate SPORT badge is supplied on a cassette (highlighted in blue).
- NOTE: All dimensions shown are to the edge of the new badge cassette.

Using the dimensions shown, install the new tailgate SPORT badge.
