| Reference | SSM72887 |
| Models | Range Rover / L405 Range Rover Sport / L494 |
| Title | Range Rover (L405) & Range Rover Sport (L494) Hi-Line Rear Centre Armrest Cupholder |

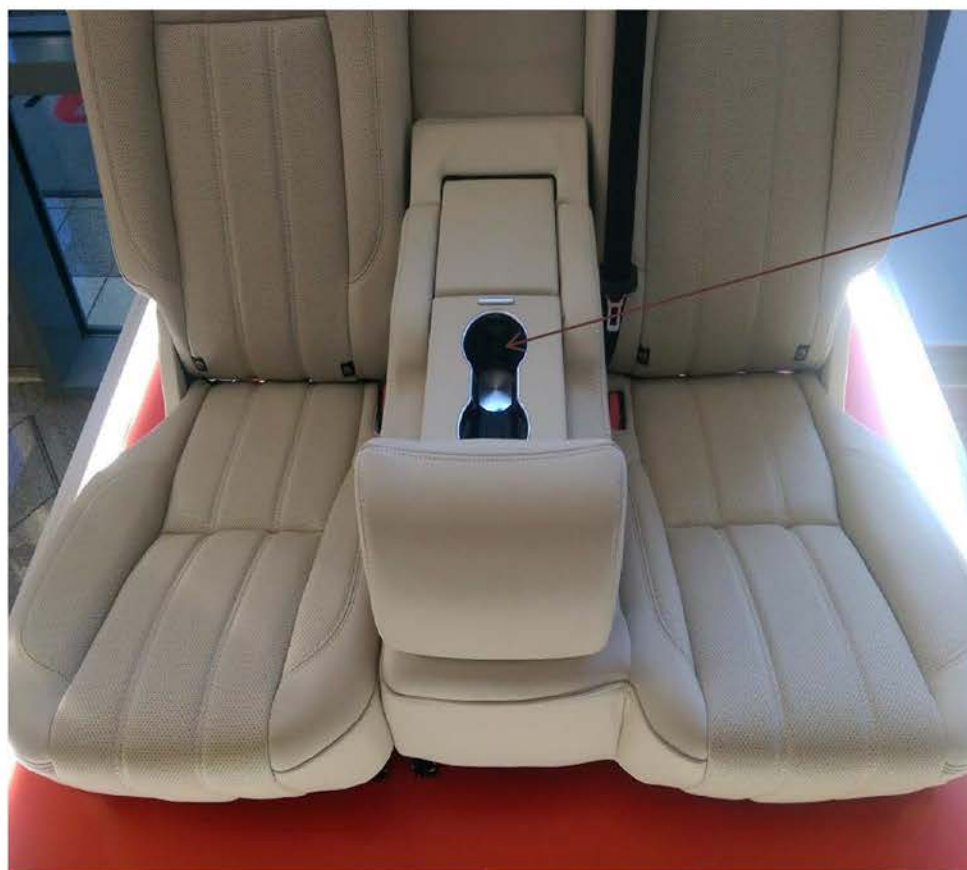
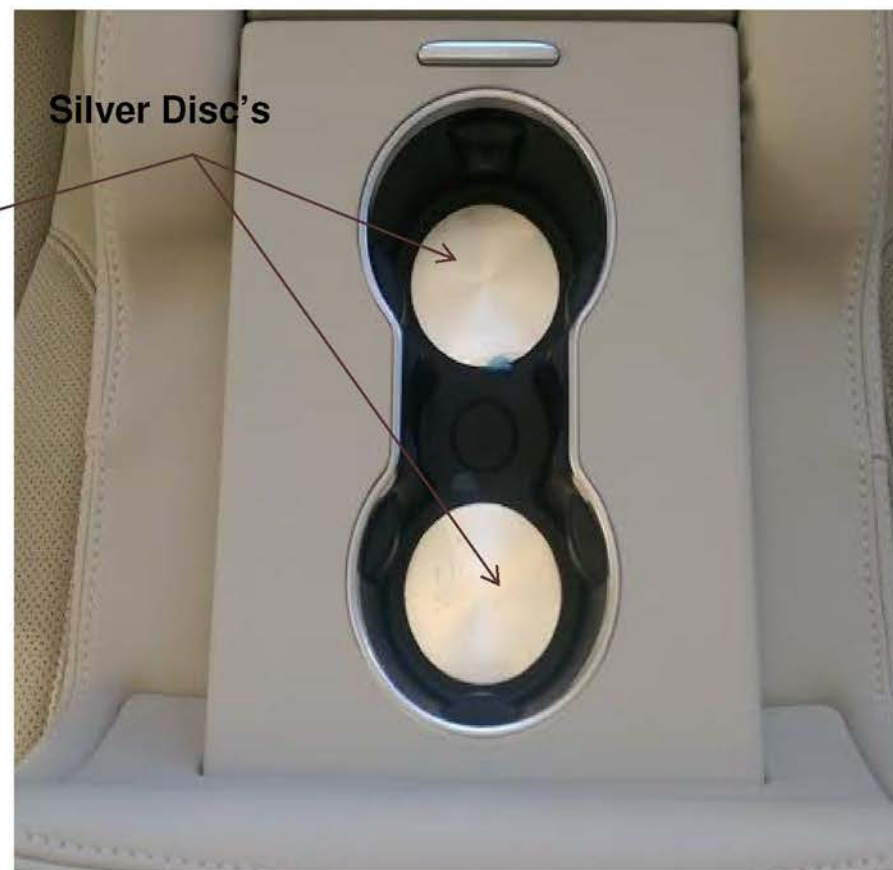
Range Rover (L405) & Range Rover Sport (L494) Hi-Line Rear Centre Arm rest Cup holder Disc's

Range Rover or Range Rover Sport Customers with 2nd Row Hi-Line Armrests fitted, may report that the Silver Disc's which are fitted into the base of the cupholders have become detached. The attached file details the part

Over a period of time in Service the adhesion has deteriorated

In the few cases reported, Retailers are having to replace the whole Armrest for this concern, when the disc's can simply be stuck down again by applying a small spot of Superglue - (STC50546) or equivalent to the underside of the disc.
