**FRONT WIPER SYSTEM WORKSHEET:  
2007 & 2011 Outlander, 2011 & 2013-15 Outlander Sport**

3) If the vehicle is 2011 - 2015 Outlander Sport, look up the VIN on the Warranty Superscreen to verify whether this vehicle is involved in SR-16-010, Windshield Wiper Motor – Safety Recall Campaign.

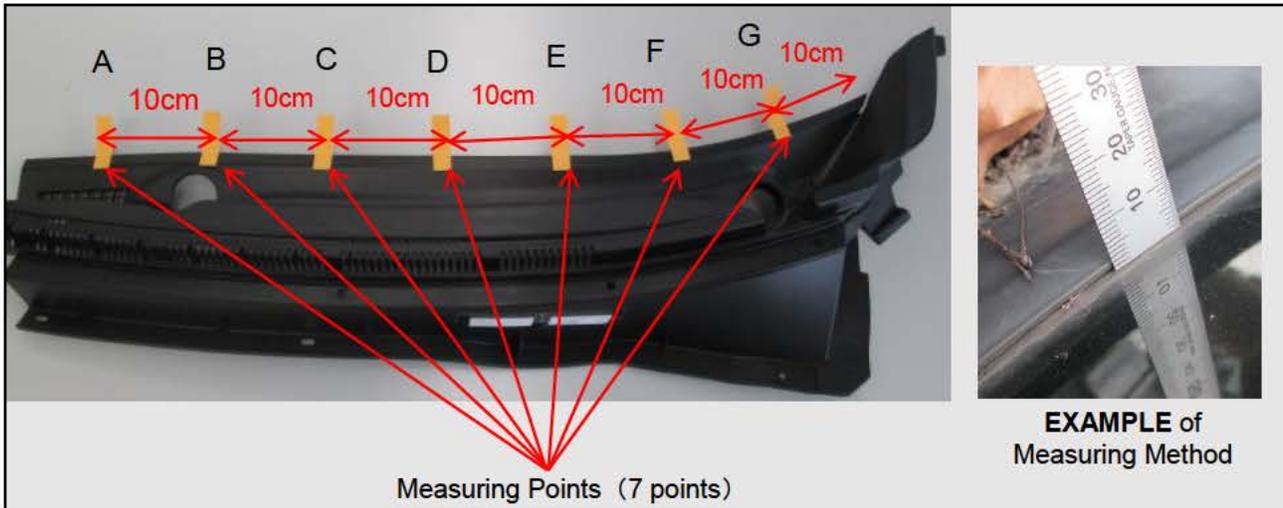
c) Measure gap between Deck Garnish and Glass at 10 cm intervals, starting at "G," as shown below.

Check the appropriate boxes below based on your measurements.

Measuring point	A	B	C	D	E	F	G
0 mm ~ 0.5 mm	<input type="checkbox"/>						
0.5 mm ~ 1.5 mm	<input type="checkbox"/>						
1.5 mm or more	<input type="checkbox"/>

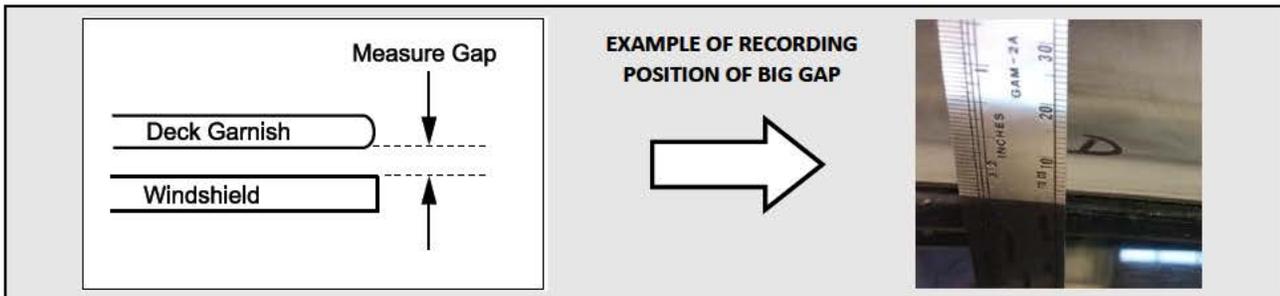
d) If there is a big gap (1.5 mm or more), take a picture and record the position of each one by writing with permanent marker on the Deck Garnish.

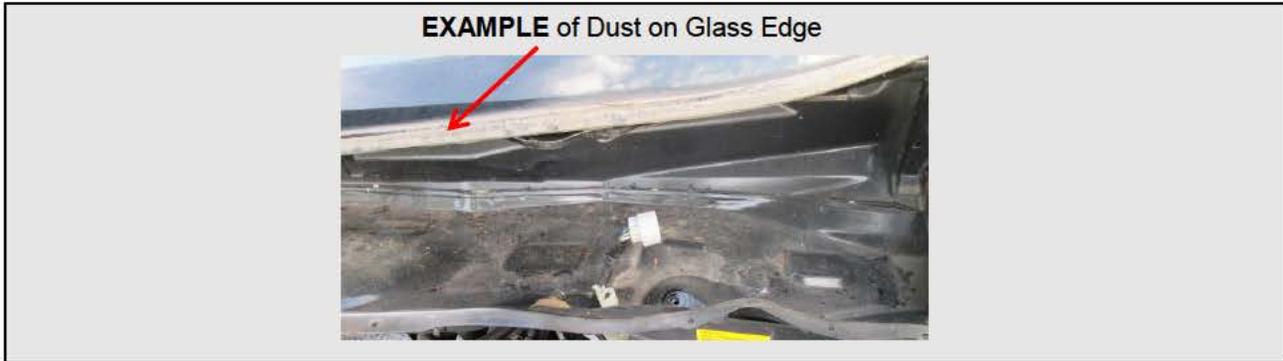
If there is dust or debris on the edge of the glass, clean before assembly of Deck Garnish.

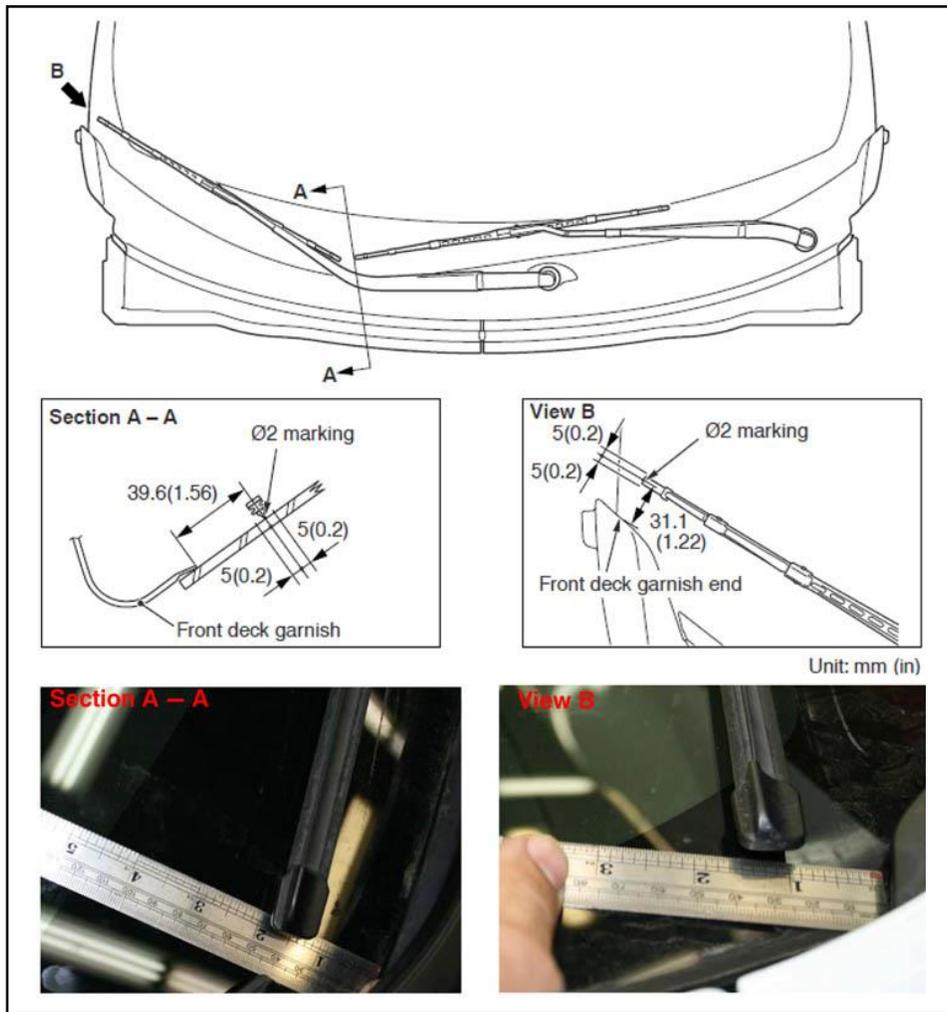
13) Reinstall wiper arm and blade assembly as shown.

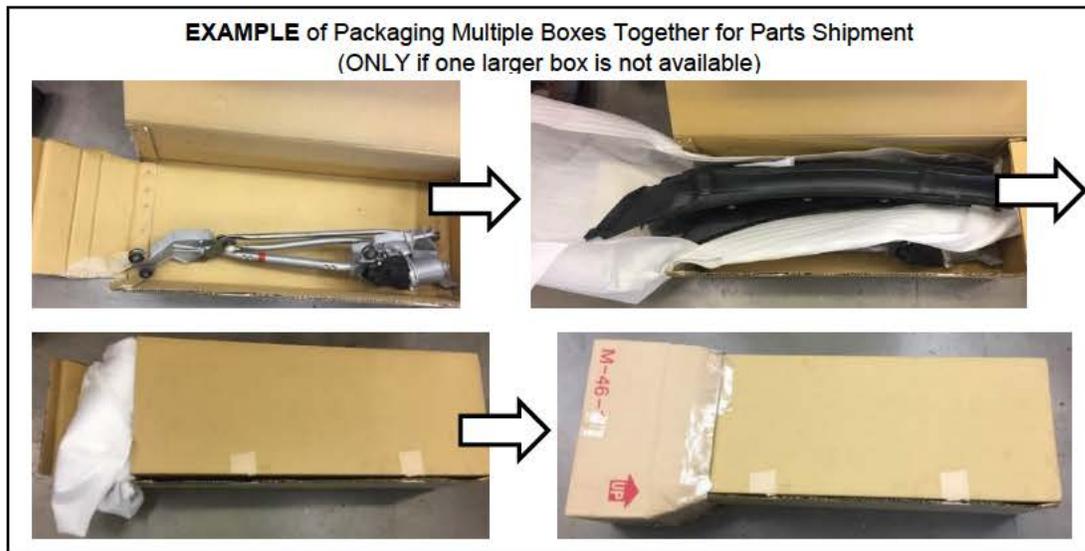
**NOTE:** If a larger box is not available, 2 boxes securely taped together is acceptable. Use adequate protective packing material (see below for example of this method).
