Loose Trunk Mat Trim Fasteners

2017 NSX

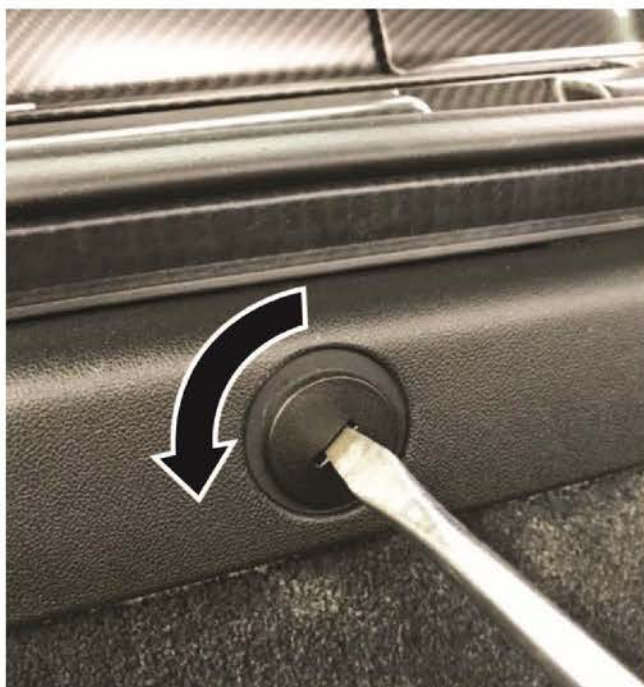
The right way to remove these fasteners is to insert a flat-tip screwdriver into their slotted heads and turn the fasteners **counterclockwise**, just like you would for slotted screws. Also, be careful with the screwdriver so you don't scratch the fasteners.

Installing these fasteners is really easy; just press them into the threaded studs.

If you follow this method for fastener removal, you'll avoid fastener damage and will be able to reuse them. Of course, if you find any loose fasteners, be sure to replace them.
