ACURA ServiceNews Article

B17040B Version 1

SH-AWD[®] Rear Differential Leaks

2014-17 MDX and 2015-17 TLX with SH-AWD

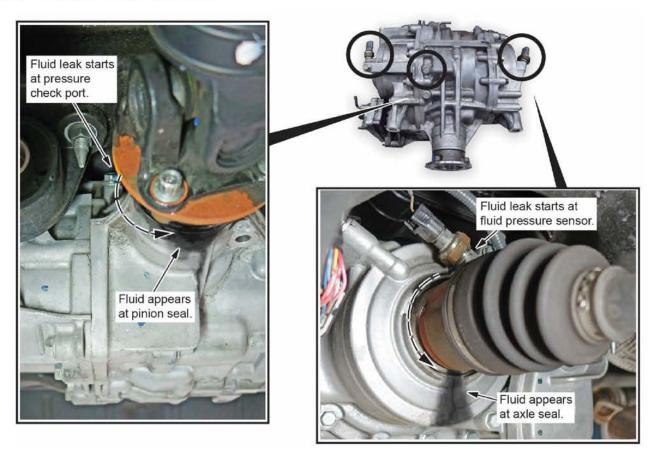
Are you looking at what seems to be a rear differential axle seal or pinion seal leak? Something to keep in mind: The actual culprit may be something loose or damaged above it.

A loose or damaged fluid pressure sensor will drip rear differential fluid onto the axle seal. A loose fluid pressure check port will drip that fluid onto the pinion seal.

Before considering rear differential replacement, be sure to check those items carefully. The repair could be as easy as tightening/replacing the fluid pressure sensor or tightening the fluid pressure check port.
