# Ferrari North America

## Technical Information

| Bulletin #: | 2408 |

**Model Type:** All  
**Model Year:** All  
**Subject:** Replacing Windshield

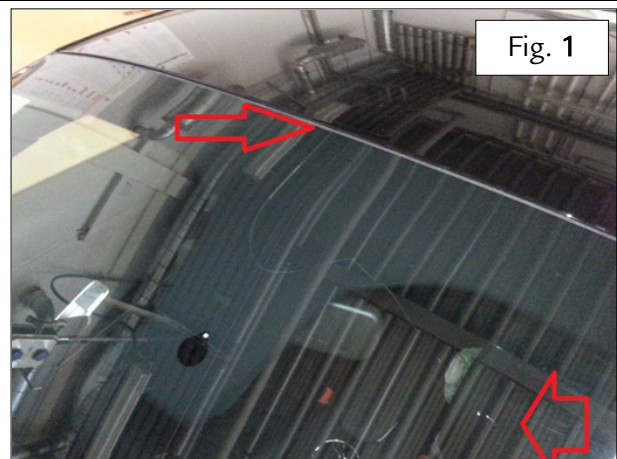
- Take high definition photographs of the crack line in the windshield from outside the vehicle and from inside the vehicle (Fig. 1).

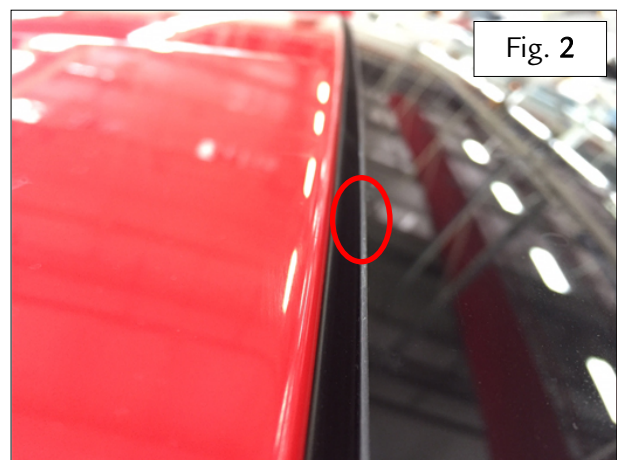
- Determine if the crack line originates from the edge of the windshield (Fig. 2).
- Take a high definition photograph of the edge of the windshield in the vicinity of the crack line (Fig. 2).

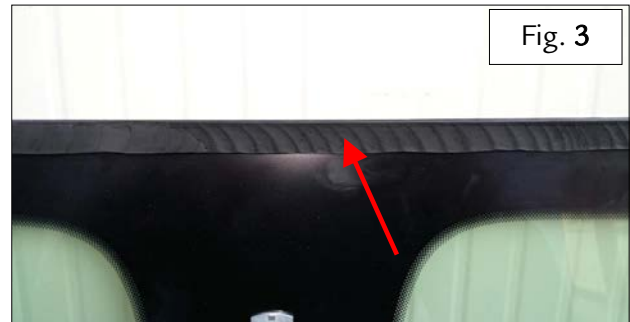
- Check whether the cut bead of sealant material is adhered correctly around the entire perimeter (Fig. 3) on both the bodyshell side and the windshield side.

- Take high definition photographs of the cut bead of sealant material on both the bodyshell side and the windshield side (Fig. 3) (take several photos of the beads from different angles, and take detailed close-ups)

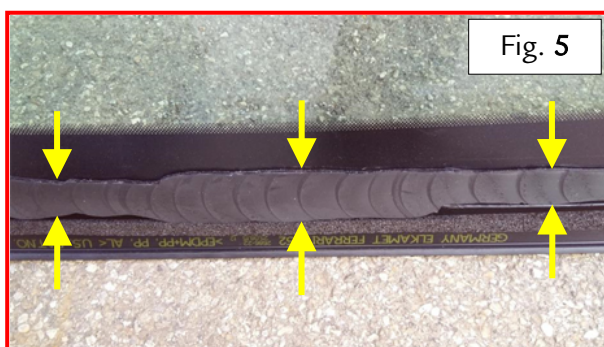
- Check that at the center of the bottom edge of the windshield (Fig. 4), the cut bead of sealant material is evidently thicker, demonstrating that it was overlapped correctly during application to close the perimeter (Fig. 5).

- Take a high definition photograph of the overlapped bead at the center of the bottom edge of the windshield (Fig. 5).

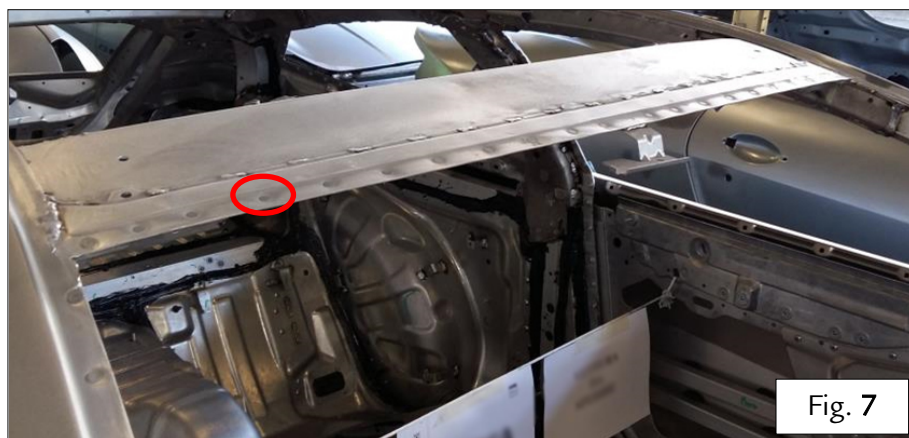
- Check that the rivets near the crack line in the windshield are installed correctly and do not protrude from their seats (Fig. 7-8-9);
- Take high definition photographs of the rivets in the area around the crack line.
