FORD:

2013-2016 C-MAX, Fusion

LINCOLN:

2013-2016 MKZ

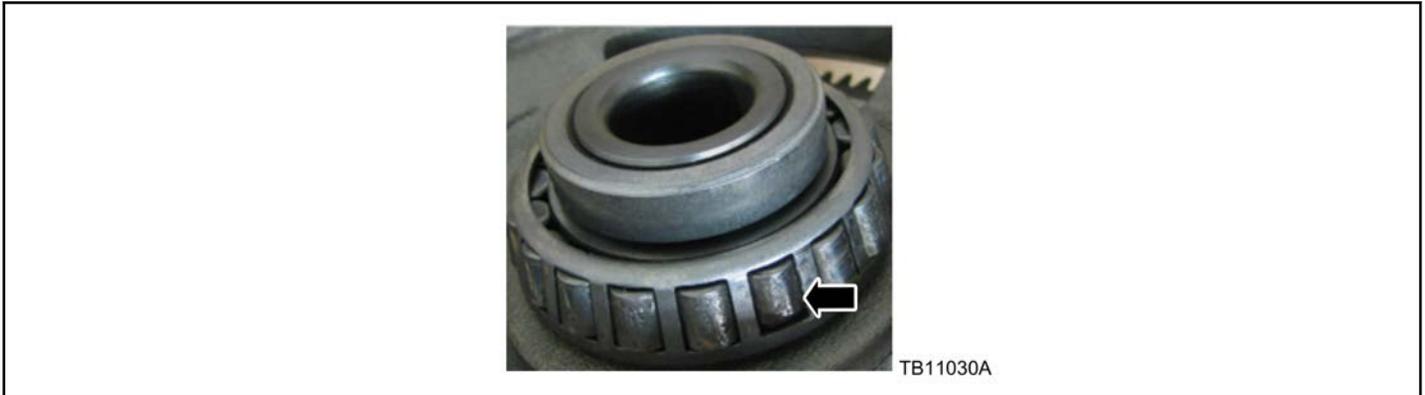
Figure 1 - Article 17-0039

- b. No - proceed to Step 7.
7. Inspect differential and transfer shaft bearings. Is there any noticeable roller bearing damage? (Figure 1)

- a. Yes - proceed to Step 10.
 - b. No - proceed to Step 8.
8. Install transfer shaft kit. Follow kit repair and assembly procedure.
 9. Reinstall the transmission assembly. Refer to WSM, Section 307-01. Proceed to Step 11.
 10. Install a new transmission assembly. Refer to WSM, Section 307-01.
 11. Flush transmission fluid cooling system. Refer to WSM, Section 307-02.
