SERVICE BULLETIN

Classification:	Reference:	Date:
RS16-013	NTB17-006	January 25, 2017

2013 – 2016 ALTIMA AND 2015 – 2016 MURANO OCCUPANT CLASSIFICATION SYSTEM RETROFIT

APPLIED VEHICLES: 2013 – 2016 Altima (L33)
2015 – 2016 Murano (Z52)
2016 Murano Hybrid (Z52)

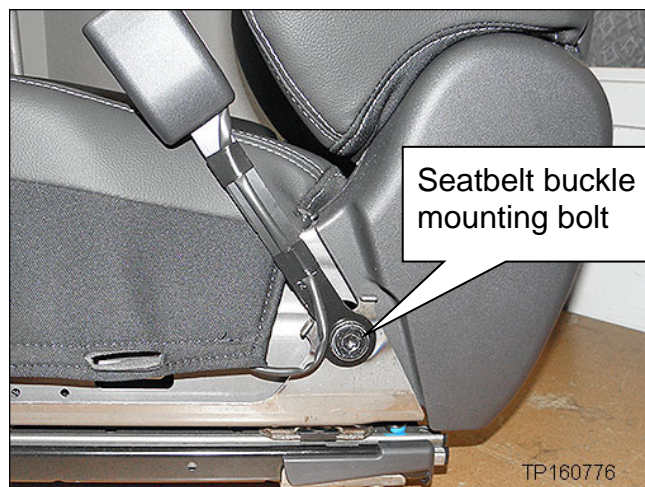
Figure 1

7. Remove the seatbelt buckle.

- Buckle is held on with one bolt.

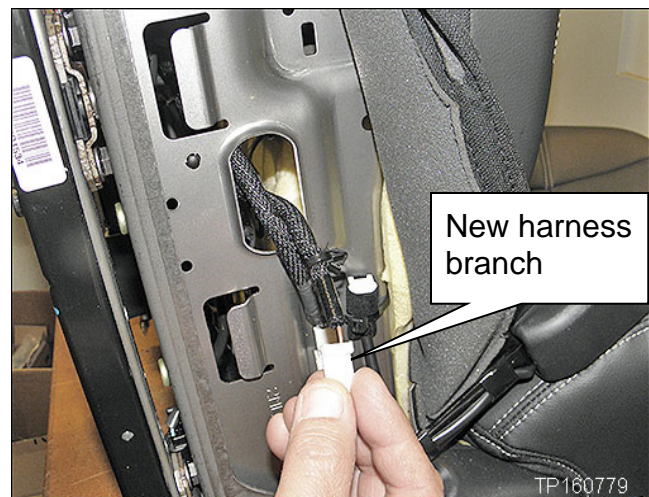
Figure 11

13. Route the new branch/connector of the OCS harness through the seat frame as shown.

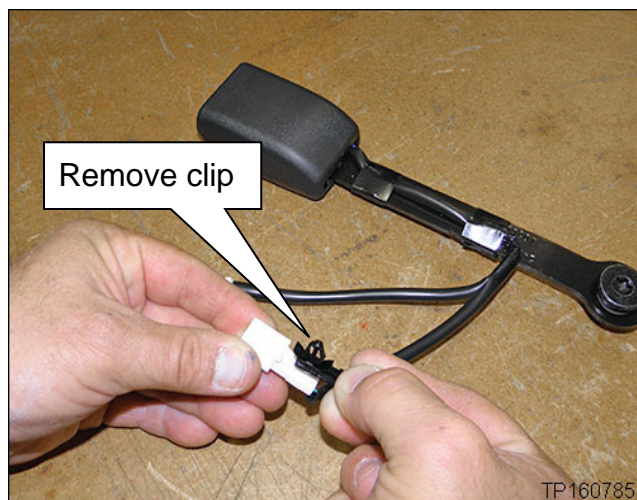
Figure 12

14. Remove the harness mounting clip from the new seatbelt buckle connector.

- This clip will not be used.

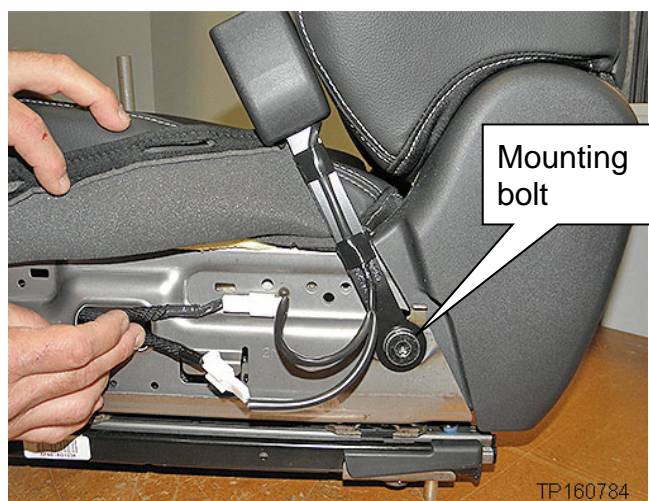
Figure 13

15. Install the new seatbelt buckle.

- Torque the mounting bolt to:
49 N·m (5.0 kg-m, 36 ft-lb)
- Connect the 2 electrical connectors.

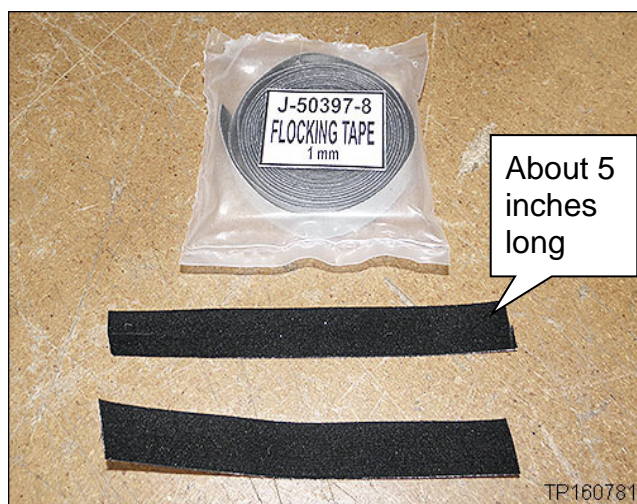
Figure 14

16. Cut 2 strips of flocking tape (J-50397-8); each strip about 5 inches long.

- Flocking tape is part of the squeak and rattle kit – J-50397.
