SERVICE BULLETIN

AT15-005g

March 31, 2017

PATHFINDER, QUEST, MURANO, MAXIMA, ALTIMA V6; CVT JUDDER AND DTC P17F0 OR P17F1 STORED

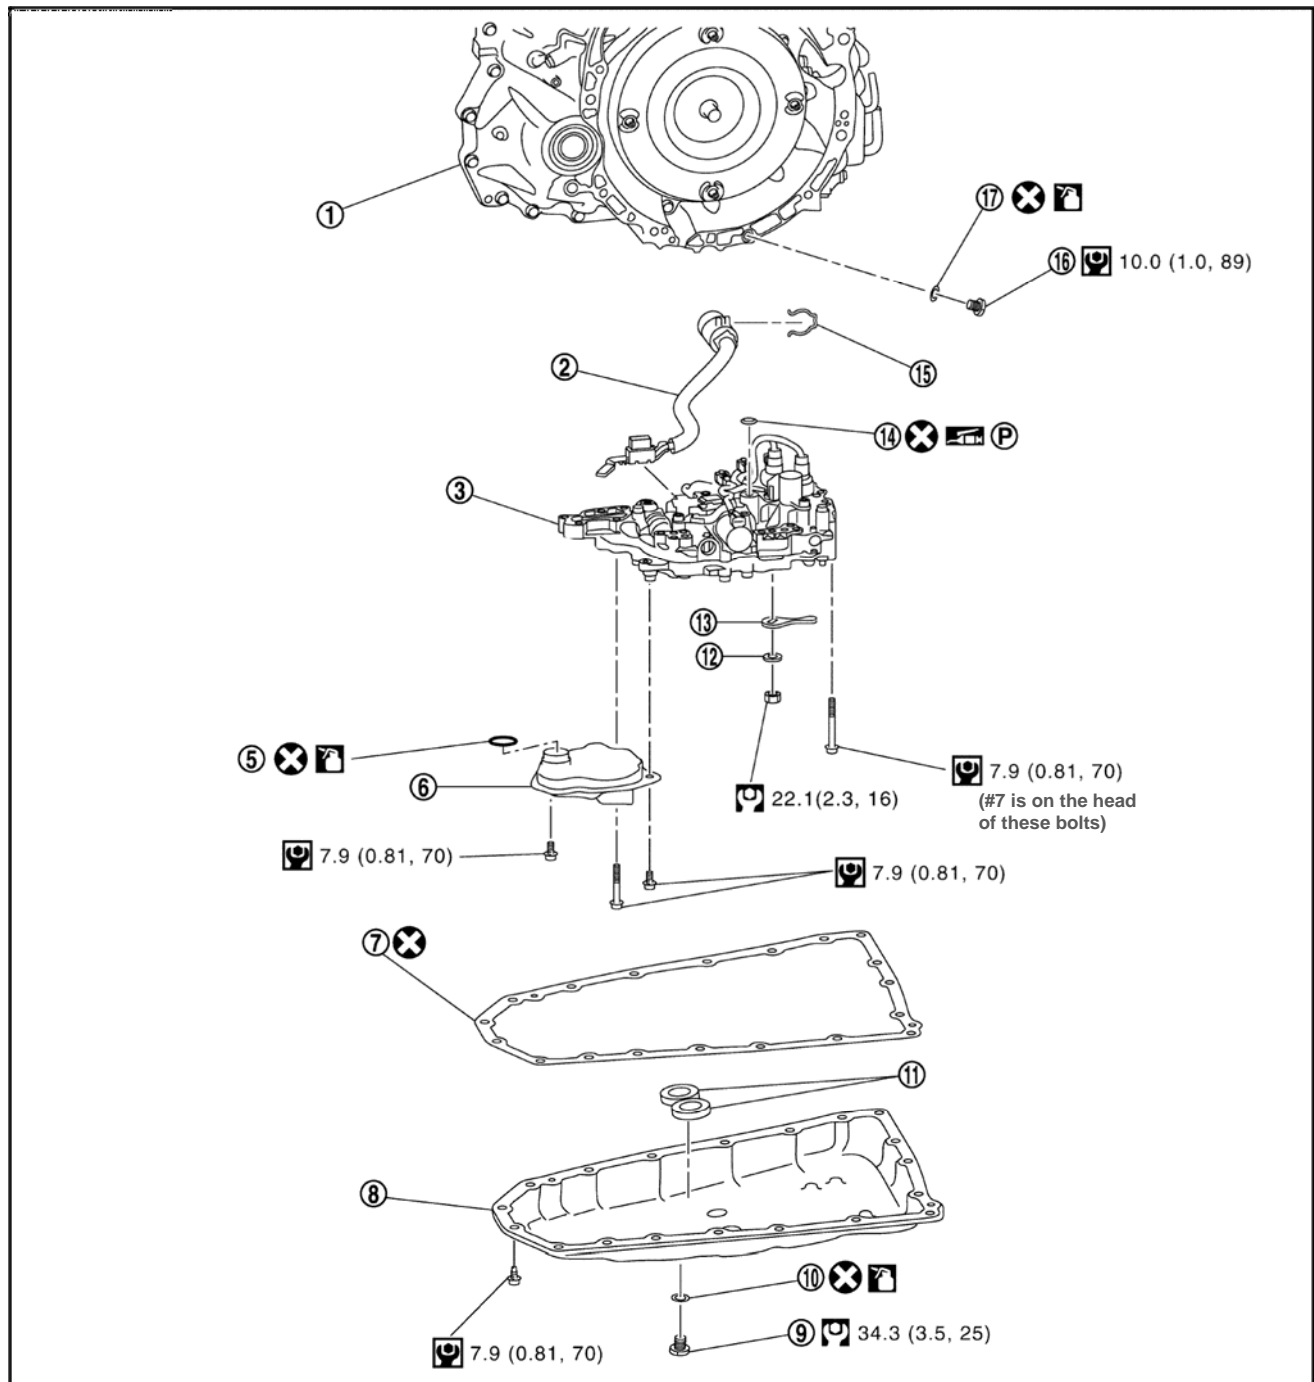
Figure 4

Example: Exploded View of Control Valve (valve body)

| ① Transaxle (CVT) assembly | ② Terminal cord assembly | ③ Control valve (valve body) |
| ④ Oil pan gasket | ⑤ Oil pan | ⑥ Oil strainer assembly |
| ⑦ Drain plug gasket | ⑧ Two magnets | ⑨ Drain plug |
| ⑩ Manual plate | ⑪ Lip seal | ⑫ Spring washer |
| ⑬ Overflow plug | ⑭ O-ring | ⑮ Snap ring |

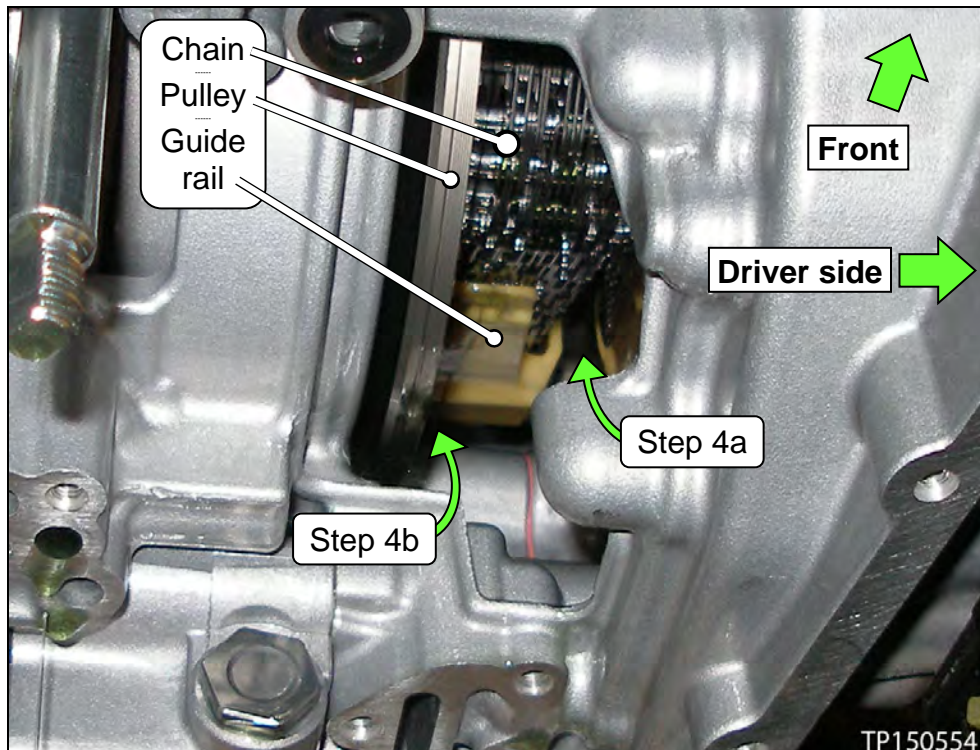
- Insert the camera lens behind the pulley between the guide rail and the pulley where shown in Figure 6 (also see page 9-10, Figure 7-10).
- Insert the lens approximately 8-9 inches, and then view the side of the chain that contacts the pulley.

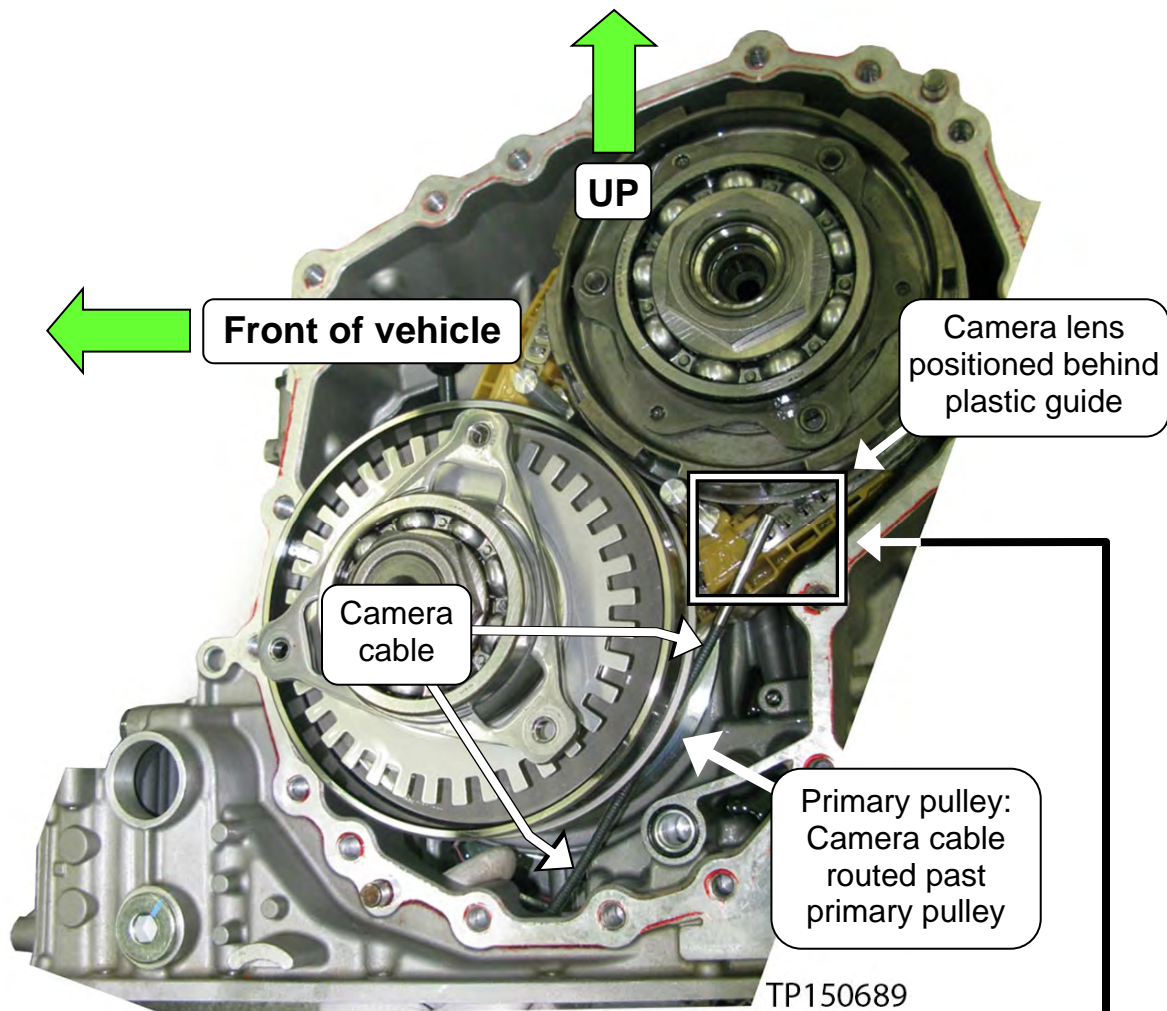
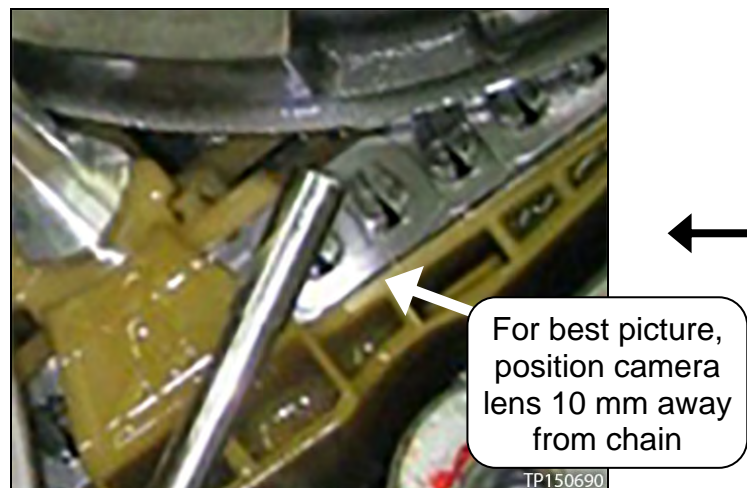
- Figures 9 and 10 shows the routing and location of the camera.

NOTE: The CVT's side cover was removed for easier viewing of camera location. The side cover is not to be removed at any time during this procedure.

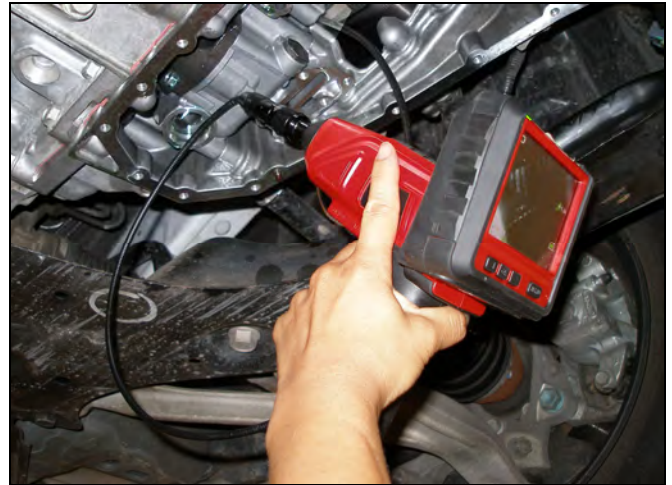
Figure 11

- Holding the borescope with one hand allows for turning the tire with the other hand (see Figure 11).

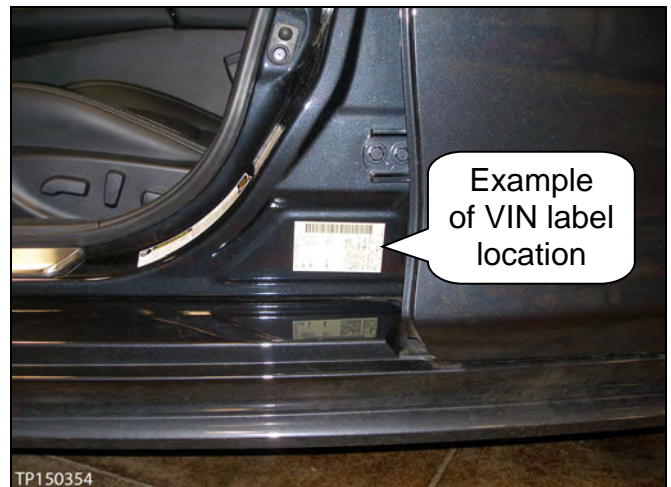
Figure 12

e. Once CVT replacement is determined as required, use borescope J-51951 to record a 15 second or less continuous video of the most severe evidence of chain slip and the VIN on the F.M.V.S.S. certification label (VIN label). See example in Figure 12.

- For best picture, the camera lens should be about 10 mm away from the object being recorded.

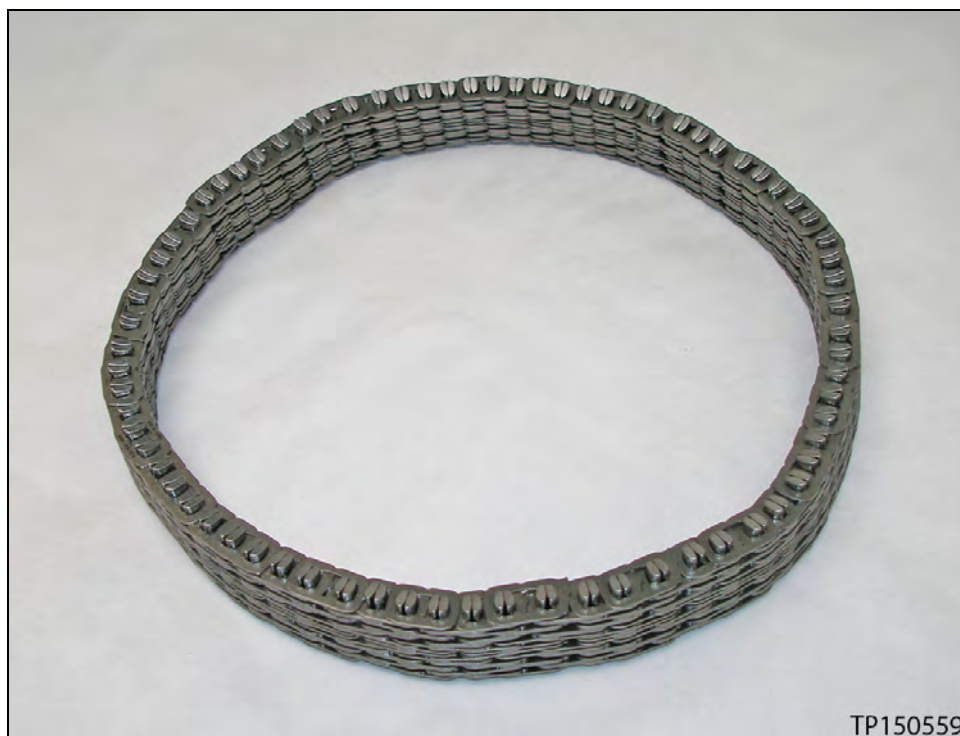
Figure 14: CVT chain

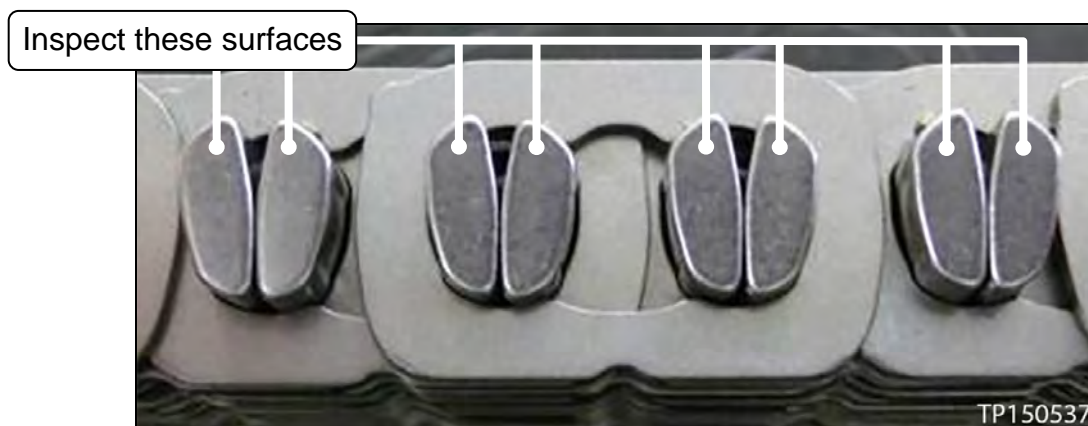
Figure 15: Close-up of area to be inspected

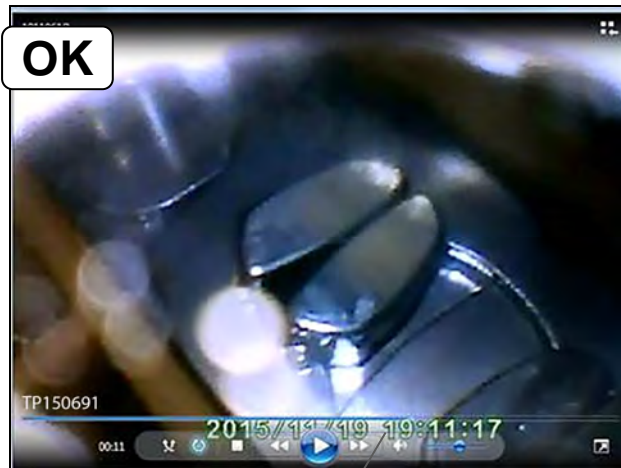
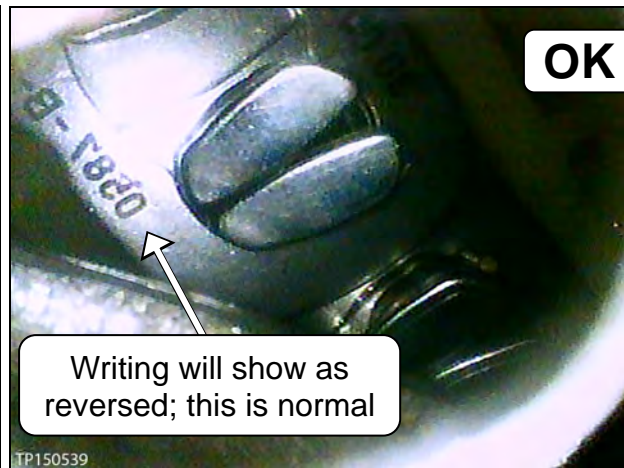
Pictures in Figure 16 and 17 were taken with borescope J-51951.

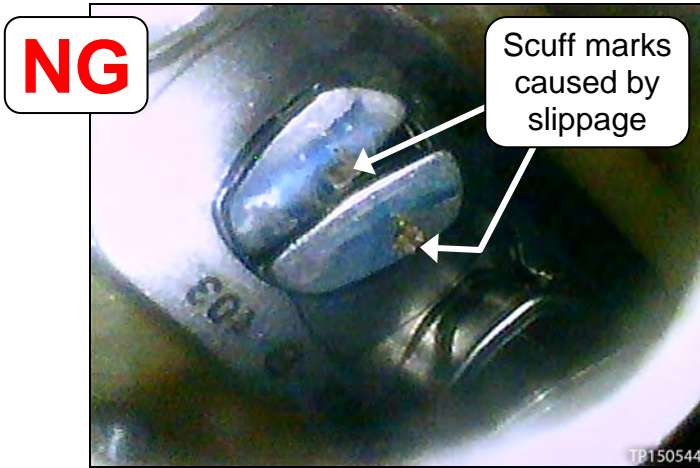
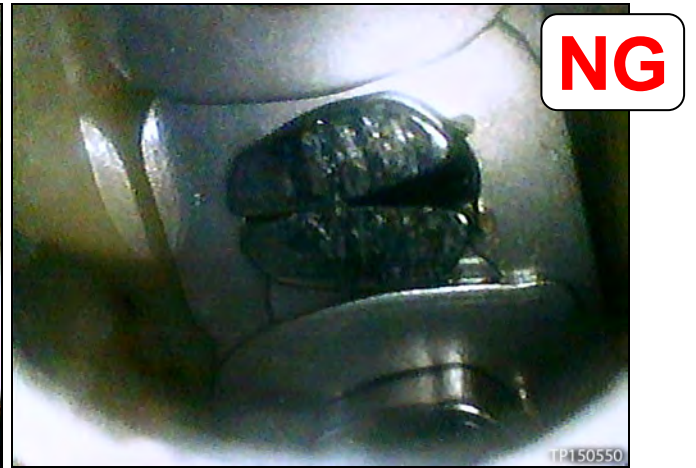
Pictures in Figure 20-21 were taken with borescope J-51951.

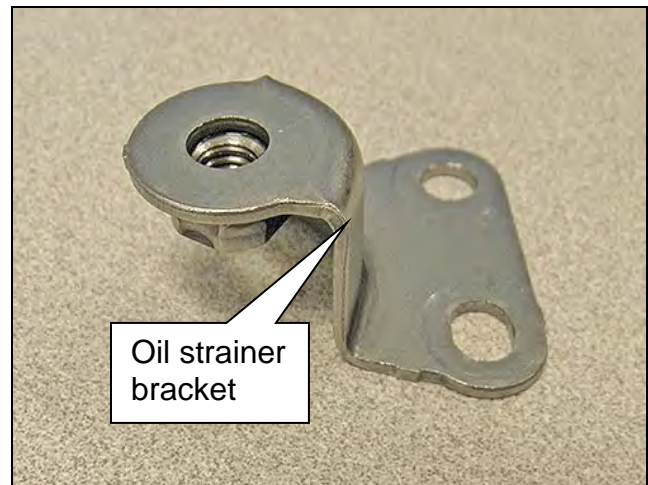
Figure 25

1. Discard the oil strainer bracket (Figure 25).

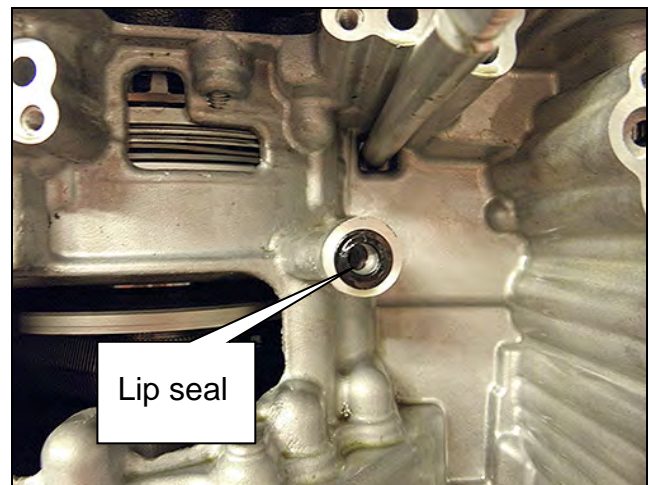
Figure 26

2. Install a new lip seal. Do NOT reuse the old lip seal (Figure 26).

NOTE: Apply a small amount of petroleum jelly to the lip seal to keep it in place on the CVT.

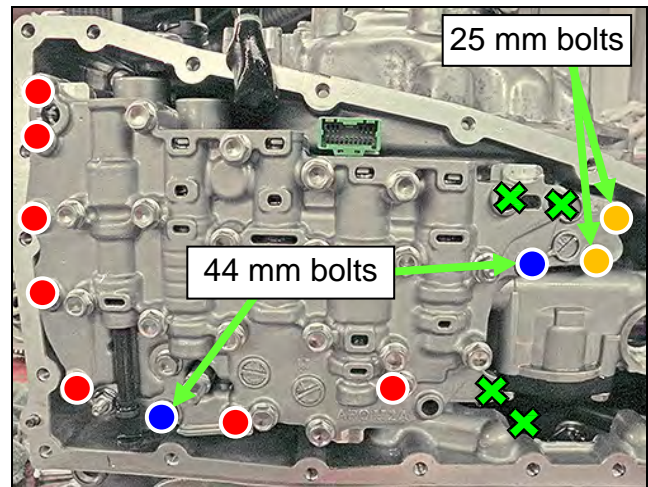
Figure 27

3. Install the Control Valve with eleven (11) mounting bolts (Figure 27).

IMPORTANT: Leave Four (4) ✕ bolt holes blank at this step.

- 54 mm long bolt ● – 7 pieces
- 44 mm long bolt ● – 2 piece
- 25 mm long bolt ● – 2 piece

CAUTION: The two 25 mm bolts are installed WITHOUT the strainer bracket.

- Bolt torque: 7.9 N•m (0.81 kg-m, 70 in-lb.)

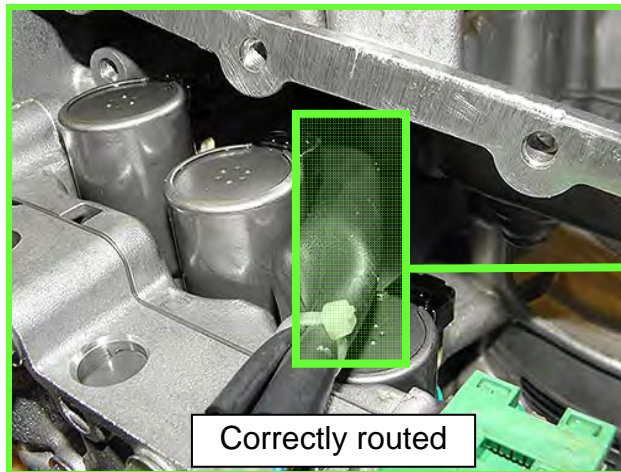
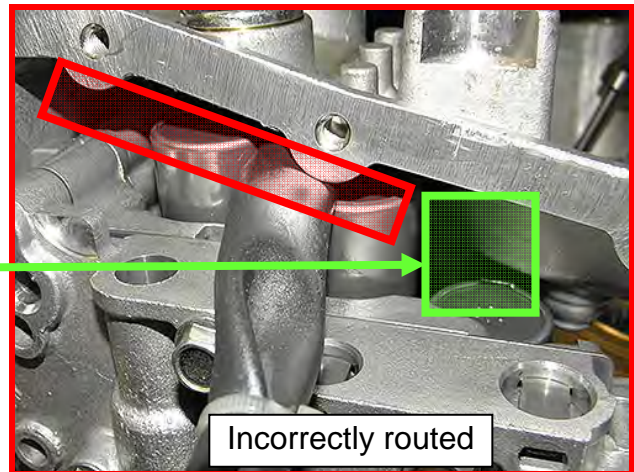
CAUTION: Make sure the wiring harness does not get pinched (see Figures 28 and 29 for correct routing).

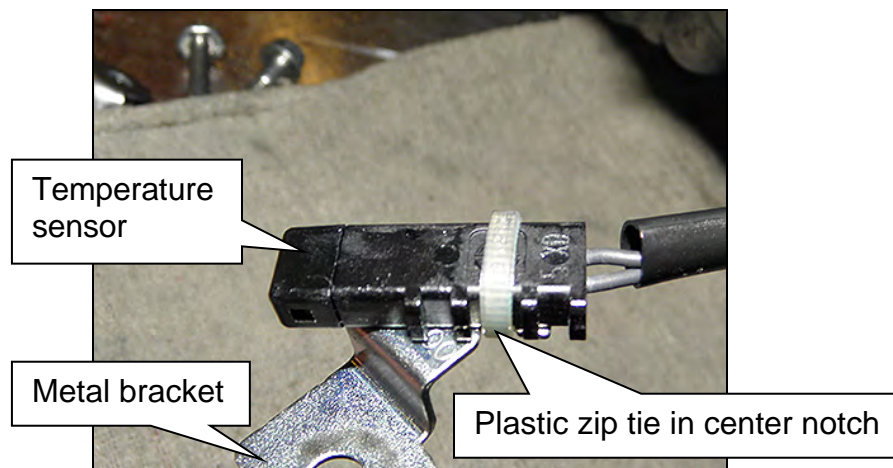
Figure 30

- a. Cut the plastic zip tie with an appropriate tool to remove the temperature sensor bracket from the terminal harness assembly. (Figure 30).

CAUTION: Cut the plastic zip tie over the metal bracket to avoid damage to the temperature sensor.

IMPORTANT: Locate the plastic zip tie at the **center notch** of three notches on the temperature sensor.

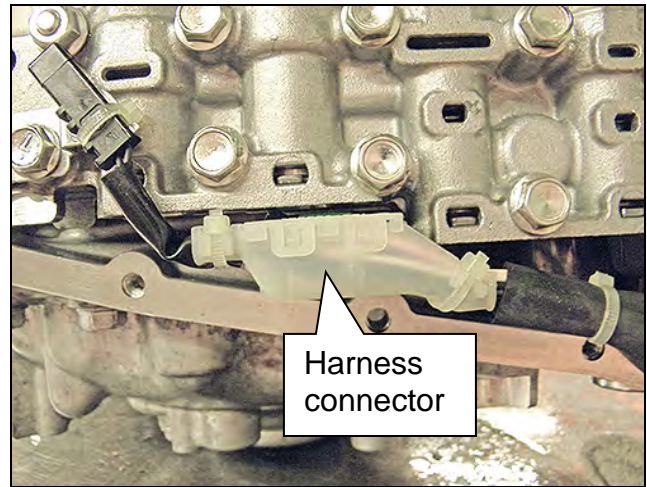
Figure 31

5. Connect the electrical harness connector (Figure 31).

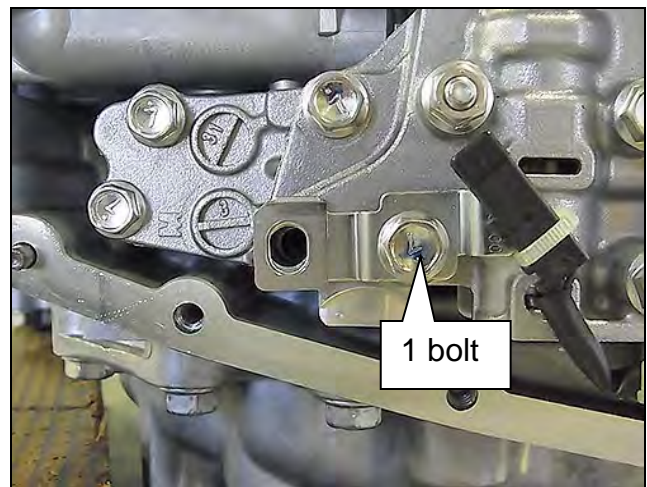
Figure 32

6. Install the CVT fluid temperature sensor bracket to the valve body with one (1) bolt (Figure 32).

NOTE: Leave one (1) bolt hole blank as it will be used to secure the oil strainer at a later step.

- Bolt torque: 7.9 N•m (0.81 kg-m, **70 in-lb.**)
- Bolt length: 54 mm

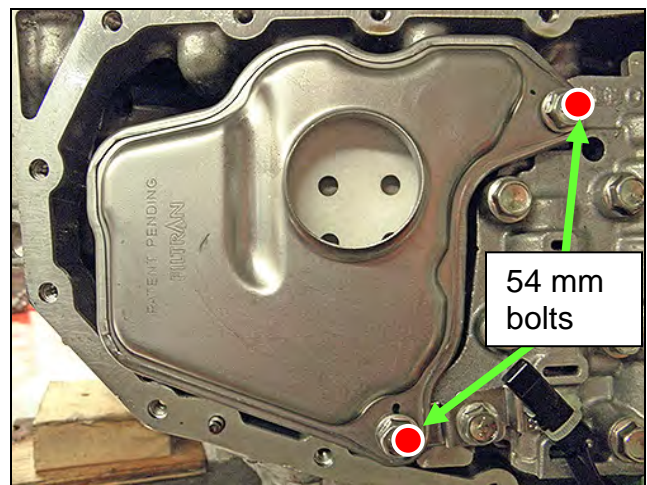
Figure 33

7. Install the new oil strainer with its new O-ring seal with two (2) bolts (Figure 33).

NOTE: replacement strainer maybe a different shape.

- Bolt torque: 7.9 N•m (0.81 kg-m, **70 in-lb.**)
- 54 mm long bolt

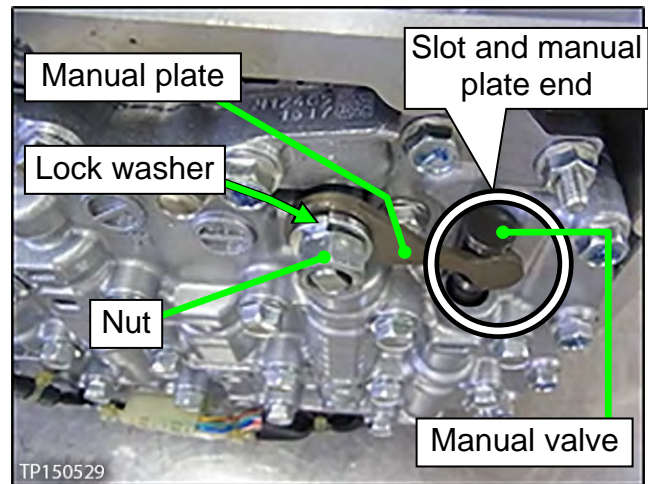
Figure 34

8. Install the manual plate, lock washer, and nut (Figure 34).

NOTE: Make sure the manual plate fits into the slot of the manual valve before applying torque to the nut.

- Reuse the existing manual plate, lock washer, and nut.
- Nut torque: 22.1 N•m (2.3 Kg-m, **16 ft-lb.**)

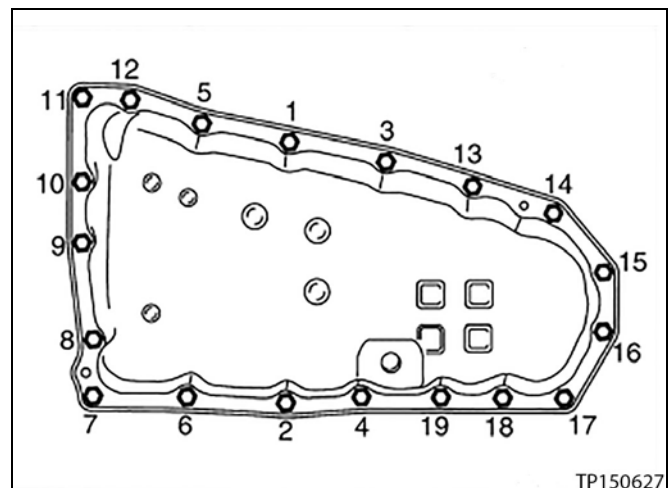
Figure 35

12. Install the oil pan bolts (see Figure 35).

- Reuse the existing pan bolts.
 - Oil pan bolts torque: 7.9 N•m (0.81 kg-m, **70 in-lb.**)

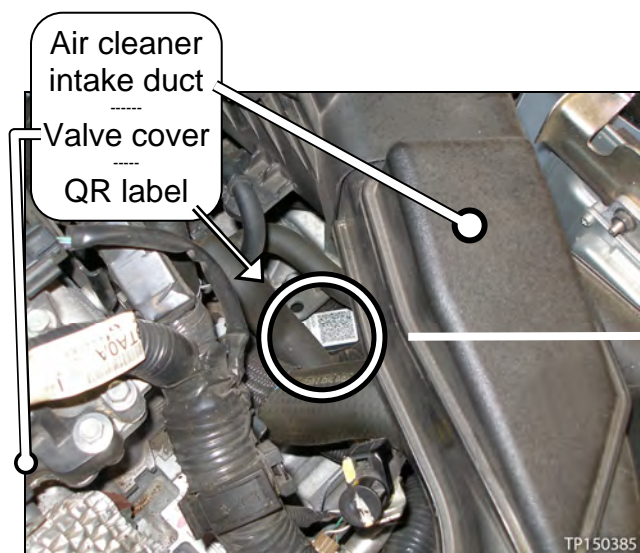
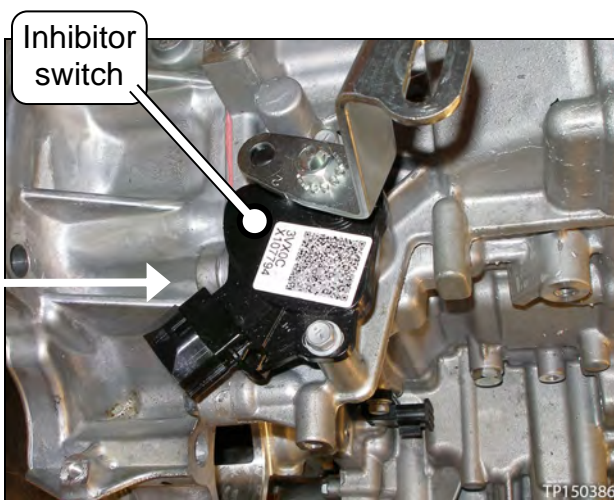
- Refer to **TM – Transaxle & Transmission / BASIC INSPECTION**, and perform **ADDITIONAL SERVICE WHEN REPLACING TRANSAXLE ASSEMBLY**.
 - Check for fluid leakage.
 - Attach the QR label with the new calibration data onto the transmission range switch (inhibitor switch).
 - See Figure 36 and 37 below.
 - A QR Label and CD-R are included with the replacement valve body.
