SERVICE CAMPAIGN BULLETIN

NTB16-120a

VOLUNTARY SERVICE CAMPAIGN 2013 – 2014 PATHFINDER; CVT

APPLIED VEHICLES: 2013 – 2014 Pathfinder (R52)

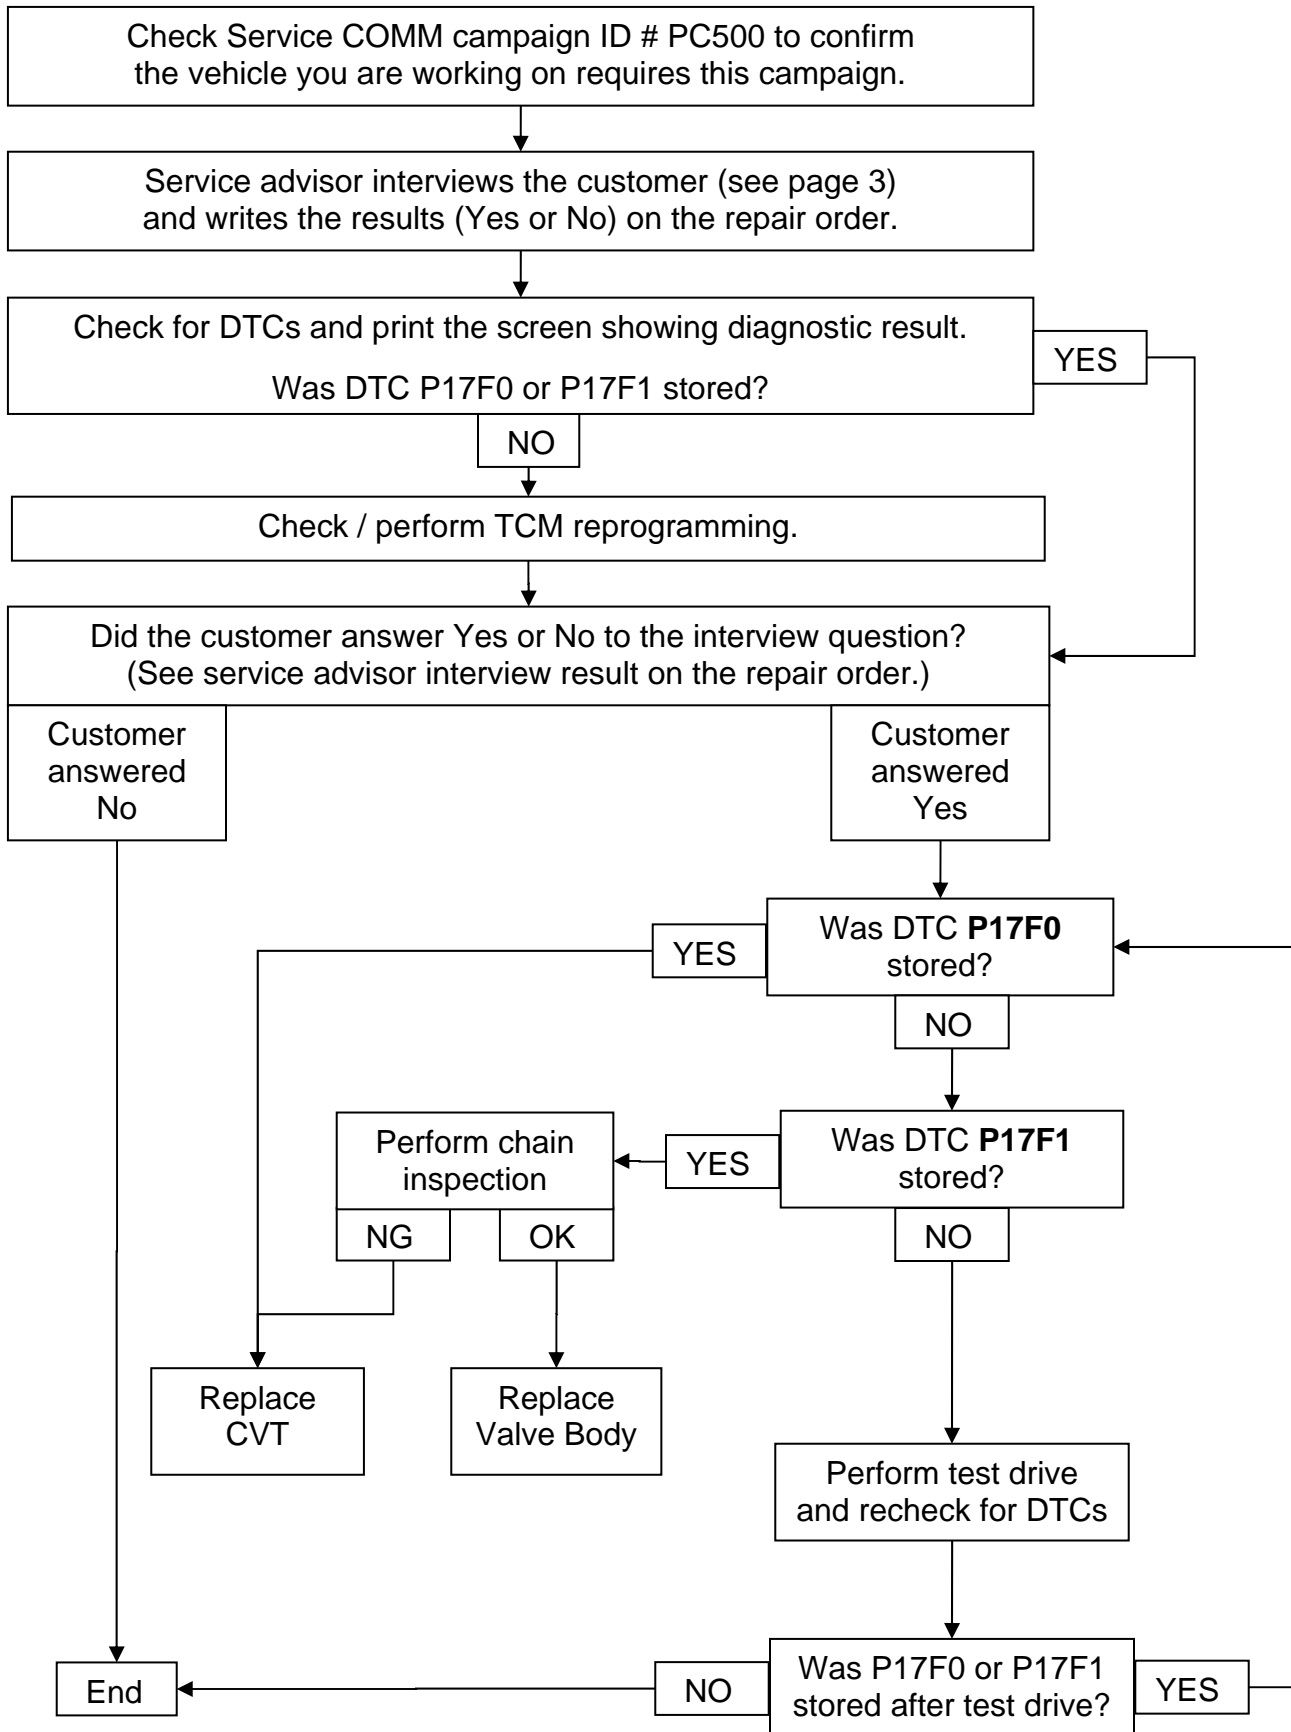
REPAIR OVERVIEW

Nissan is conducting this voluntary service campaign on certain specific 2013-2014 Pathfinder vehicles to reprogram the TCM and, if needed, inspect and replace the CVT or CVT control valve. This service will be performed at no charge to the customer for parts or labor.

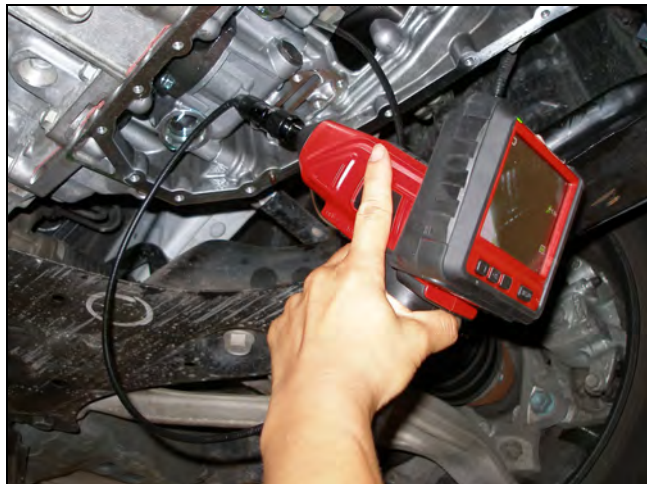
Figure 2C

- Holding the borescope with one hand allows for turning the tire with the other hand (see Figure 2C).

CAUTION: If the tire is rotated in the rearward rotation, the camera lens may get caught between the chain and pulley.

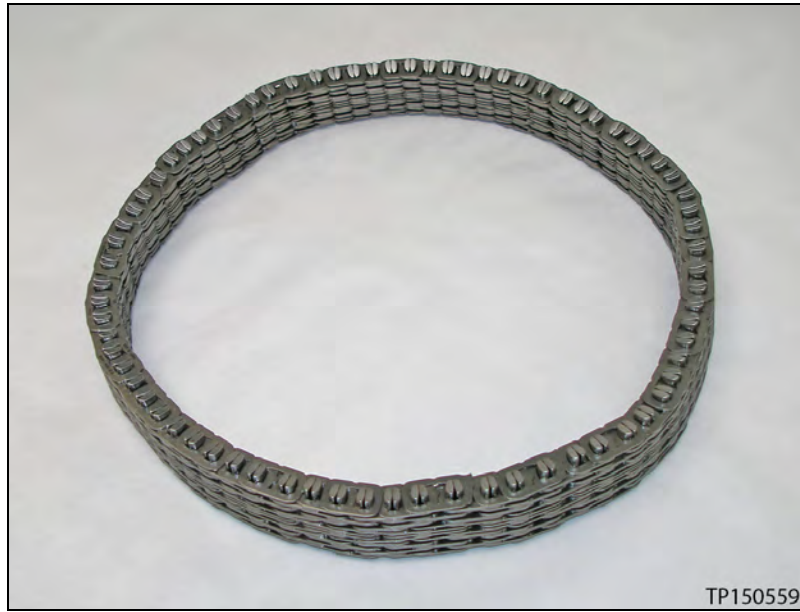
Figure 9C: CVT chain

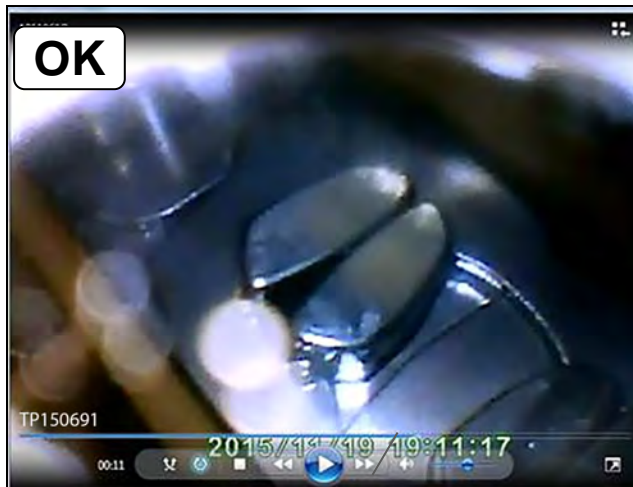
Photos in Figure 12C and 13C were taken with borescope J-51951.

NOTE: Reference the photos on pages 22 – 24 for examples of chain slippage and for comparison to the vehicle you are working on.

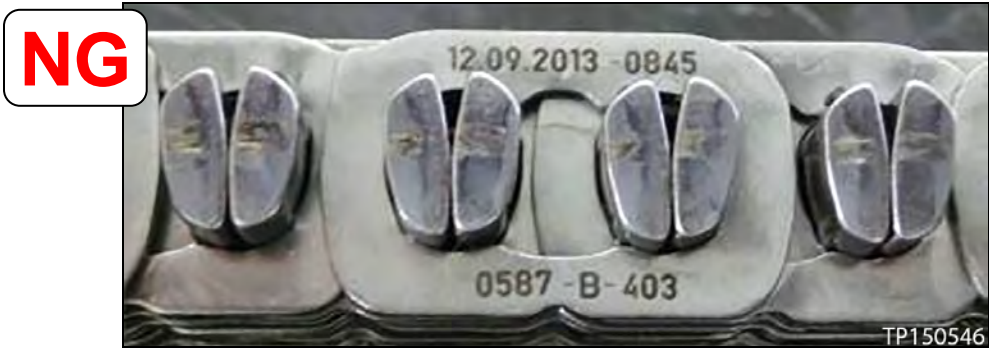
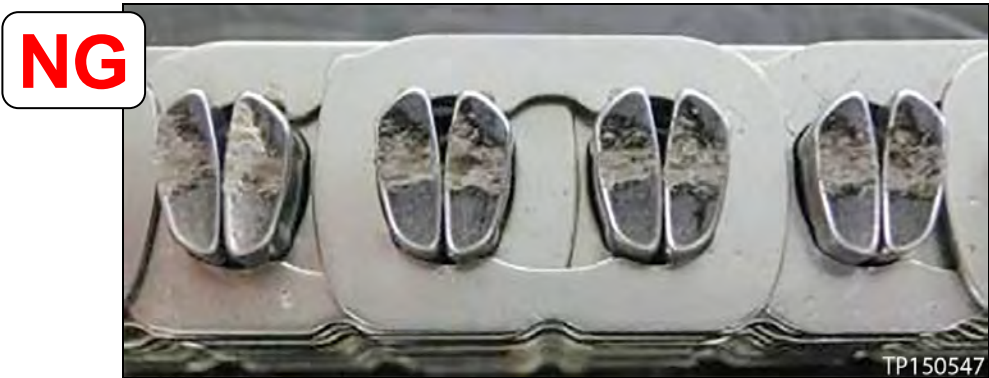
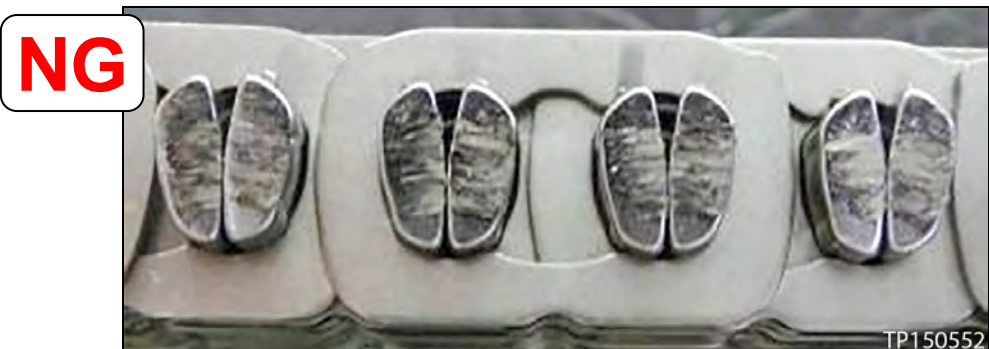
Pictures in Figure 16C – 20C were taken with borescope J-51951.
